# Foundation Report:

**3005 26th Street  
Vernon, BC  
V1T 4T9**

**Purpose of report:** Assessment of foundation

**Scope of assessment:** Assessment of foundation and drywall cracks

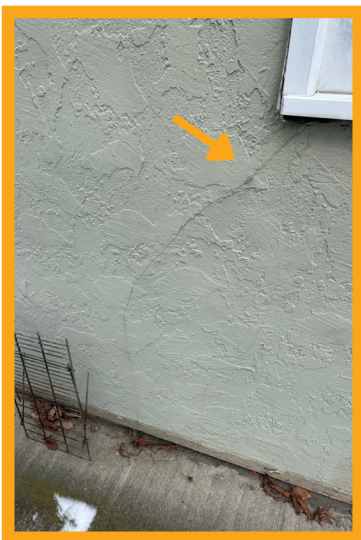
1.a

**Type:** Diagonal settlement crack

**Location:** Stucco exterior near the window and foundation

**Cause:** Differential movement between the main house and the sinking porch foundation

**Signs of Structural Stress:** The crack originates near the window frame, which is a common stress point in foundation movement cases.

To mitigate further movement and stabilize the affected area, we recommend injecting polyurethane beneath the existing porch foundation. This method will solidify and densify the bearing soils, increasing their load-bearing capacity and reducing settlement risks.

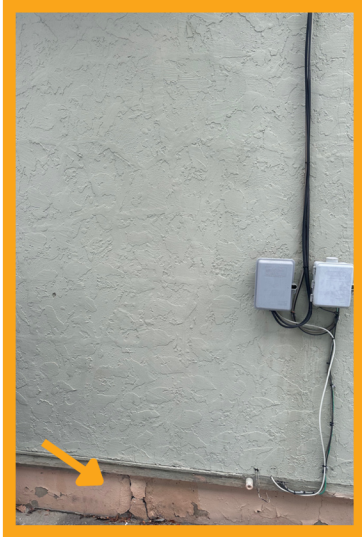
1.b

**Type:** Severe settlement crack / separation

**Location:** Base of the porch foundation, near the junction with the main structure

**Cause:** The porch foundation is sinking, causing detachment from the main structure

**Severity:** Significant - Visible separation, material loss, and crumbling

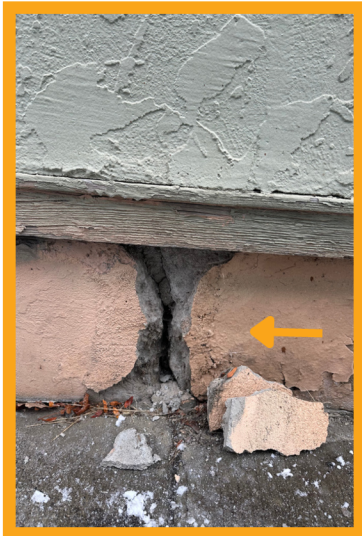
1.c

Same crack pictured in 1. b after material has been removed.

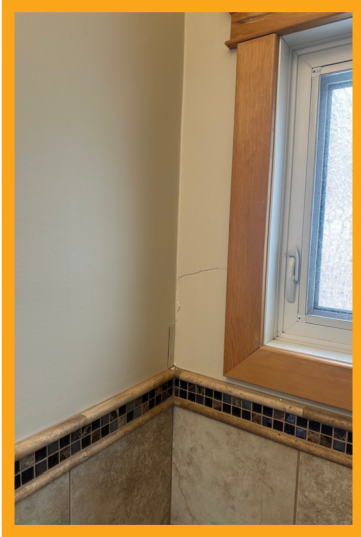
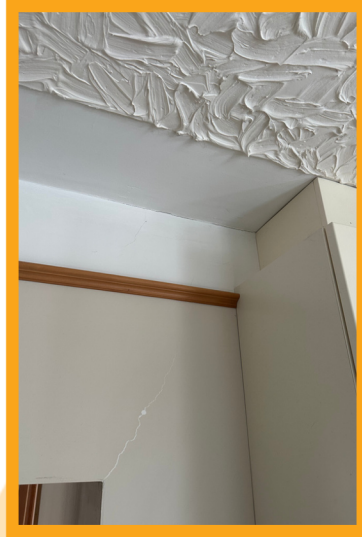
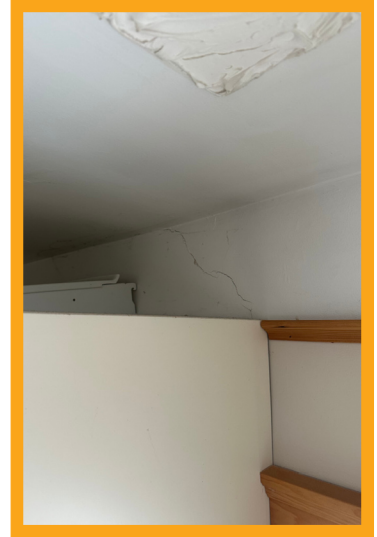
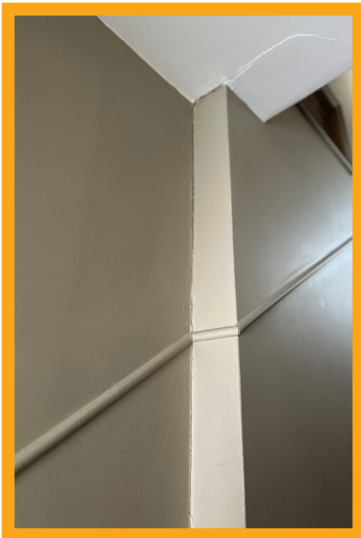
The observed drywall cracks inside the home are consistent with the ongoing settlement of the porch foundation. As the porch sinks and shifts, it places differential stress on the main structure, leading to cracking in the interior finishes, particularly near windows, doors, and wall intersections.

Given the correlation between exterior foundation cracks and interior drywall damage, this further supports the porch as the primary source of settlement-related stress. If left unaddressed, continued movement may lead to progressive interior damage and further structural strain on the adjoining areas of the home.

The drywall cracks and foundation crack is a clear indicator of ongoing foundation movement. Timely intervention is necessary to prevent worsening structural damage. The recommended approach remains soil stabilization using polyurethane injection, drainage improvements, and crack repair post-stabilization.
