THE CORPORATION OF THE CITY OF VERNON REPORT TO COUNCIL

SUBJECT: HISTORIC O'KEEFE RANCH FACILITY CONDITION ASSESSMENT

Facility Condition Assessment

At the City of Vernon's request Read Jones Christoffersen Ltd. (RJC) has completed a Facility Condition Assessment (FCA) at the Historic O'Keefe Ranch located at 9380 BC-97 near Vernon, BC per our proposal dated September 14, 2023. The FCA forms part of Phase 1 of the overall services. Phase 1 also includes preparation of Statements of Significance (SoS).

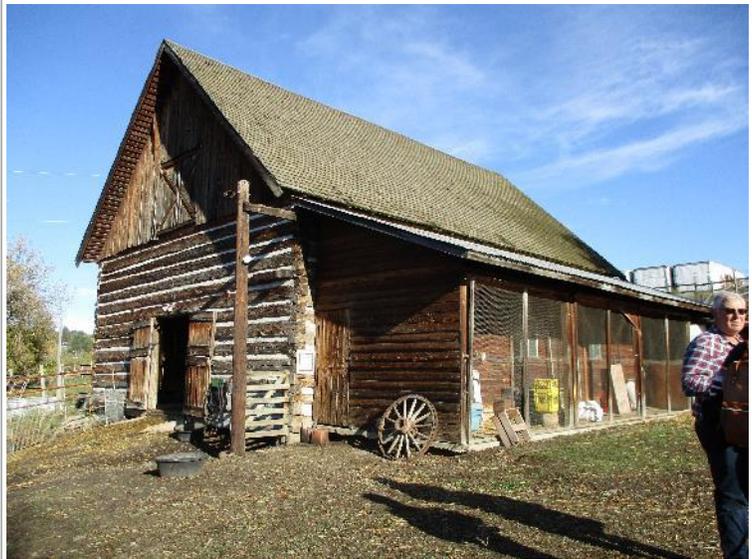
Photo 36

11: Log Barn:
Stained roof sheathing.

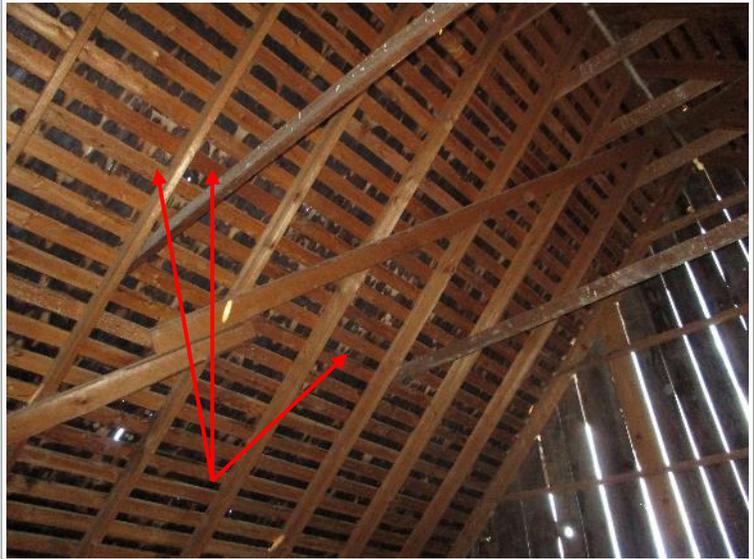
Photo 37

11: Log Barn:
Heaved out wood retaining wall.

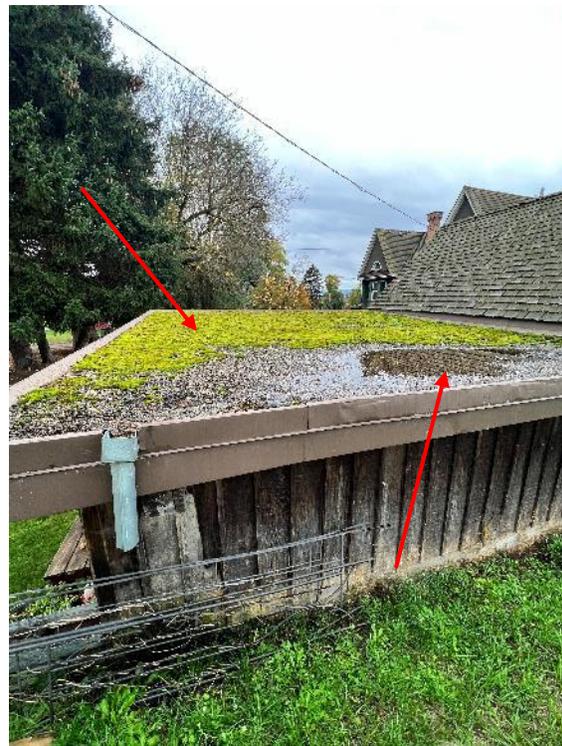
Photo 46

14: Meat & Dairy:
Corroded cladding and rotten structure at
North elevation.

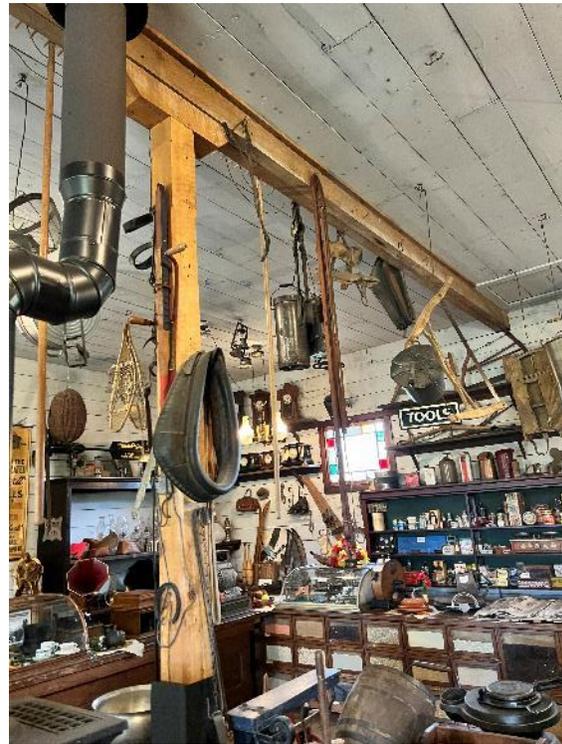
Photo 56

17: General Store:
Water-stained soffit.

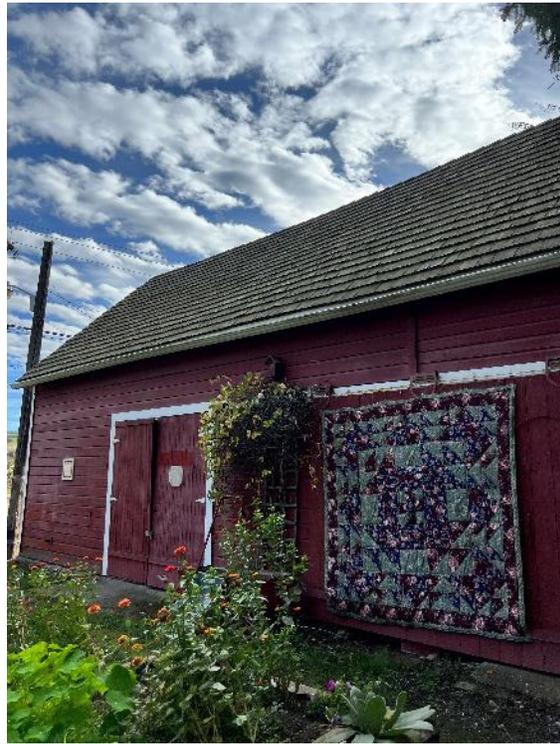
Photo 61

19: Red Shed:
Foundation bowed out at South elevation.

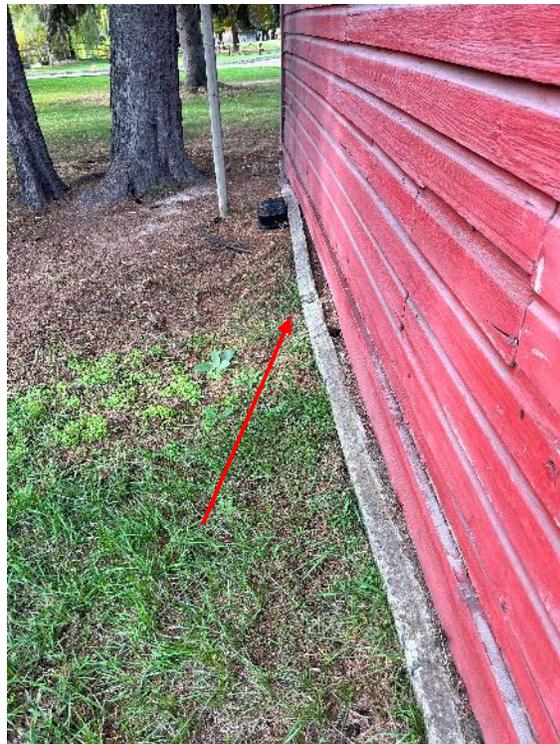
Photo 62

19: Red Shed:
Deflected ceiling in East room.

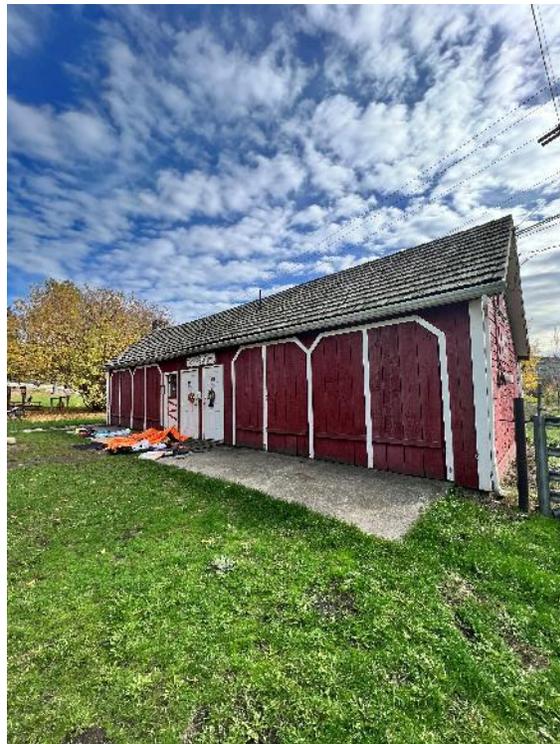
Photo 64

20: Carriage Shed:
Undermined foundation at South elevation.

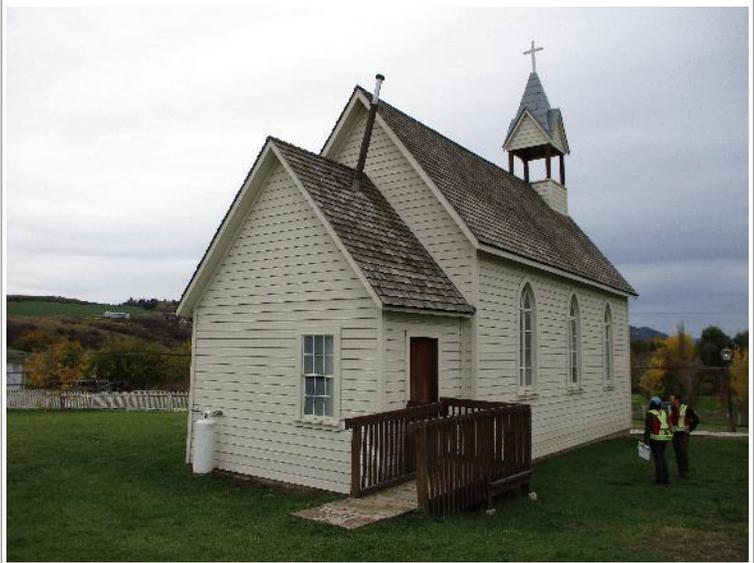
Photo 67

21: St. Anne's Church:
Typical condition of windows.

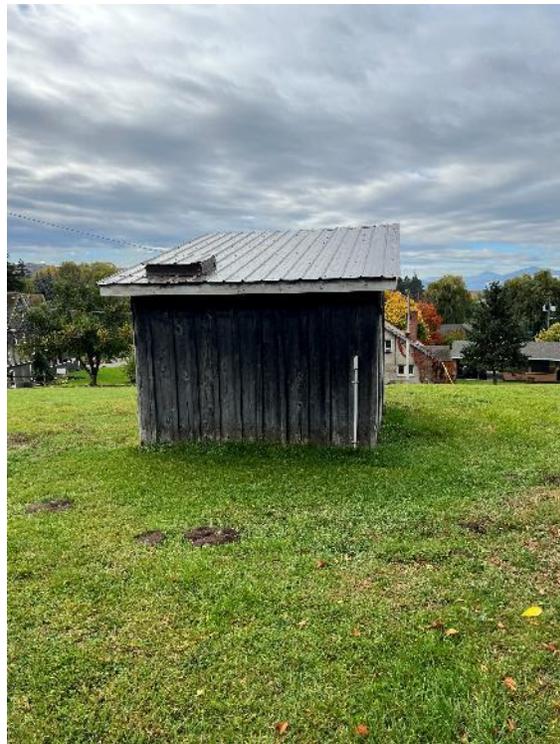
Photo 72

23: Pump House:
Interior water staining.

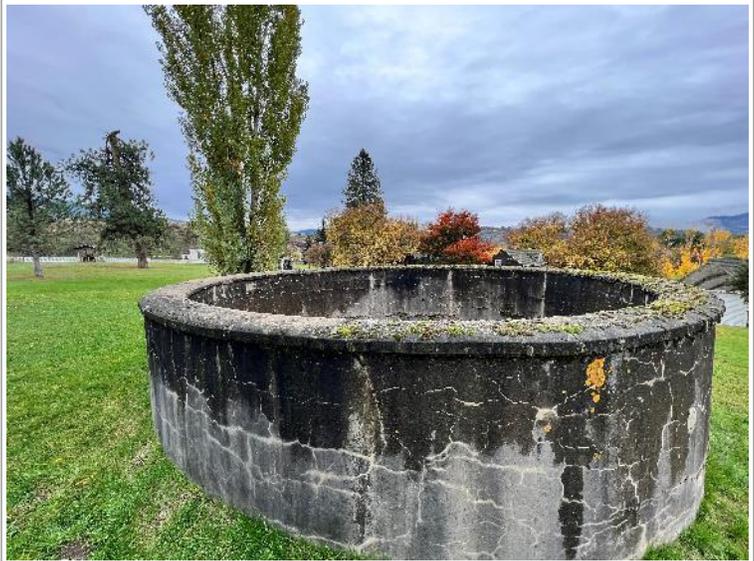
Photo 75

25: Water Cisterns:
Spalled parging at East uncovered cistern.

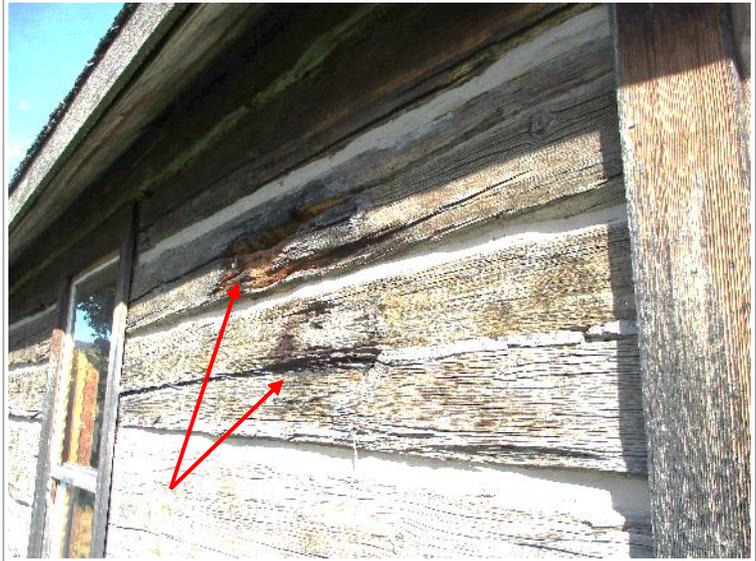
Photo 92

33: Balmoral School House:
Previous patch repair at south elevation.

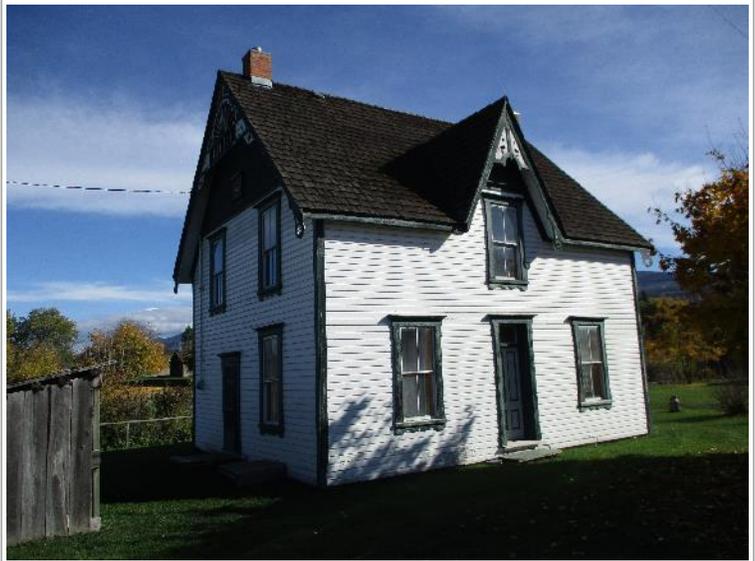
Photo 94

34: Schubert House:
Typical condition of windows.

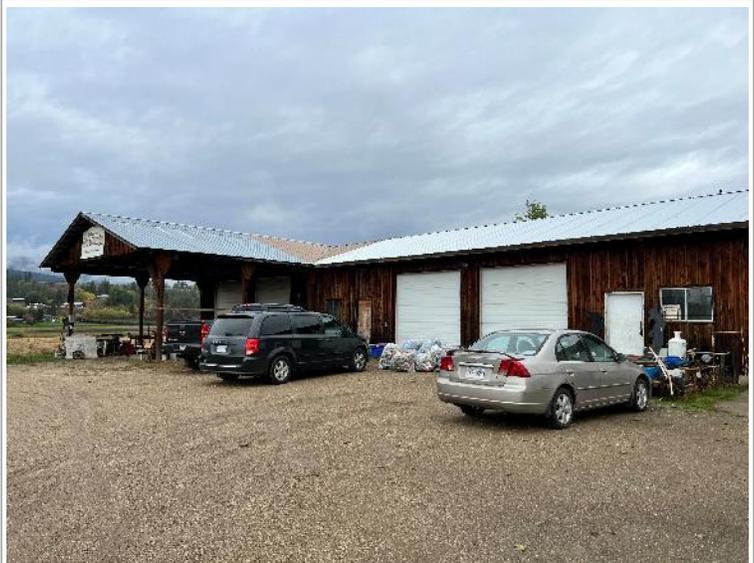
Photo 101

36: Spallumcheen Pioneer Power Club
Clubhouse:
Rotted buried post at North lean-to.

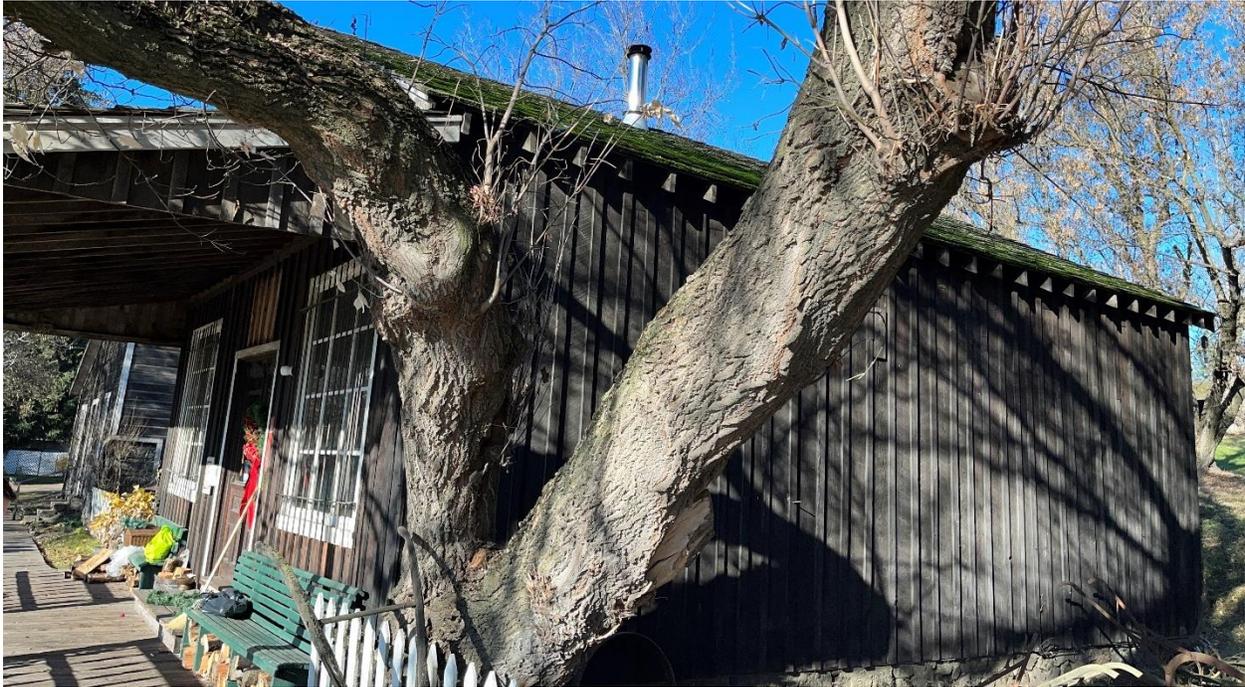
18 Blacksmith Shop

D3040 – Forge Venting Systems

- The systems should be replaced, and appropriate thimbles are needed for the penetrations through the roof. Risk Rank 5C.

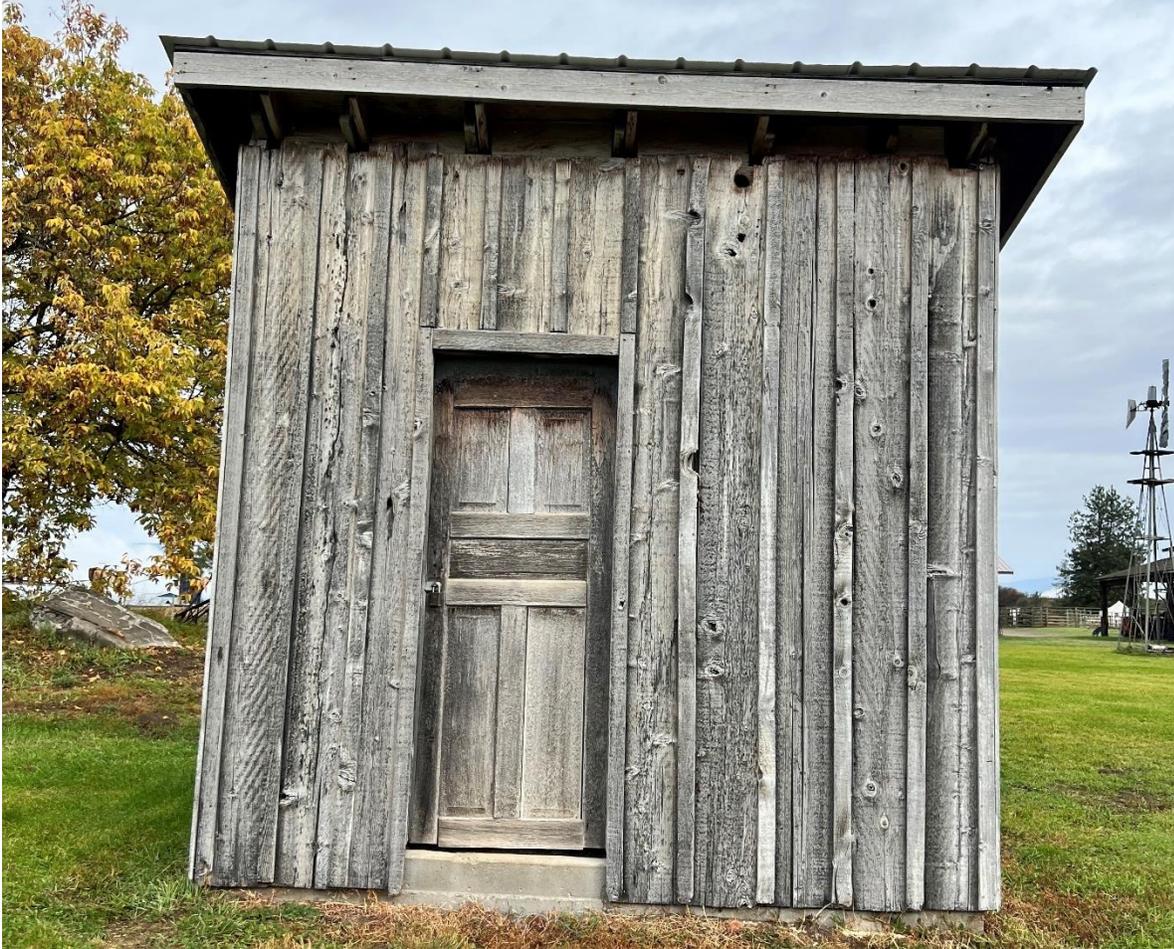
23 Pump House

D2020 - Domestic Water Distribution

- The next time the system needs work, we recommended replacing the galvanized piping with approved domestic water system piping. Risk Rank 3D.
