SUBJECT: HISTORIC O'KEEFE RANCH FACILITY CONDITION ASSESSMENT

Facility Condition Assessment

O'Keefe Ranch
Near Vernon, B.C
City of Vernon
Building Condition Assessment Report
Mechanical

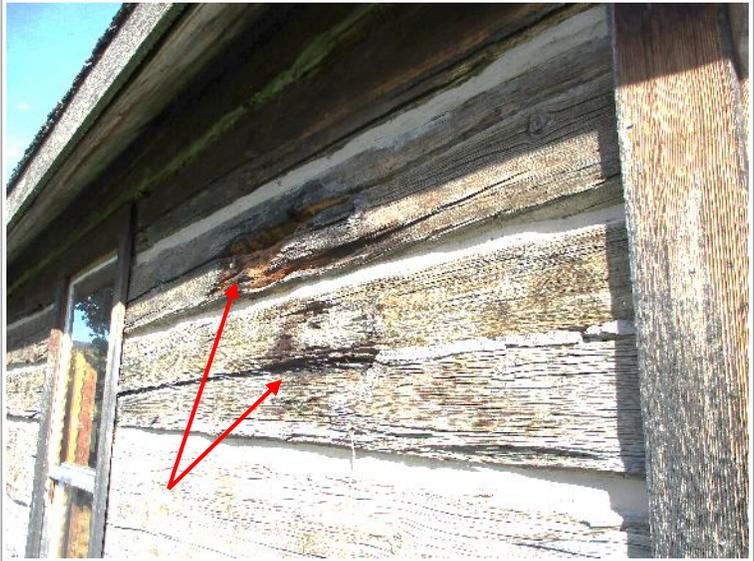
Photo 92

33: Balmoral School House:
Previous patch repair at south elevation.

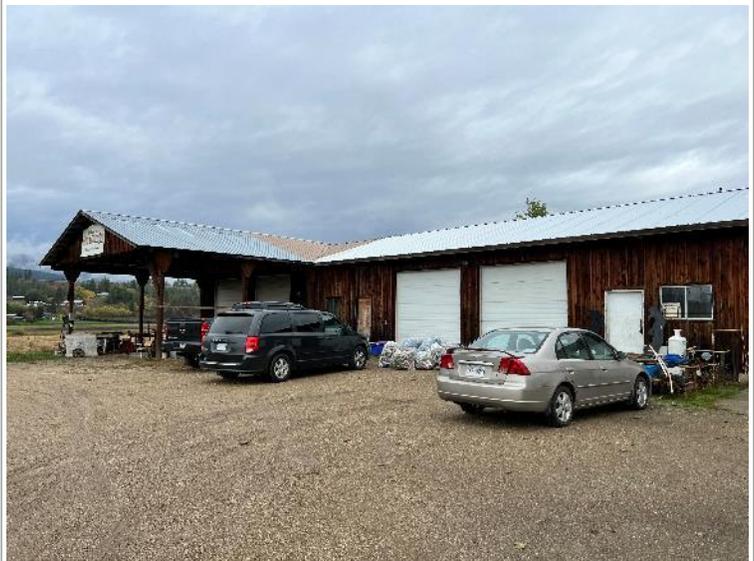
Photo 101

36: Spallumcheen Pioneer Power Club
Clubhouse:
Rotted buried post at North lean-to.

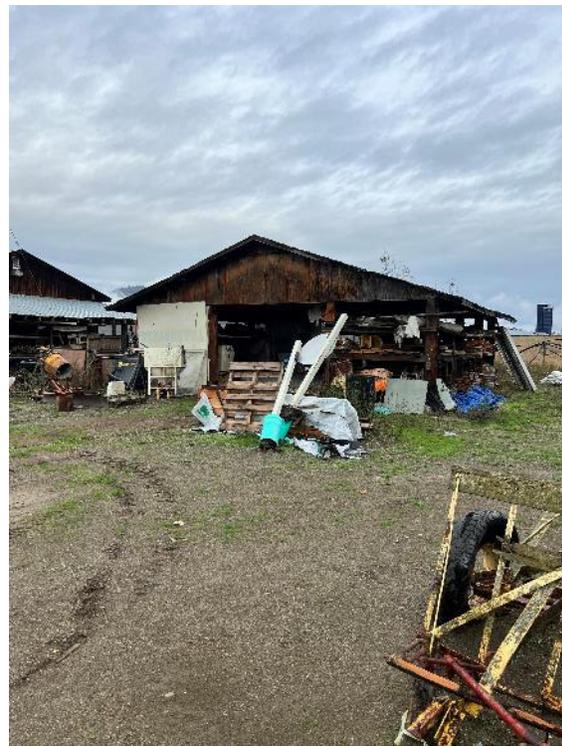
Photo 105

38: Storage Shed:
Missing shingles and sheathing at South end
of roof.
