**Re: Environmental Impact Assessment (EIA) – Proposed Residential Development,
Vernon Springs, 1607 43rd Avenue, Vernon, B.C.**

Environmental Impact Assessment
Proposed Multi-Family Residential Development
1607 43rd Avenue, Vernon, BC

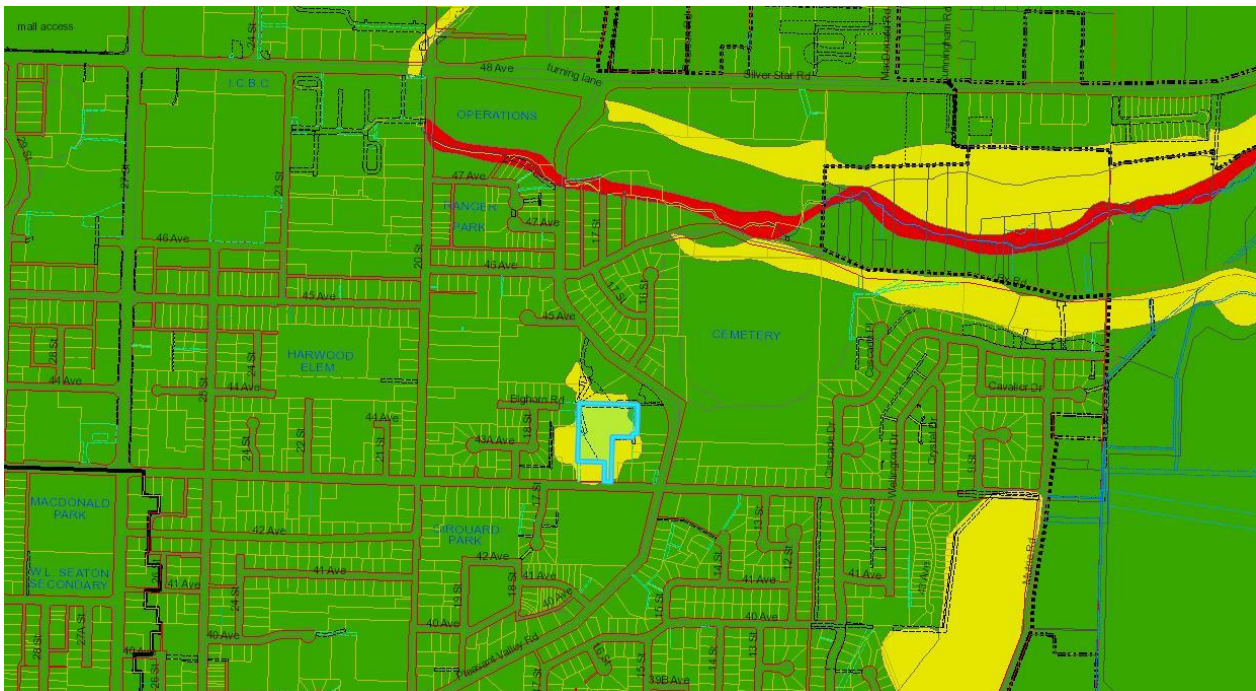
Figure 1: Location of the Site in Vernon and mapped EMA Polygons at and nearby the Site

There is a large polygon for a *Typha latifolia* (Common Cattail) Marsh that has been mapped (iMapBC) as covering the Site and adjacent properties. Refer to the polygon outlined in blue presented in Appendix B. The approximate outline of the Common Cattail Marsh is also outlined in green on the Habitat Map in Appendix A. This mapped polygon closely resembles the polygon mapped on the Vernon web map for the EMA Strategy Moderate Sensitivity (yellow) polygon shown on Figure 1.

There is a Red-listed Ecological Community along B.X. Creek East of Swan Lake (Occurrence ID 10474) identified as a *Populus trichocarpa* / *Symphoricarpos albus* - *Rosa* spp. ecological community. The mapped polygon for the *Populus trichocarpa* / *Symphoricarpos albus* - *Rosa* spp. (black cottonwood/common snowberry/ rose) ecological community closely corresponds to the City's EMA Strategy High Sensitivity (red) polygon about 350 m north of the Site (refer to Figure 1).

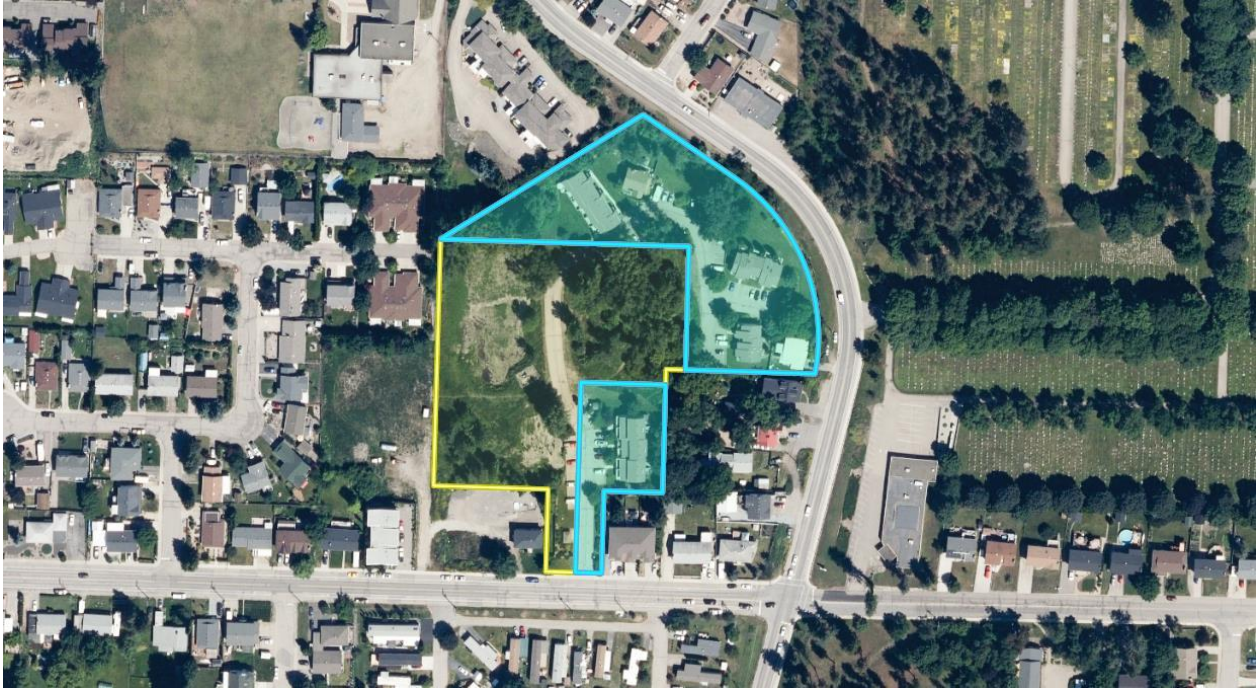
Figure 2: Aerial imagery of the Site in Vernon (yellow outline) and existing adjoining development (blue outline)

As shown in the 2022 aerial imagery of the Site in Figure 2, as well as the Location Map in Appendix A, the Site is mostly vacant except for the access road and existing surface parking for the adjacent apartment building to the southeast. The adjacent apartment building to the southeast (blue outline) also has a civic address of 1607 43rd Avenue. There are adjoining buildings to the north and northeast of the Site that have a civic address of 4308 Pleasant Valley Road.

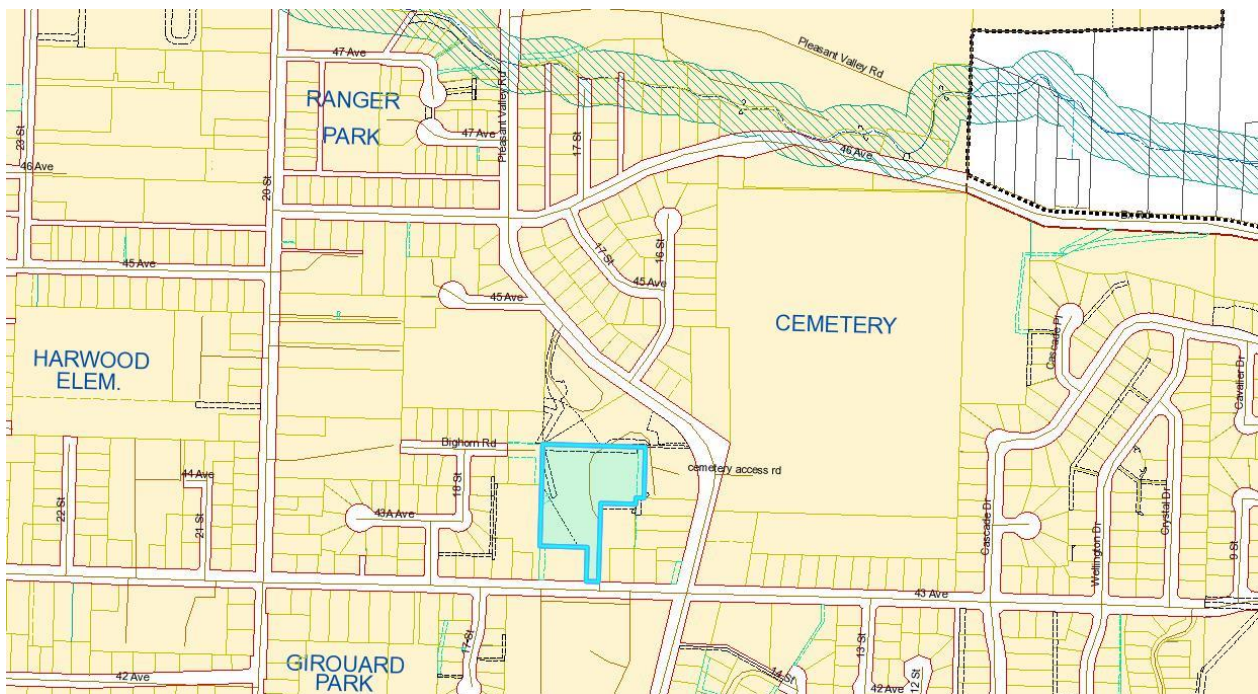
Figure 3: The natural stream, BX Creek, located north of the Site showing the Riparian Assessment Area along the stream.

The closest fish-bearing stream to the Site is B.X. Creek around 380 m distant to the north of the Site. B.X. Creek (Watershed Code 310-939400-08200) has recorded populations of rainbow trout, brook trout, sucker, carp, prickly sculpin, and burbot (BC Habitat Wizard) and drains to Swan Lake. The Riparian Assessment Area (RAA) of B.X. Creek (30 m) does not intersect the Site. There are no other fish habitats nearby the Site based on databases and field observations of the vicinity of the Site.

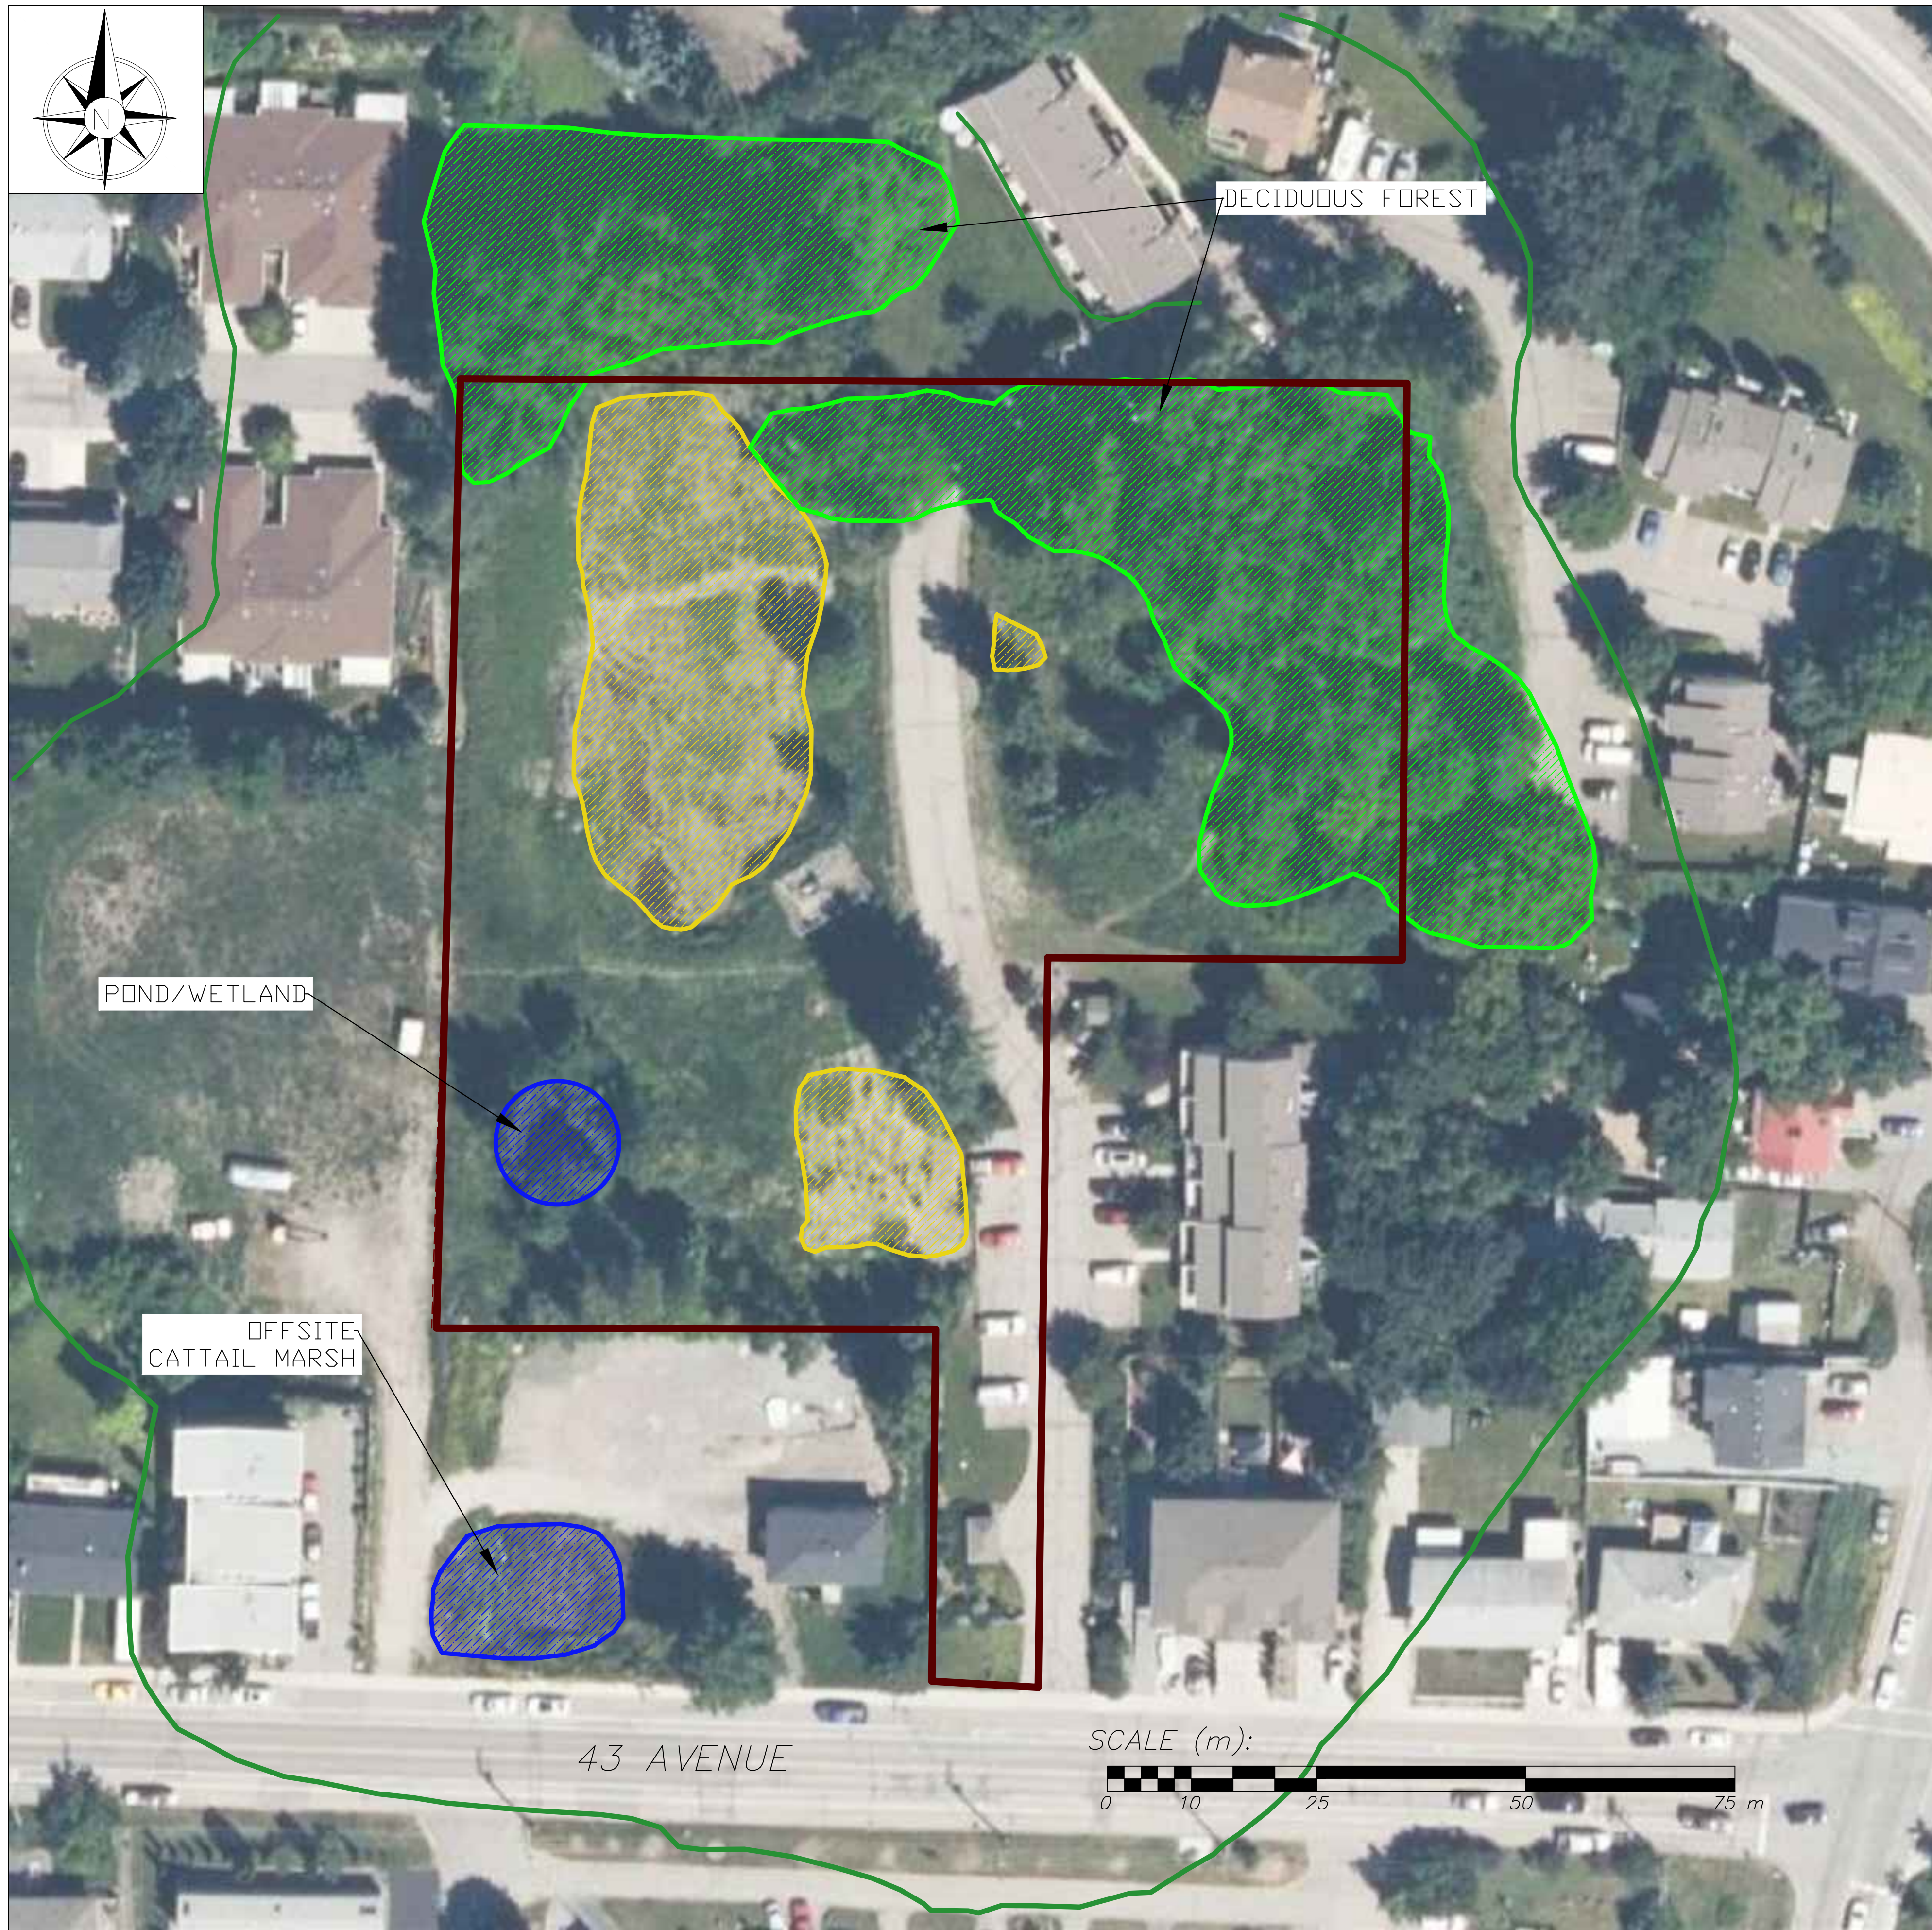
HABITAT MAP

Remnant excavations for building foundations that were not built are within the disturbed vegetation type as shown on the Habitat Map in Appendix A. The excavation areas are extensively lined with crushed (~3-4 in.) rock. The largest of the excavations near the northwest corner of the Site also has accumulations of silts between the rocks with small pockets of standing water observed in the lowest northwest and southeast corners. While appearing to be regularly mowed, there is bulrush (cattail) and sedge vegetation within the base of the excavation in the largest excavation to the northwest side of the Site. The side slopes of the excavations primarily consist of mowed grasses. The southern excavation is predominantly exposed crush rock along its base. A small pool of standing water and area of cattails extends to the southwest of the excavation along the south edge of the Site adjacent to 1609 43rd Avenue. The area west of the southern excavation is within the Restrictive Covenant area that also encompasses the pond wetland.

The following vegetation communities have been identified within and adjacent to the Site where existing urban development has not already occurred. Refer to the Habitat Map in Appendix A showing general habitat types found at the Site.

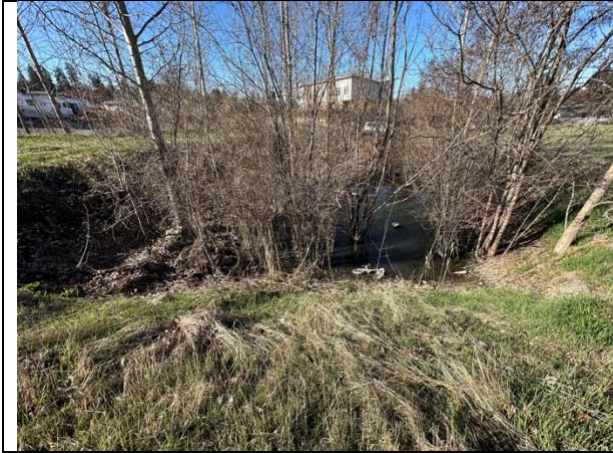
There is a small pond at the southwest corner of the Site which has been retained and protected by an existing Restrictive Covenant. The small pond was observed on April 17, 2023 to contain shallow, standing water with tree and shrub vegetation in and around the pond and grassed side slopes to the pond top of bank. Refer to the Site Photos presented in Appendix C. The City web map for storm sewer infrastructure shows that there is a stormwater pipe at the south edge of the pond that is connected to a storm sewer in 43rd Ave. and an extensive storm sewer network beyond. There is no indication that there is a surface flow connection of the pond to another water feature that may be fish habitat. As such, the small pond at the Site has been determined to be an isolated wetland. While the isolated pond wetland meets the definition of a “stream” under the BC Water Sustainability Act (WSA), it is not a fish habitat nor a “stream” as defined under the BC Riparian Areas Protection Regulation (RAPR) because it is an unconnected isolated wetland. Therefore, streamside setbacks or streamside protection and enhancement areas (SPEA) do not apply to the isolated pond wetland at the Site. However, the isolated pond wetland is protected under the WSA.

There is a small pond at the southwest corner of the Site. The pond was observed to contain shallow standing water during the April 2023 field assessment. The pond is a type of wetland and is an isolated wetland as discussed in section 6 of this report. There are cottonwood and willow trees and shrubs vegetating the margins of the pond with grasses covering the side slopes and areas surrounding the pond.

Photo 1: View of the pond wetland looking south

1. The triangular Restrictive Covenant (RC) area containing the pond wetland should be planted with native trees and shrubs to enhance side slopes of the pond wetland and adjacent areas of the RC area around the protected pond wetland. Adding ponderosa pine or similar coniferous native species as well as native birch and aspen trees should be considered to increase diversity and increase overall tree canopy coverage within the RC area.

2. The filled and mowed grass area between the pond wetland and the south Site boundary should be re-graded to lower the elevation within this area of the RC area, as well as within the area north of the pond wetland within the RC area. Following re-grading, planting of native trees and shrubs would occur.

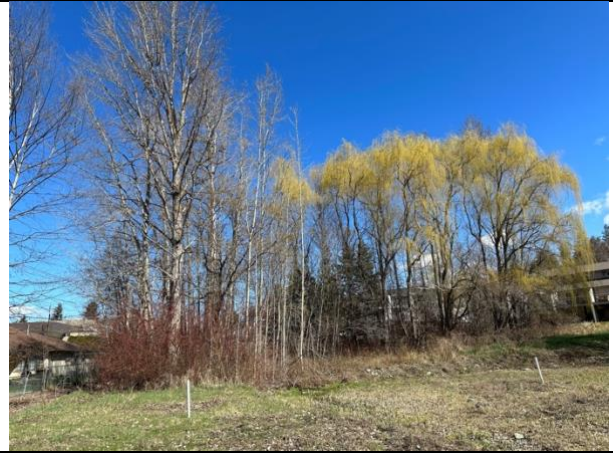
Photo 2: Forest in RC area north of the Site looking northeast

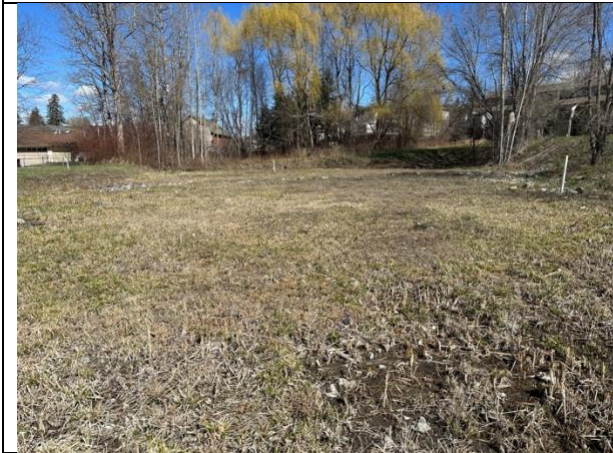
Photo 3: View of existing excavation at NW area of the Site looking north

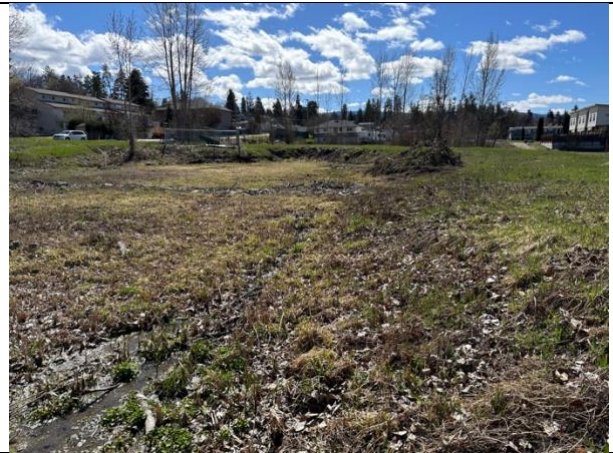
Photo 4: View of existing excavation at NW area of the Site looking south

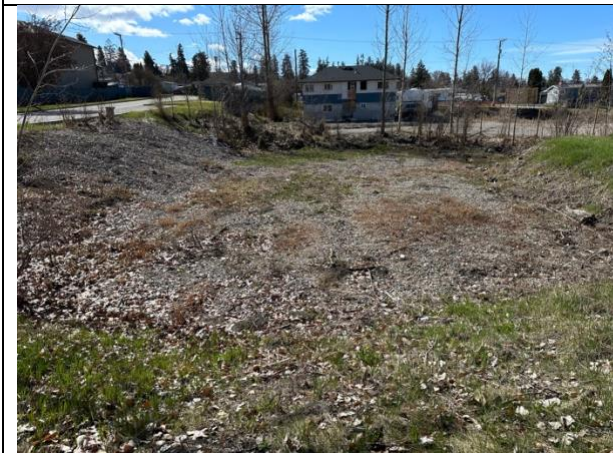
Photo 5: View of the southern excavation west of the ex. Road looking south

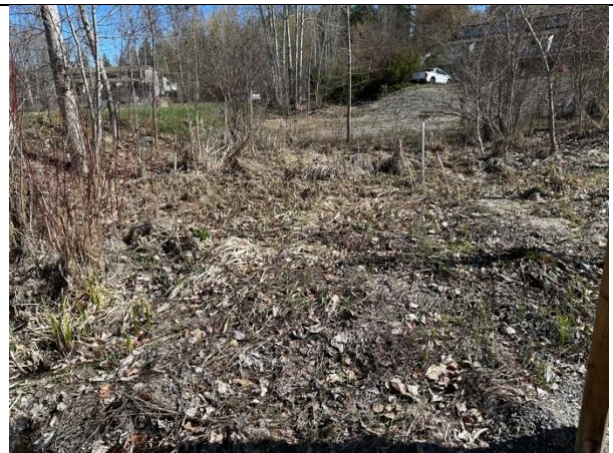
The mapped occurrence of a common cattail marsh ecological community has previously been affected by existing development alterations at and around the Site. Small pockets of cattail remain nearby the Site and adjacent to the protected pond wetland.

Photo 6: View of isolated marsh between pond wetland and south boundary of the Site

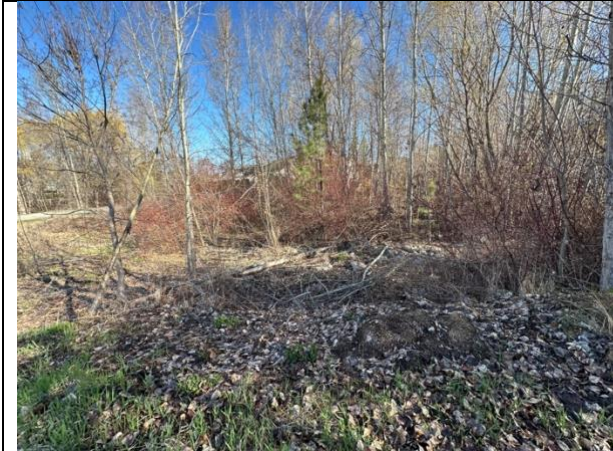
Photo 7: View of small excavation area at the NE area of the Site and adjacent forest

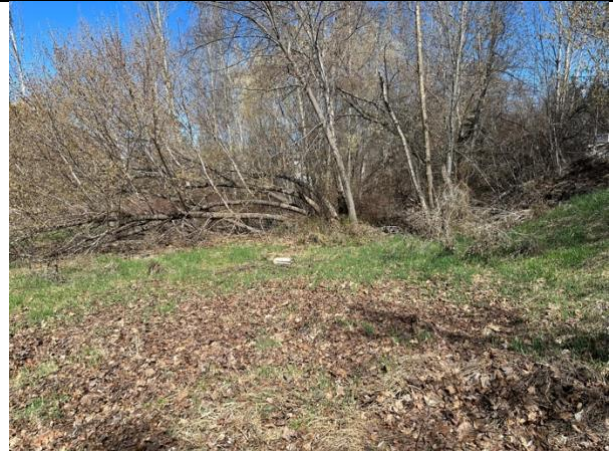
The loss of the deciduous forest in the northeast part of the Site will be the primary environmental impact associated with the proposed multi-family residential development. The loss of forest will result in reduced habitat availability for birds, small mammals, and deer. The deciduous forest that will be lost is small and fragmented within the surrounding extensively urbanized area of Vernon.

Photo 8: View of forest at the NE part of the Site where Building B will be situated

4. All land clearing and tree removal should be timed to avoid the songbird breeding window (April 1 to August 31). If tree removal and land clearing activities cannot avoid this construction timing window, then nesting bird surveys will need to be conducted to ensure compliance with the B.C. *Wildlife Act* and the Canada Migratory Birds Regulation.

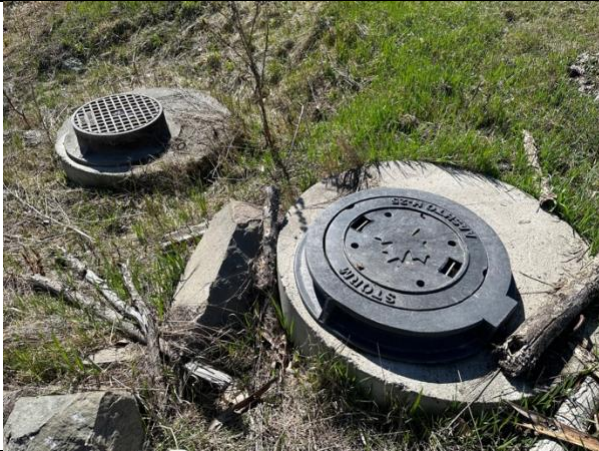
Based on field observations and mapping databases (e.g. City web map, iMap BC), there are not any creeks or ditches on the Site. During the April 2023 field assessment, a short ditch with standing water around an open manhole filled with water was observed on the adjacent property to the southwest of the Site at 1609 43rd Avenue. There is also a small pocket cattail marsh at the southwest corner of 1609 43rd Ave. adjacent to the Site. The adjacent cattail marsh appeared to be isolated and unconnected to any drainage features.

Photo 9: Existing manholes near middle west area of the Site

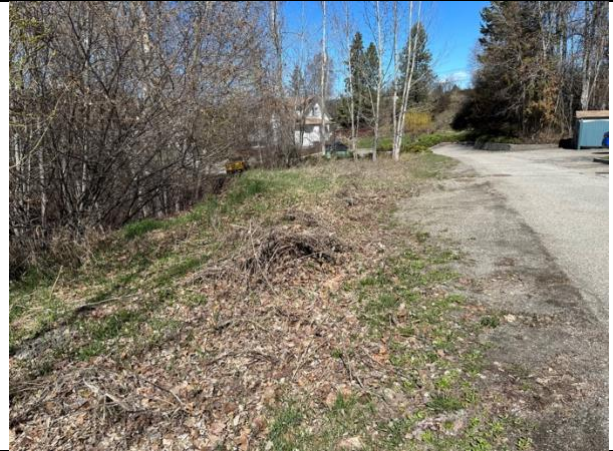
Photo 10: View of existing road and development northeast of the Site

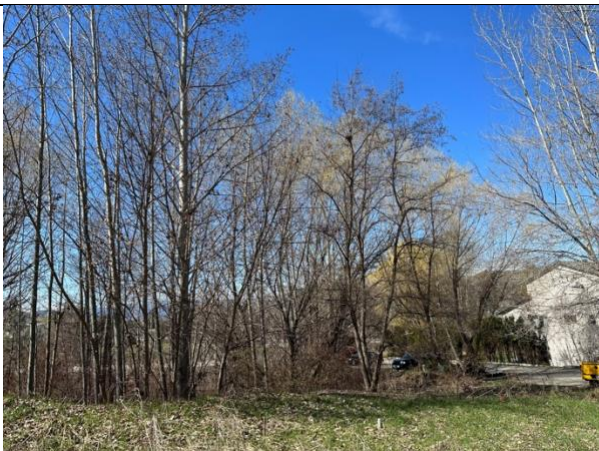
A stick nest that is likely used by American crow (*Corvus brachyrhynchos*) was observed in a cottonwood tree near the northeast corner of the Site. No raptor nests were observed in or around the Site.

Photo 11: View of stick nest to the NE of the Site adjacent to existing multi-family buildings

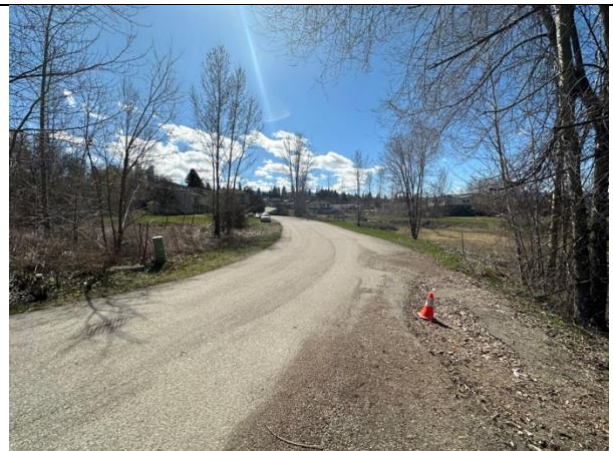
Photo 12: Existing road through the Site looking south from the north edge of the Site
