Heritage Conservation Plan

for the Historic O'Keefe Ranch :: April 2024

Prepared by Elana Zysblat, CAHP - Ance Building Services

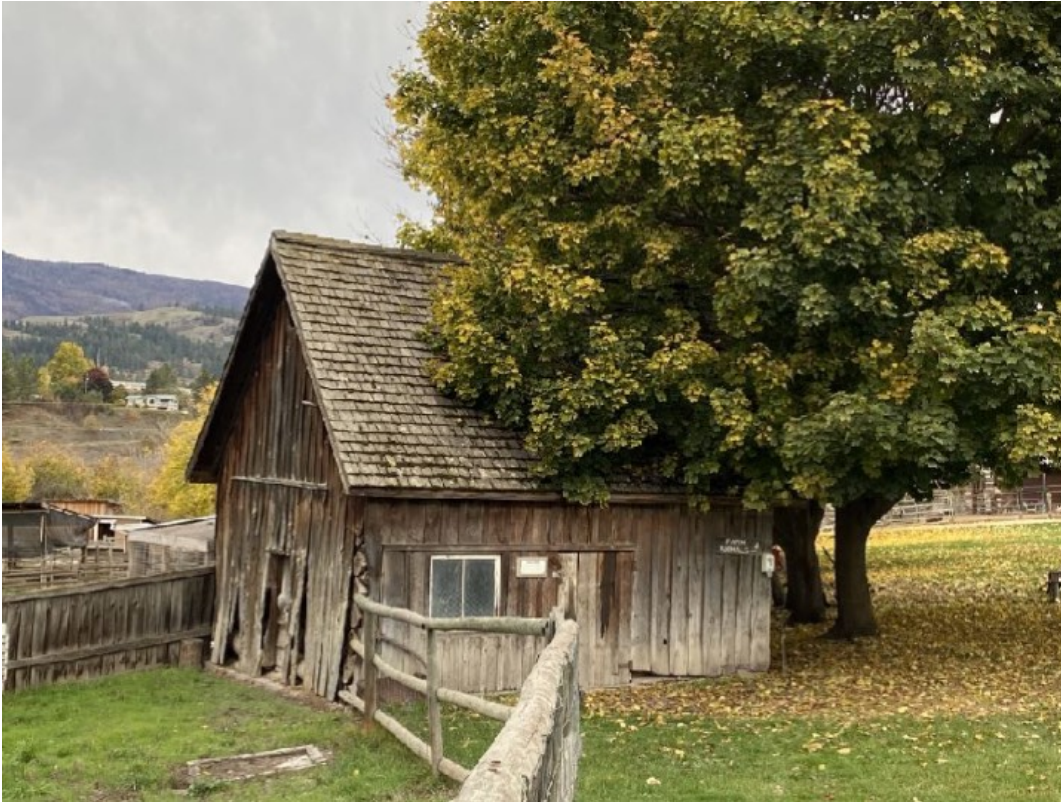
Pioneer Log Cabin - later the Chicken House – ca. 1867. The log structure is visible beneath the board and batten cladding.

Reroofed in 1989; Lifted and placed on a cement slab in 1992.

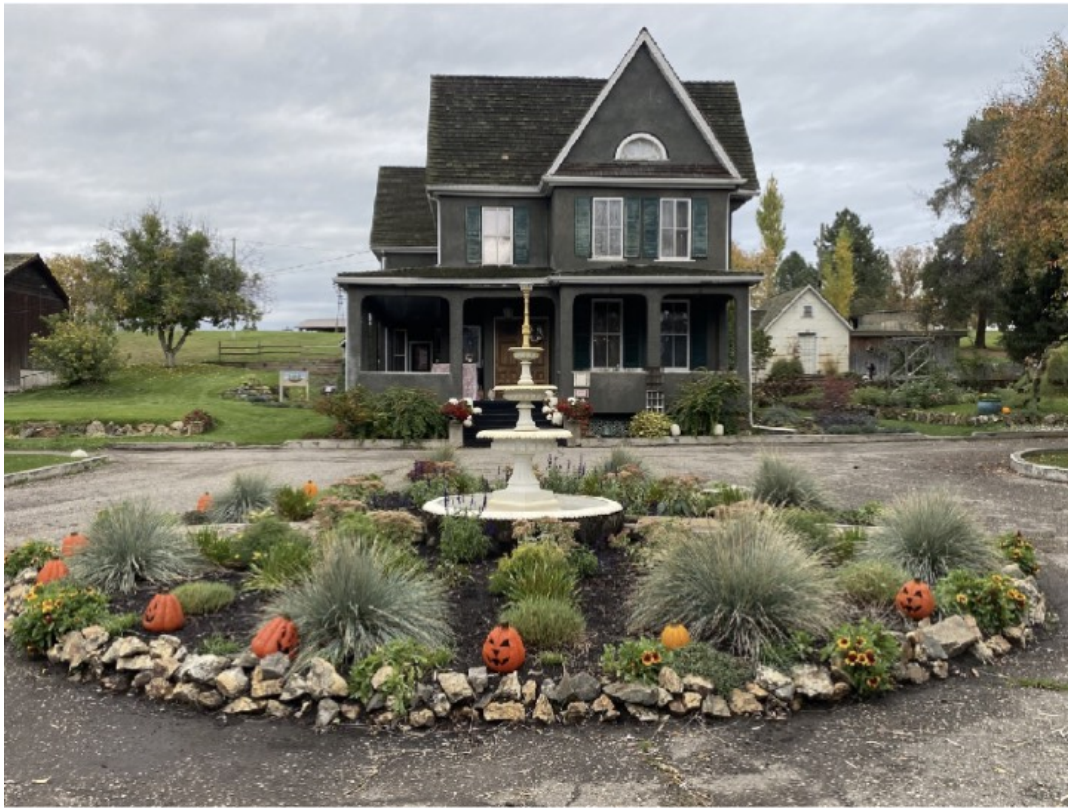
O'Keefe House – constructed in 1886, 1896, and 1900 with its circular driveway, fountain, concrete gate posts and wrought iron gates.

In 1944, a grey stucco was applied over the original drop siding exterior.

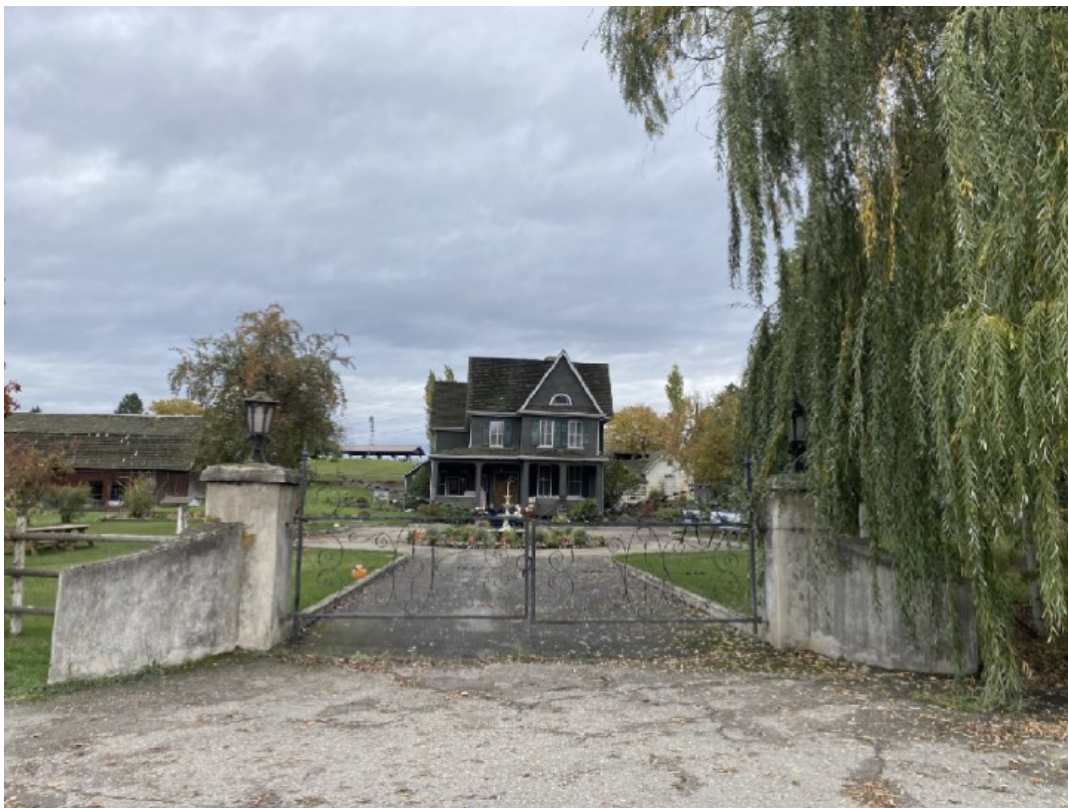
The stucco was repaired and a top coat applied in 1993. The shingle roof has been replaced several times, most recently in 1989, and the porch was repaired in 1997

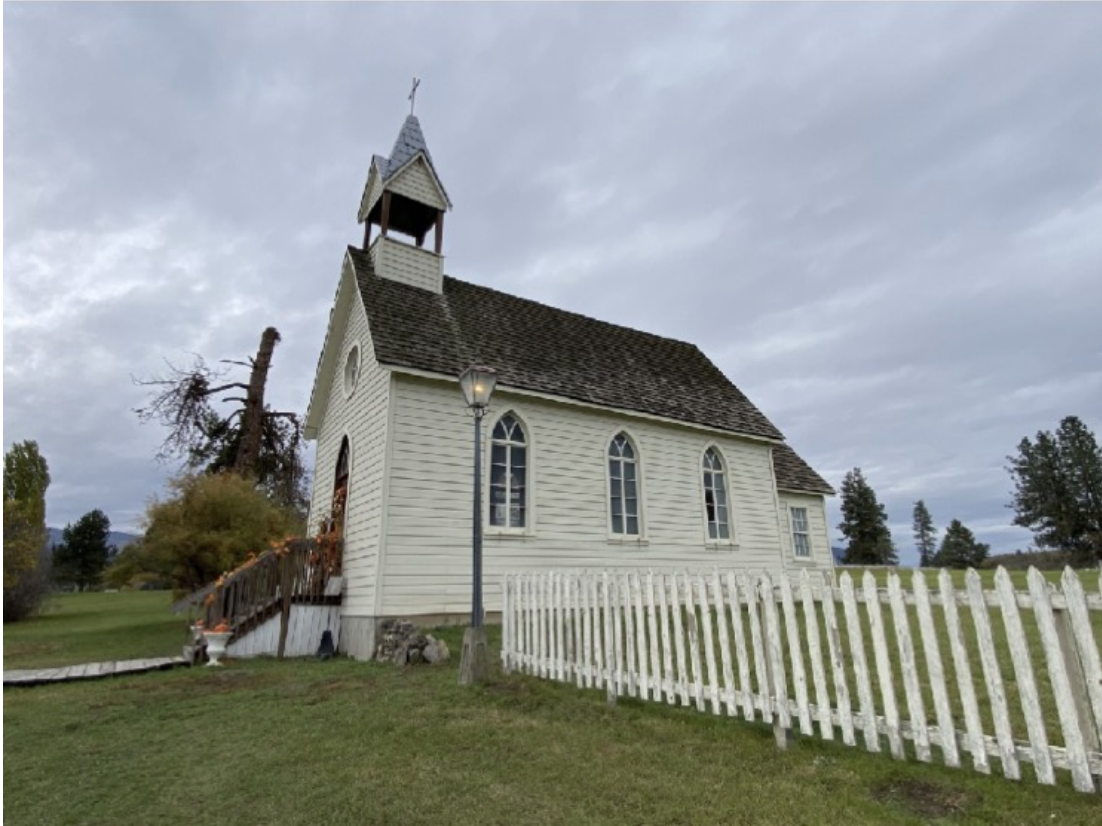
St. Ann's Church – 1889.

Interior restored in 1965. In 1989, rehabilitation of sacristy structure. From 2015-2017 the exterior was restored and a new foundation installed.

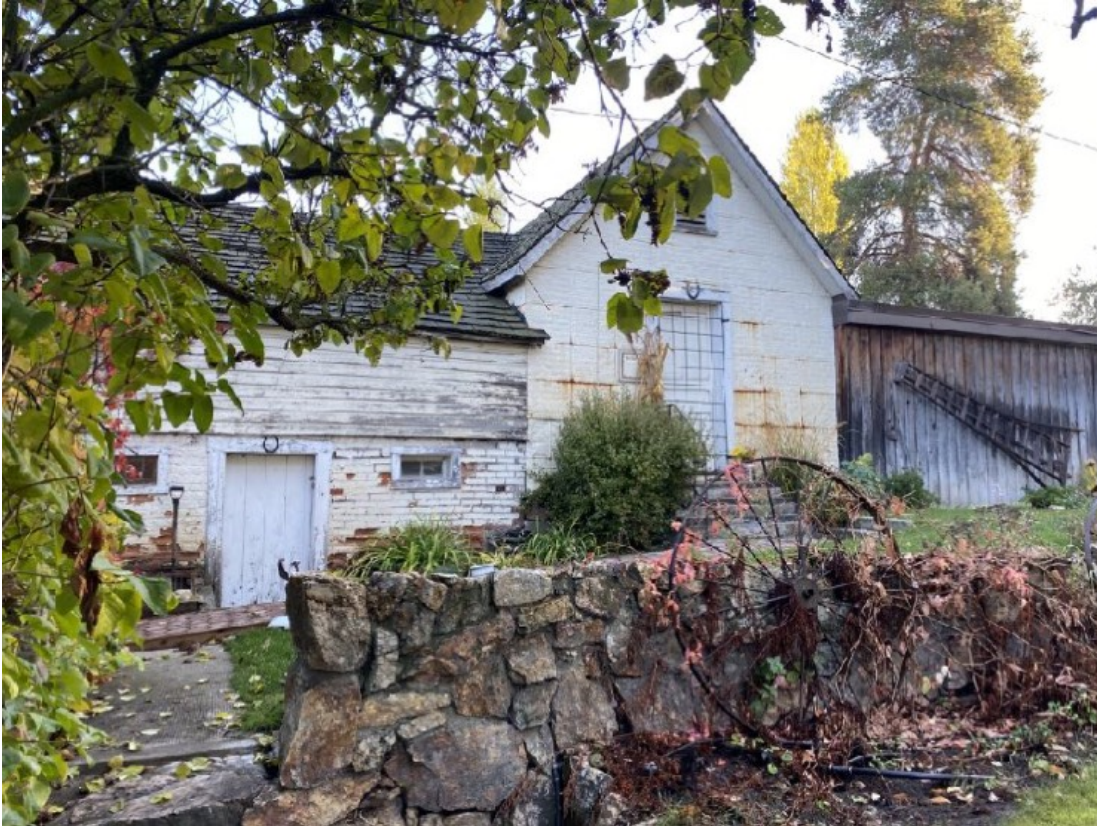
Meat and Dairy House – ca. 1890 and 1920 (Dairy House second storey)

1960s garage structure was added to the east side of the Meat House

Entire building was reroofed in 1989.

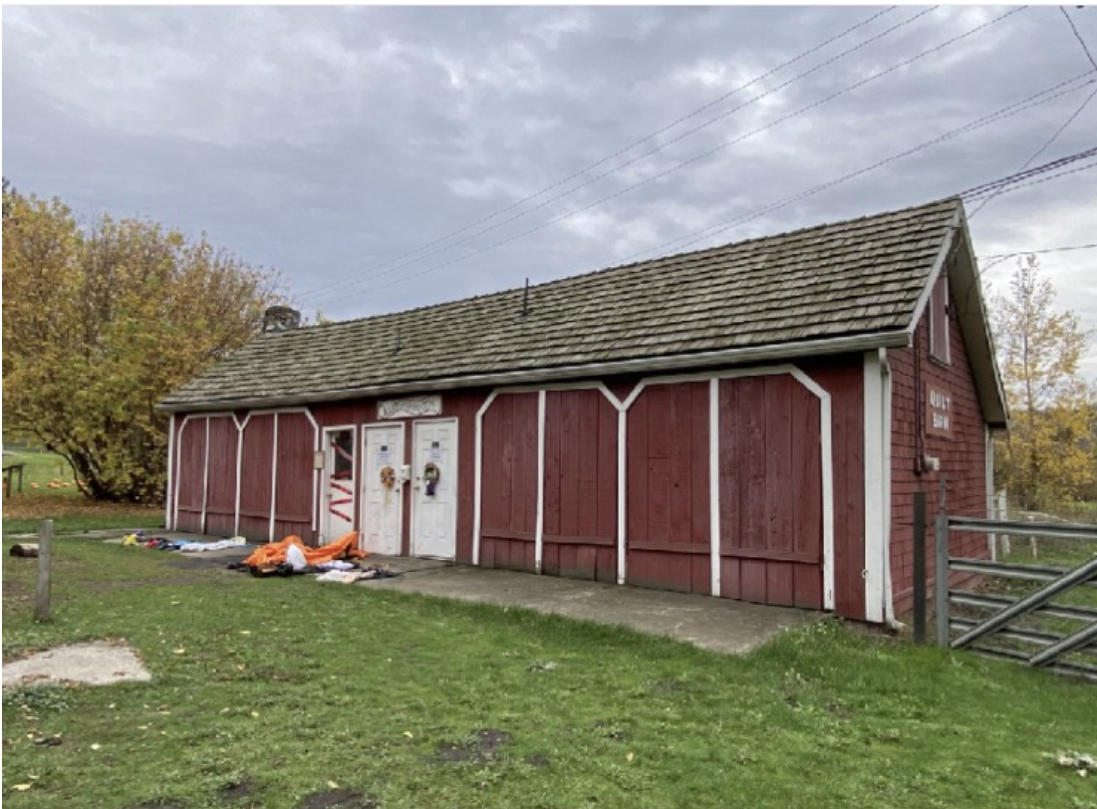
Carriage Shed – ca. 1890

Renovated for use as an entrance to the Ranch as well as a gift shop and snack bar in 1965

1981 extensive renovation.

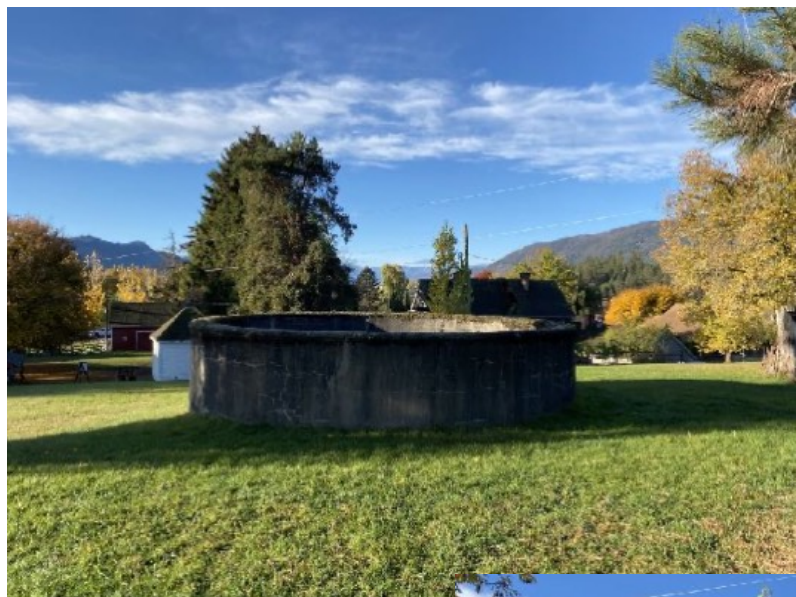
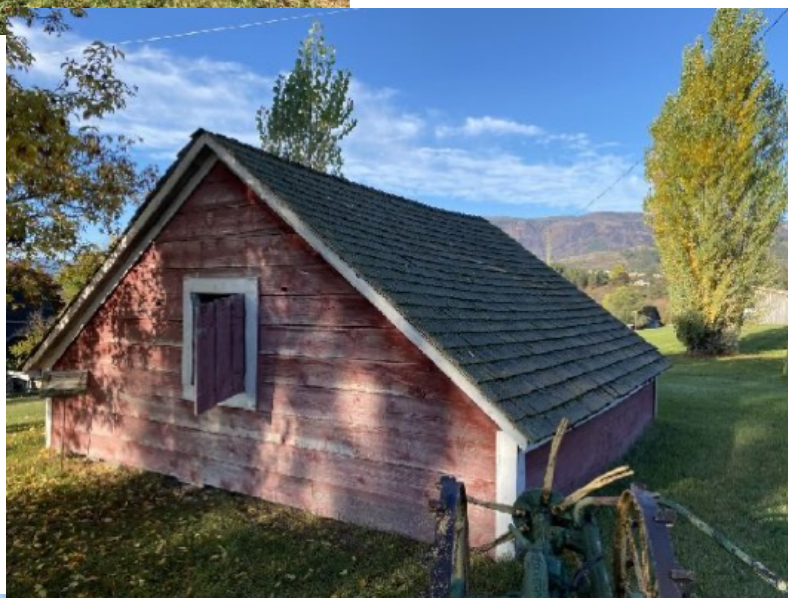
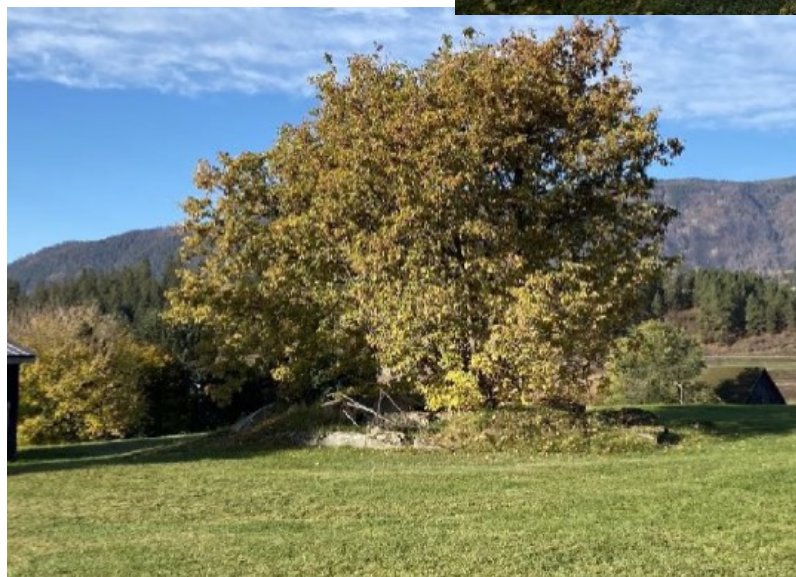
Three concrete cisterns -1901.

Two intact, one collapsed. Of the two intact, one is enclosed in a wood structure.

Left: intact, uncovered concrete cistern.

Right:
1901 concrete cistern enclosed in
a wood structure.

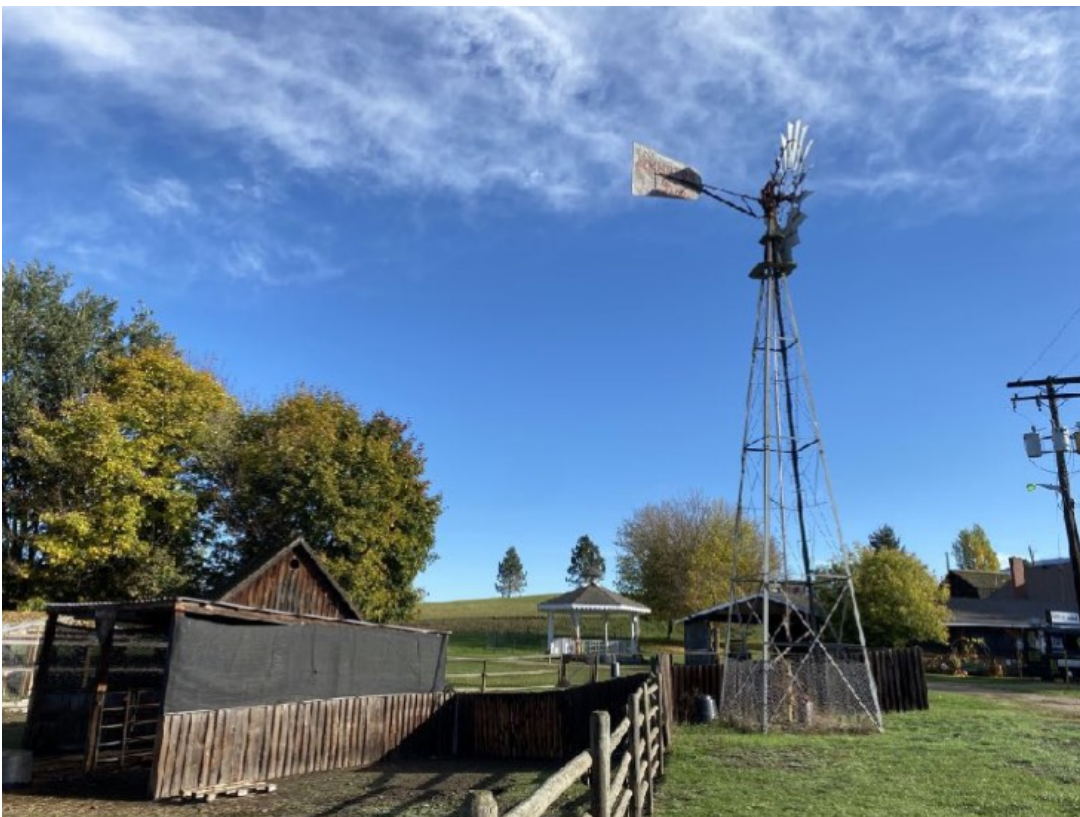
Metal windmill -
1896 - next to the
original pioneer
cabin marking the
location of the first
water well near a
natural spring.

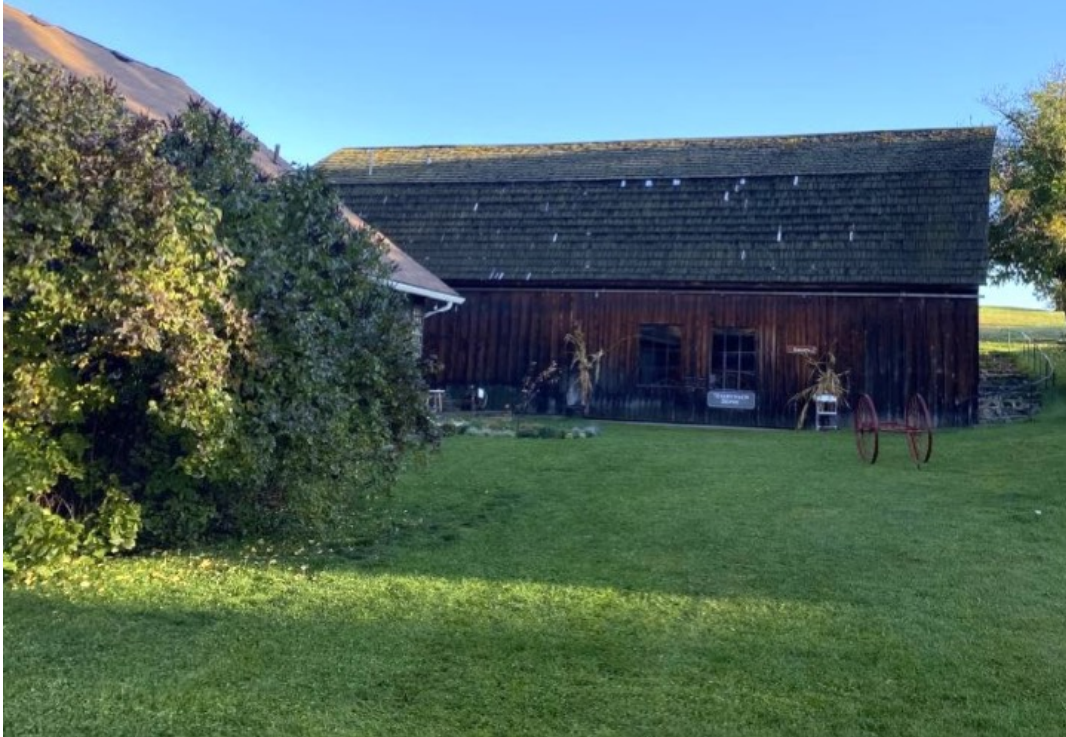
Firehall/Stagecoach
Depot - 1978

Showers were
installed in recent
years on the ground
floor to serve the
glamping customers

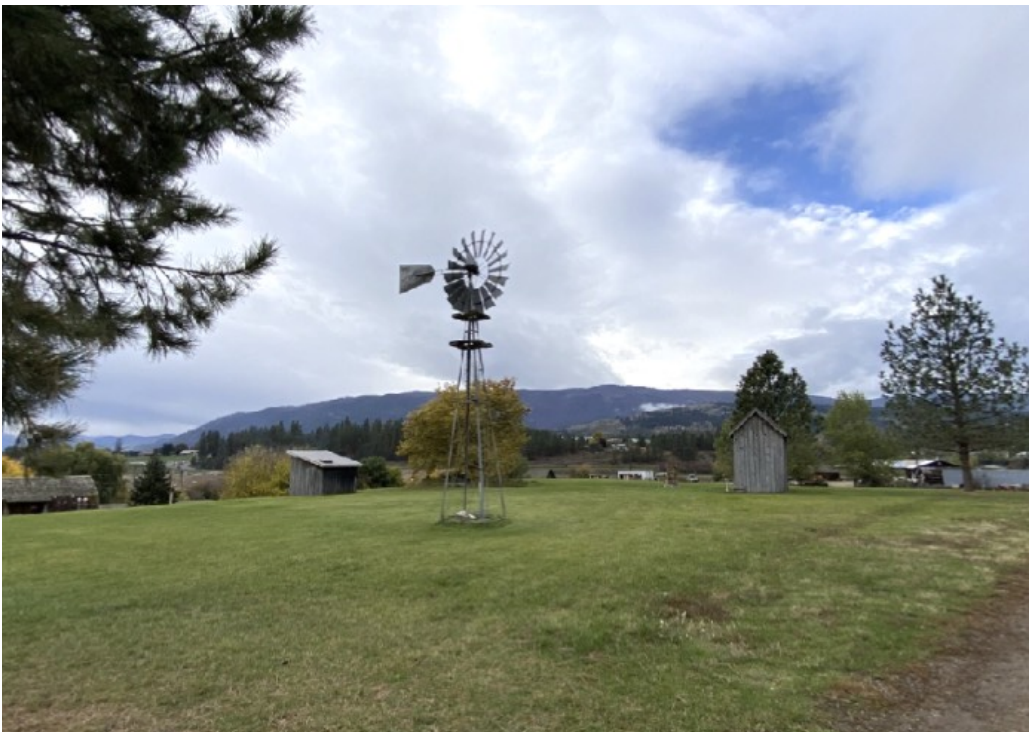
Metal windmill - c.
1900 - salvaged in
1990 from a different
North Okanagan
farm and restored by
the Spallumcheen
Pioneer Power Club.

It is intentionally
located near the
corrals, farm
buildings and former
site of the grist mill
where a second early
windmill is
documented to have
been located in the
early 1900s.
