Kofoed Contracting Ltd 11925 McGowan Road Kelowna, BC V4V 1J2 March 2, 2021 Job 21.094

Preliminary Geotechnical Report Proposed Residential Subdivision

7025 Herbert Road

Vernon, BC

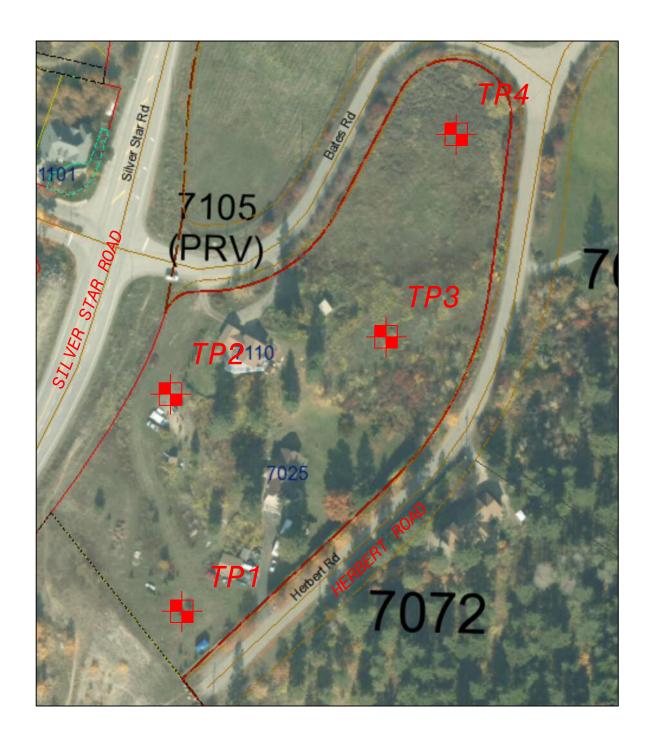
JOB NUMBER: 21.094 DRAWING NUMBER: 21.094-1

Locations of the test pits are approximately shown on the attached site plan (Drawing 21.094-1) which was adapted from the City of Vernon online mapping resource.

SITE PLAN

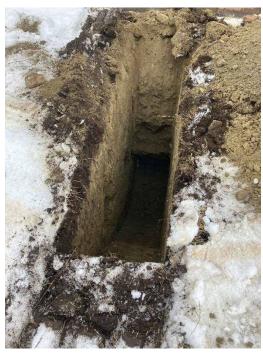
Site Photo 1 - TP1

TP 1 – South End

0.0 - 0.15	Topsoils and overburden material.	
0.15 - 3.0	Brown, dense to very dense, silty, fine SAND, some	S1 – 0.6 m / 7%
	gravel, occasional cobble.	S2 – 2.1 m / 7%
<u>3.0</u>	Base of test pit.

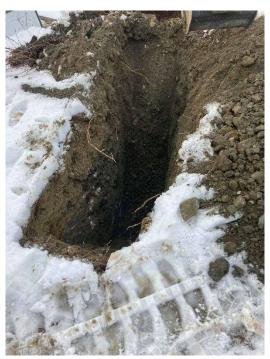
Site Photo 2 - TP2

TP 2 - West End

0.0 - 0.45	Brown, silty SAND and GRAVEL.	S1 – 0.3 m / 9%
0.45 - 2.4	Grey, very dense, silty SAND and GRAVEL (till-like).	S2 – 0.9 m / 8%
<u>2.4</u>	Base of test pit.	S3 – 2.1 m / 5%

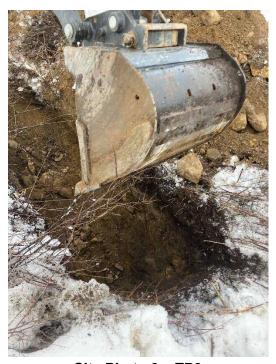
Site Photo 3 – TP3

TP 3 – East of Existing Home

0.0 - 0.3	Topsoils and overburden material.	
0.3 - 2.4	Brown, dense, silty SAND and GRAVEL, some cobble	S1 – 0.9 m / 5%
	and boulder sized materials.	S2 – 2.1 m / 6%
<u>2.4</u>	Base of test pit.

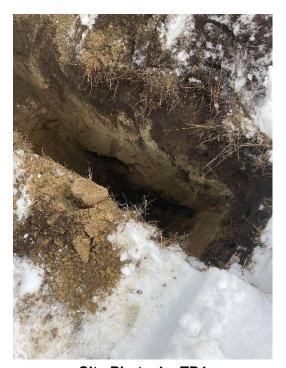
Site Photo 4 – TP4

TP 4 – North End

0.0 - 0.45	Topsoils and overburden material.	
0.45 - 2.4	Brown, compact to dense, SILT / fine SAND, trace to	S1 – 1.8 m / 12%
	some gravel.	
2.4 - 3.0	Grey, dense, silty SAND and GRAVEL.	S2 – 2.8 m / 10%
3.0	Base of test pit.

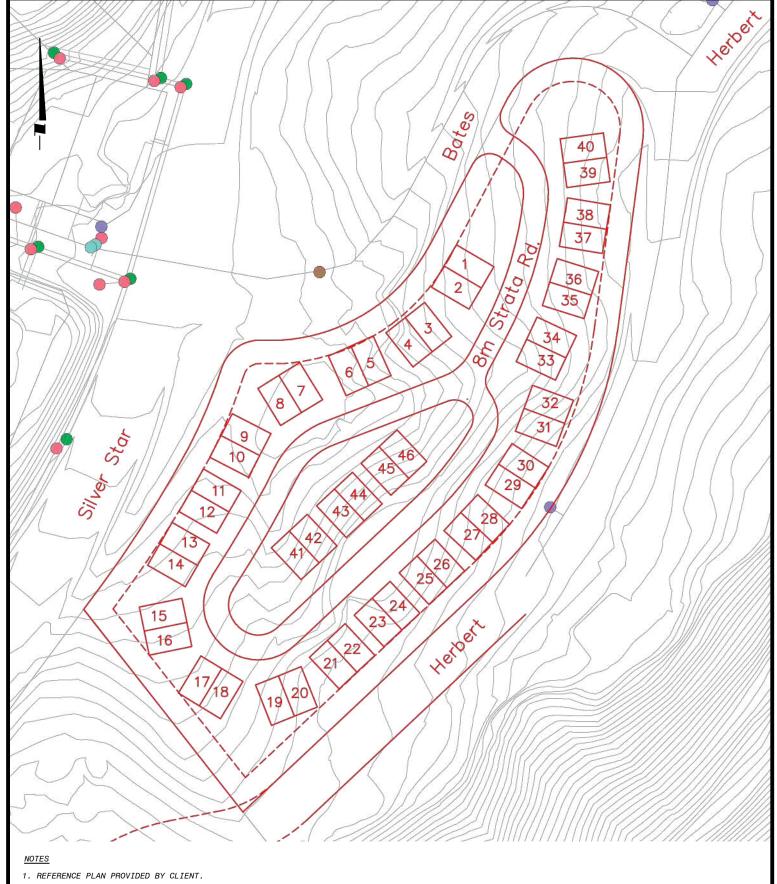
JOB NUMBER: 21.094 DRAWING NUMBER: 21.094-6

As per our proposal, and as shown on the attached preliminary subdivision layout plan (Drawing 21.094-6), ITSL understands that currently a total of 46 units are proposed for the subject property. In addition, onsite roads, driveways and site servicing will also be constructed as part of the overall development of the site.

PRELIMINARY SUBDIVISION LAYOUT PLAN INTERIOR TESTING SERVICES LTD 1-1965 MOSS COURT, KELOWNA, BC V1Y 9L3 PH: 250-860-6540 E-MAIL: INFO@INTERIORTESTING.COM
