**Zoning Amendment Application Environmental Impact Assessment**

**7025 Herbert Road, Vernon, BC**

Kofoed Contracting Inc.

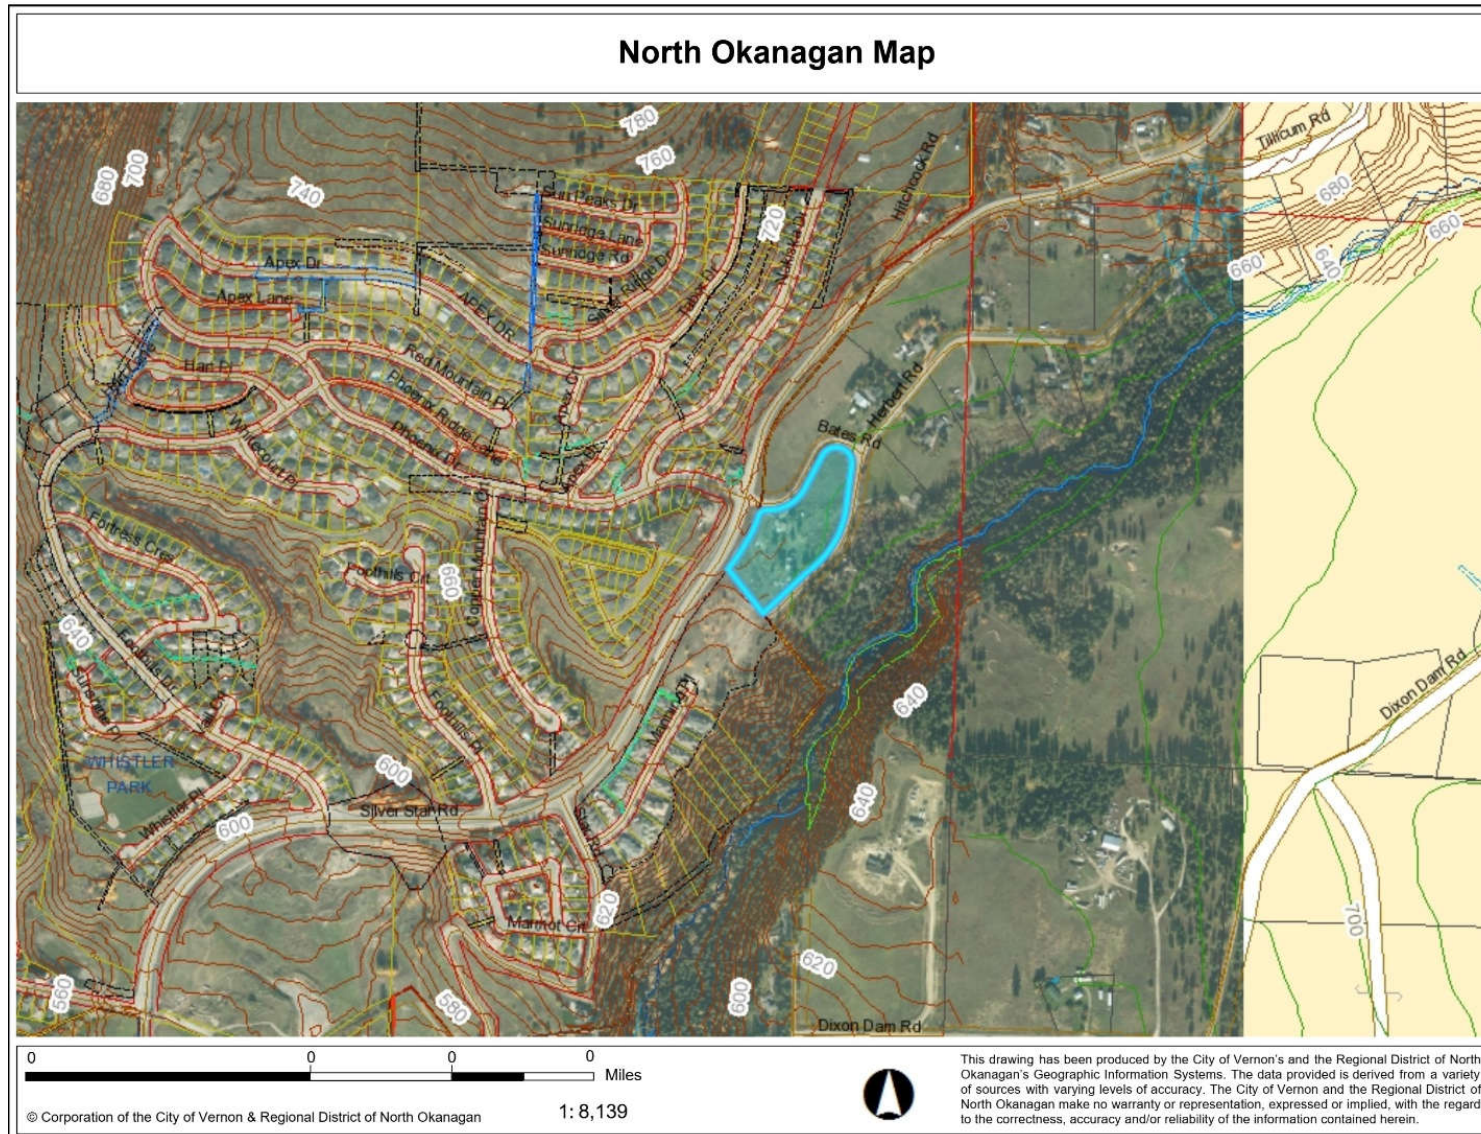
Figure 3. Slope contours (5 m interval-red lines) for the Property (outlined in blue) and surrounding area (source: RDNO GIS)

The topography of the Property is relatively flat on the upper portion of the Property adjacent to Silver Star Road. It gradually slopes to the east and a low spot occurs in the north of the Property at the corner of Bates Road and Hebert Road (Figure 3). There is a small area of pooling water observed in this section of the Property during the field visit in February 2021 which further indicates the low point of the Property.

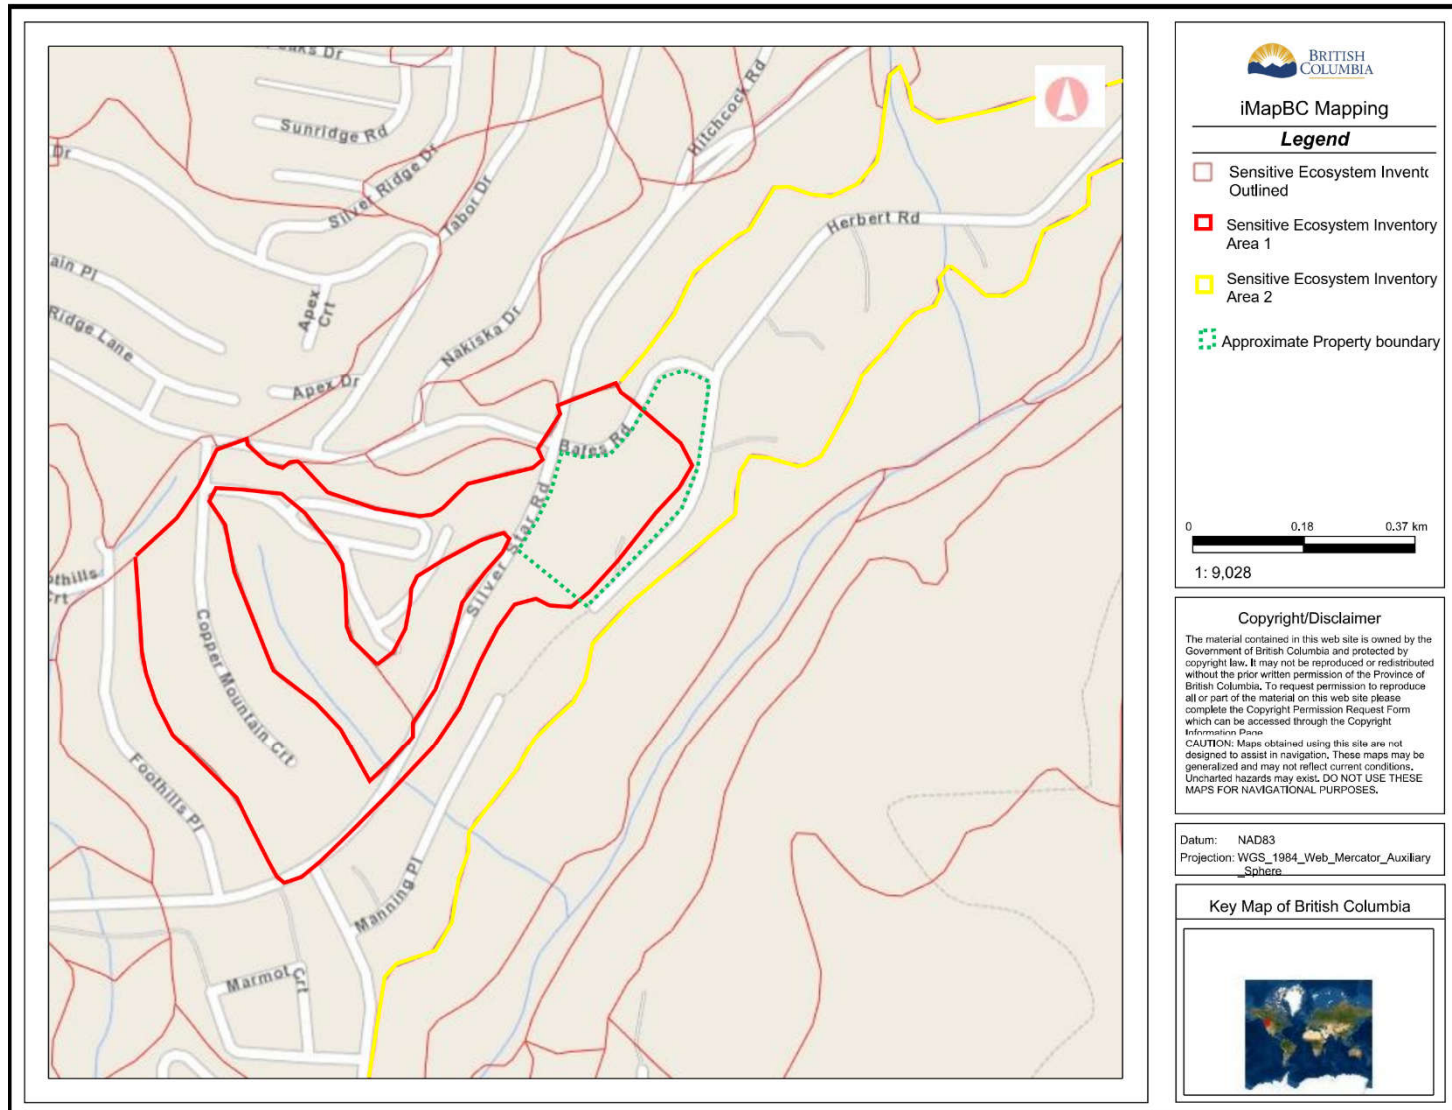
Figure 4. SEI rankings identified at the Property (source: imapBC)

The City's EMA Strategy identifies a three-class rating system which ranks sensitivities of an area from low to high. Each class requires different levels of consideration during development based on their simplified Sensitive Ecosystem Rankings (SER) value. Green or low risk areas are considered previously disturbed and require the lowest level of conservations and protection planning but must also account for site specific conditions. Yellow or medium risk ranking reflect areas with moderate levels of disturbance and moderate sensitivity. Development proposals in these areas are required to consider conservation, protection, and mitigation as part of the development permit application process. Red or high-risk rankings reflect areas with no previous disturbance and high sensitivity. The Property is identified as being medium risk (City of Vernon, 2012).

The City's tiered system of EMAs is largely a reflection of the Sensitive Ecosystem Inventory (SEI) works. SEI uses Terrestrial Ecosystem Mapping (TEM) and modelling to identify and predict ecosystems at risk, which can then be used by various levels of government to aid in development planning. SEI ranked the Property as GR:dg (grasslands and disturbed grasslands dominated by invasive species) (Iverson, 2008) (Figure 4). These ecosystems develop following the disturbance of grassland ecosystems, and no longer consist of climax species typical of undisturbed grasslands. These systems differ from grassland ecosystems due to the presence of noxious weed species (10 – 50%). Many of the species who inhabit grassland ecosystems can also find habitat in disturbed grassland ecosystems, and many rare, endangered and protected species are found in these areas (Iverson, 2008).

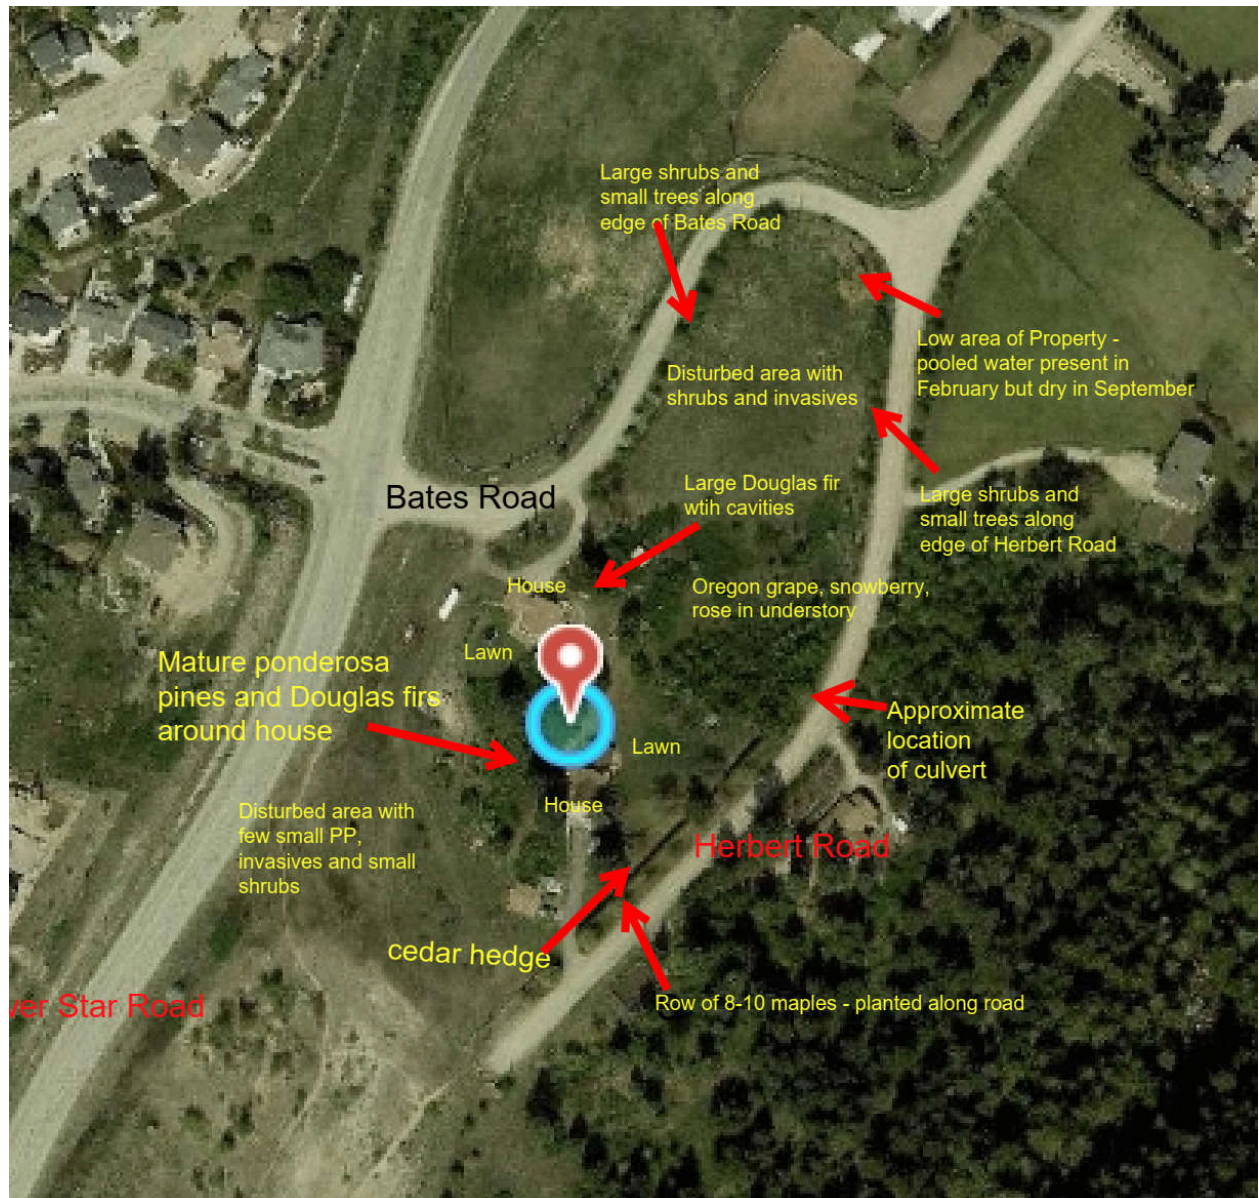
**Figure 5. Additional points of interest assessed during field visits**

An initial field visit was conducted by Triton on February 25, 2021 to confirm findings of the desktop review and identify additional information and parameters. Representative photographs from the site visit are provided in Appendix 1. The site visit was done when the Property was covered in snow which reduced the ability to survey vegetation. Additional field visits were conducted on September 21, 2021 and September 28, 2022 during snow free conditions. Points of interest at the Property are provided in Figure 5. Additional field surveys are expected to be conducted during the Development Permit stage and prior to development.

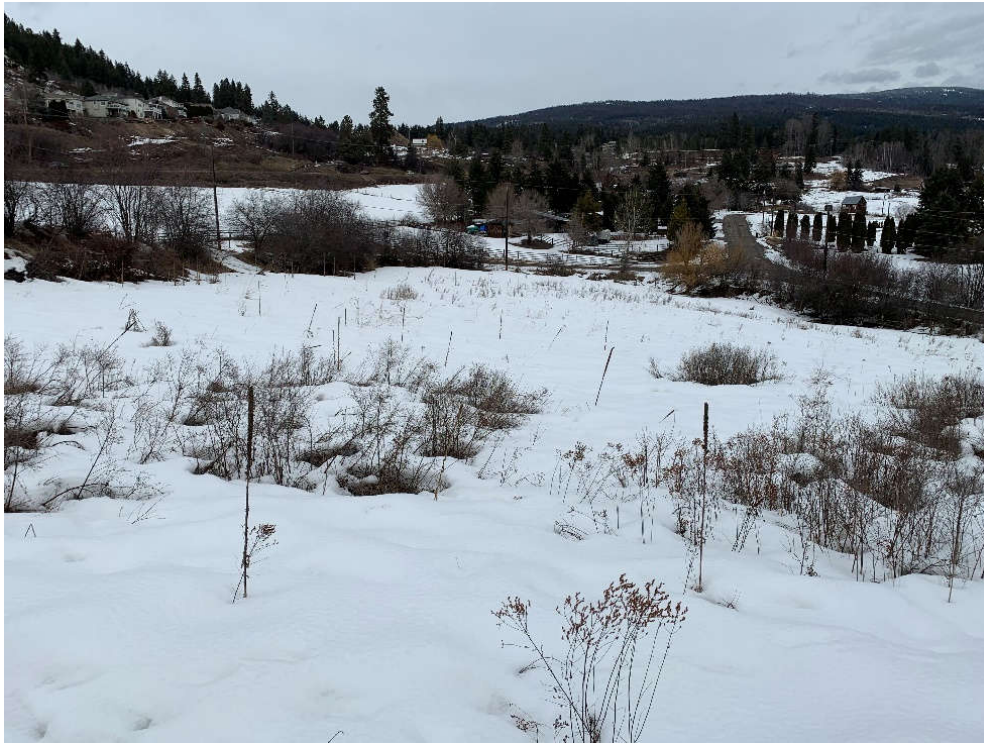
**Photograph 1.** View northeast from central area of Property showing disturbed grasslands (February 25, 2021).

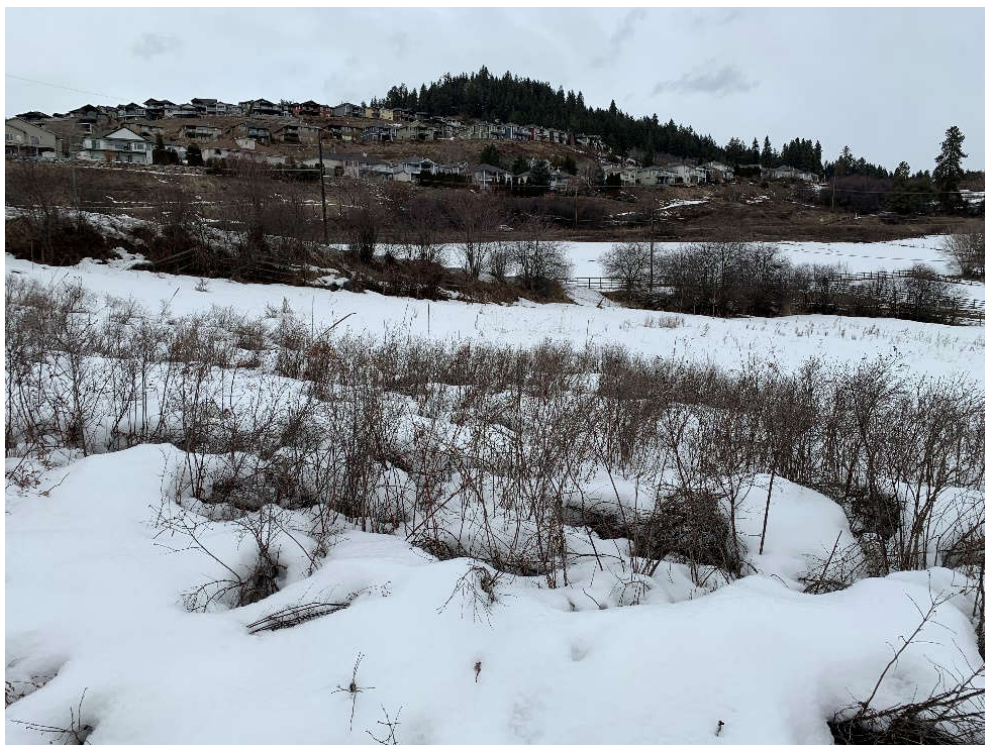
**Photograph 2.** View north towards Silver Star Road showing flat terrain, invasive weeds and limited treed vegetation (February 25, 2021).

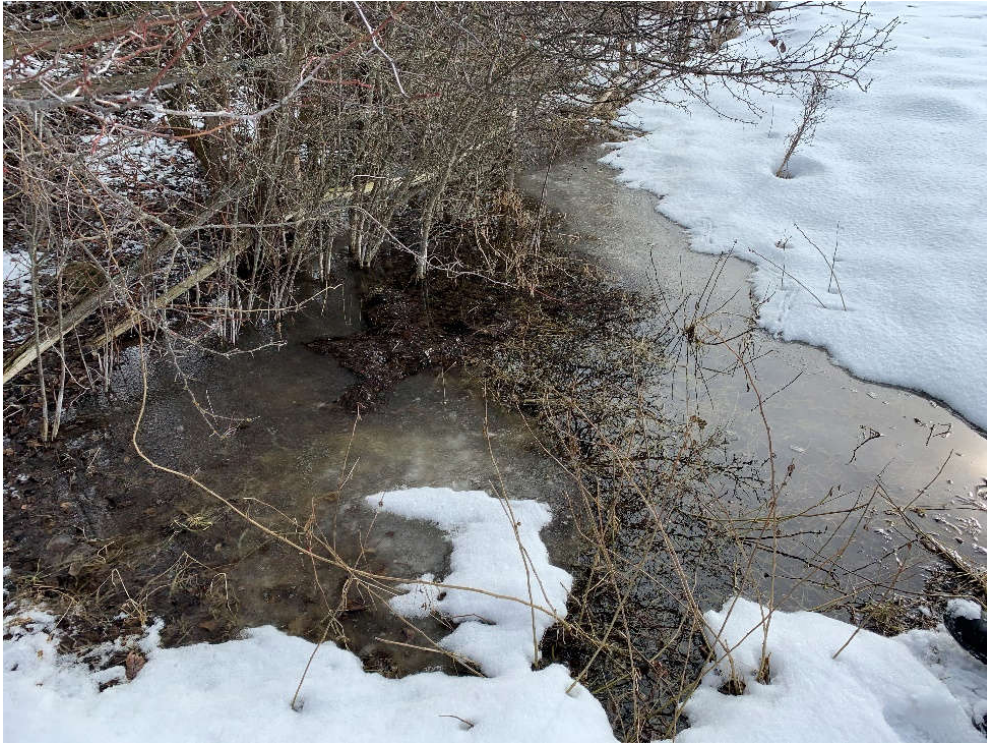
Standing water, wetlands, and slow-moving watercourses provide breeding habitat for amphibians and rearing habitat for tadpoles. Upland areas become more important during the adult stage. Within the Property there is a small area of pooled water from recent snowmelt. This pooling did not appear to have inlet or outlet channels and is likely only wet during spring snow melt. This area was dry during the site visits in September 2021 and September 2022. There is a low possibility of amphibian use in this area however it is recommended to survey the Property during the assessments during the Development Permit phase.

**Photograph 5.** View of pooling water on the Property (February 25, 2021).

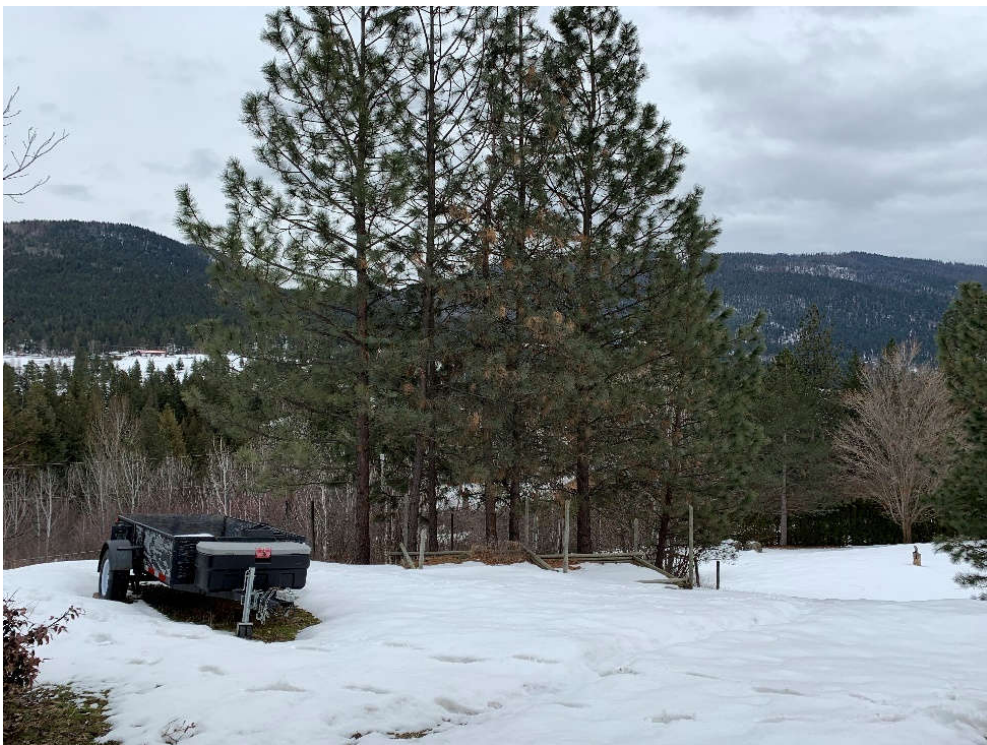
**Photograph 6.** View of ponderosa pine stand mid-Property (February 25, 2021).

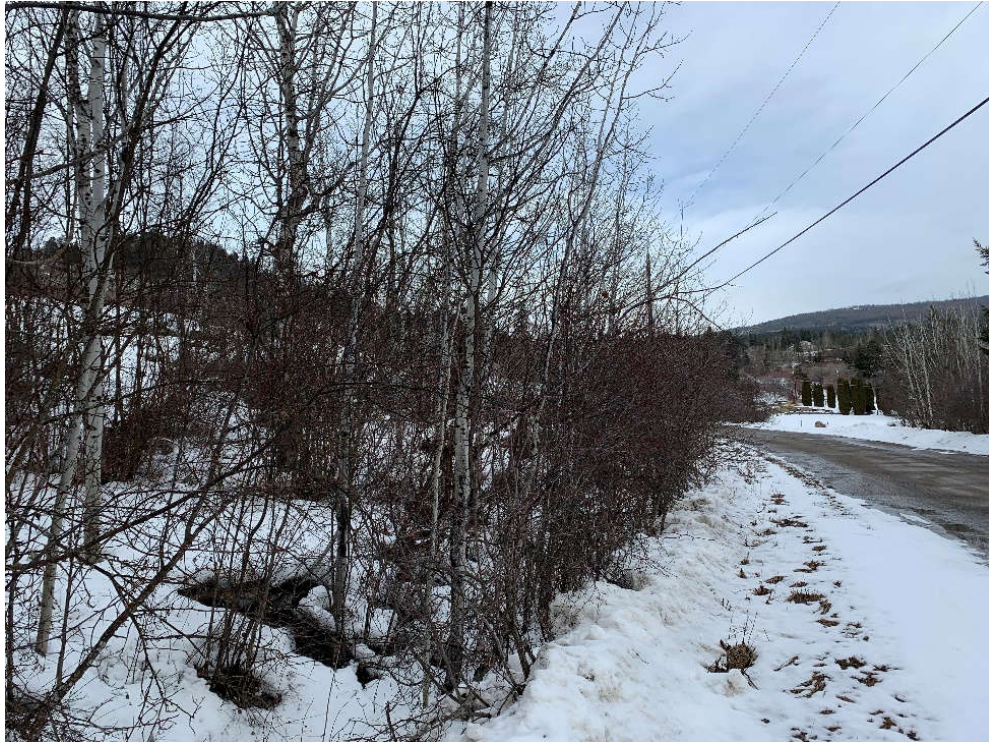
**Photograph 7.** View northeast of vegetated ditch adjacent to Herbert Road (February 25, 2021).

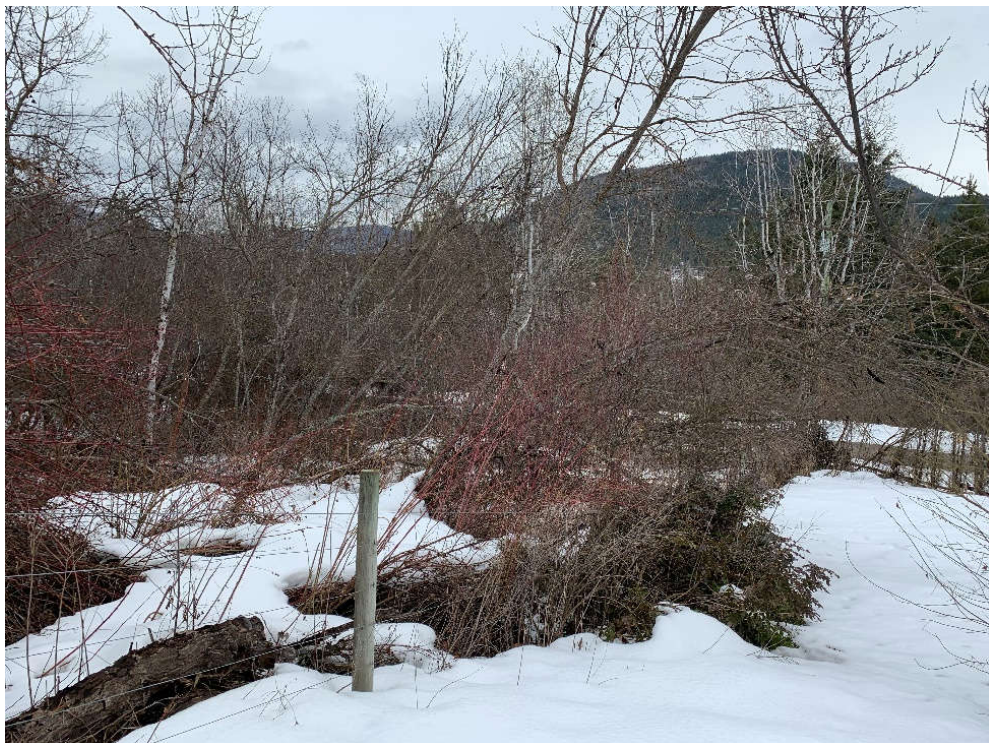
**Photograph 8.** View of densely vegetated area on the Property upslope of the culvert inlet (February 25, 2021).

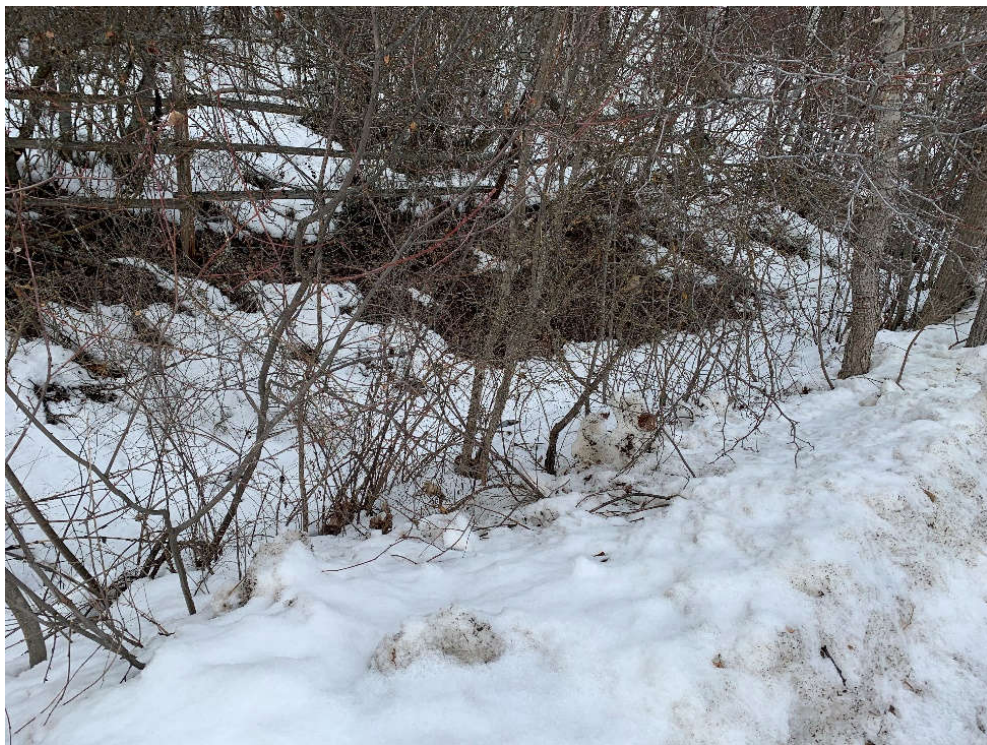
the Property. The inlet was visible during the site visits, but the outlet could not be found during the initial site visit due to snow cover. The ditch was dry, and no flow or indication of recent flow was observed in the ditch during any of the site visits. The ditch is overgrown with vegetation and there is no indication that a significant amount of flow runs in the ditch for extended periods of time. Directly upslope of the culvert is a section of dense vegetation. There is potential this area historically captured runoff from the upslope portion of the Property. However, the upper portion of the Property adjacent to Silver Star Road has been disturbed with fill and construction of the houses. The culvert outlets at a property across Herbert Road and there was no indication of a channel downstream of Herbert Road observed during the site visits. Based on the field assessments conducted in September 2021 and September 2022, the ditch would not be subject to assessment under the Riparian Areas Protection Regulation (RAPR).

**Photograph 10.** View of the area around the culvert inlet under snow cover (February 25, 2021).

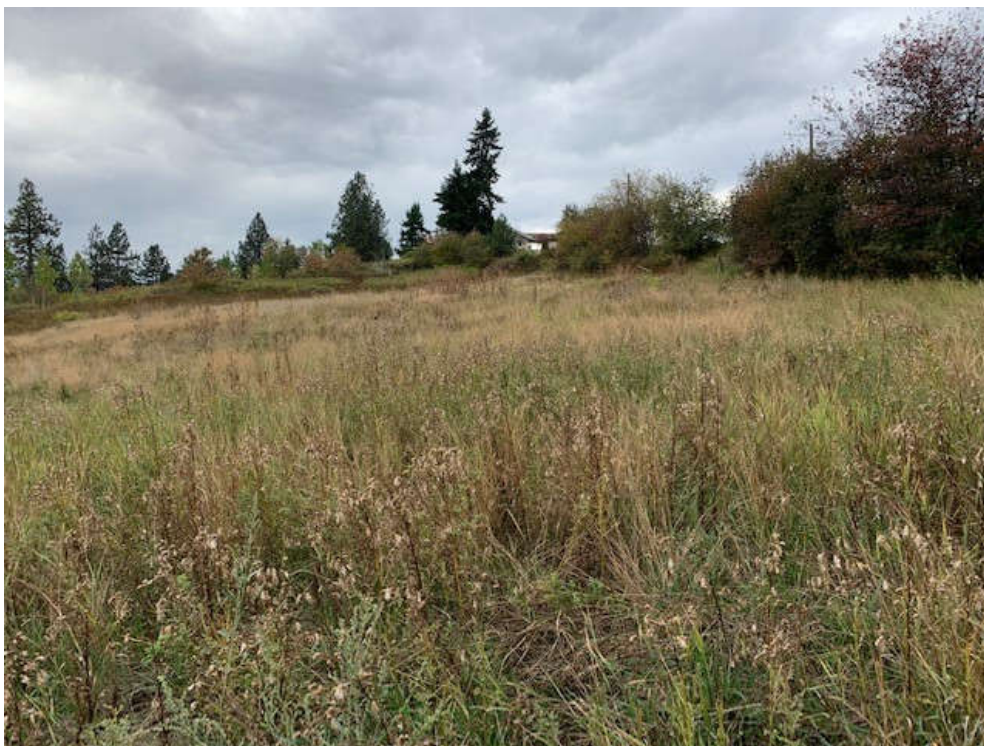
The south, west, and north portions of the Property can be described as Disturbed Grassland based on SEI classification and vegetation observed during the field visits. Vegetation in these areas indicate a high degree of anthropologic influence and disturbance and limited native species contributing to habitat or ecological value. These sections of the Property are predominately disturbed fill with forbs, shrubs, and small trees interspersed with non-native and invasive weed species dominant in the understory (Table 8). Young (seral stage) ponderosa pine are interspersed in the southern section of the Property.

**Photograph 12.** View south of Property from Bates Road. This portion of the Property has been previously disturbed and is dominated by non-native vegetation (September 28, 2022).

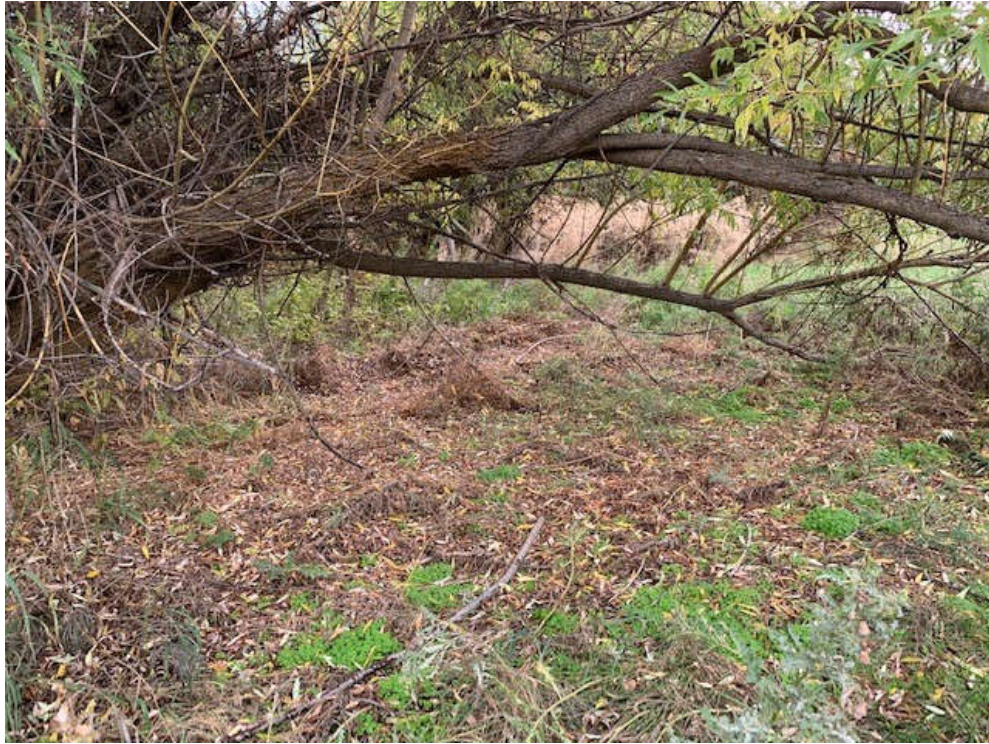
**Photograph 13.** View of the low spot on the Property at the corner of Bates Road and Herbert Road. This area was dry during the site visit in September 2021 (September 21, 2021).

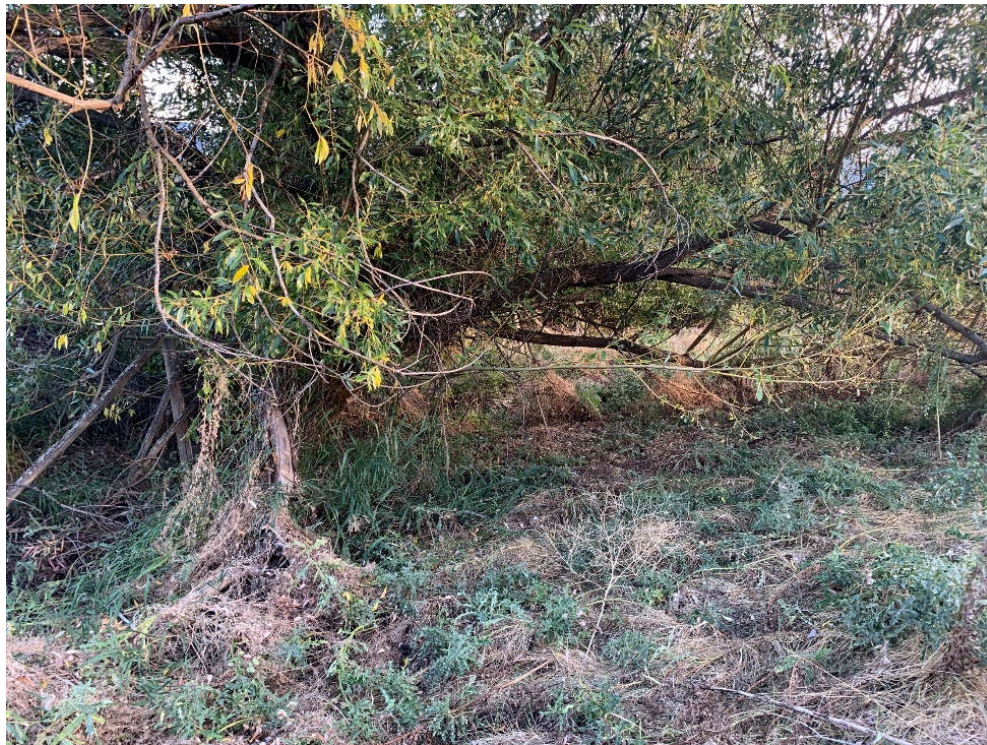
**Photograph 14.** View of the low spot. This area was dry in September 2022 (September 28, 2022).

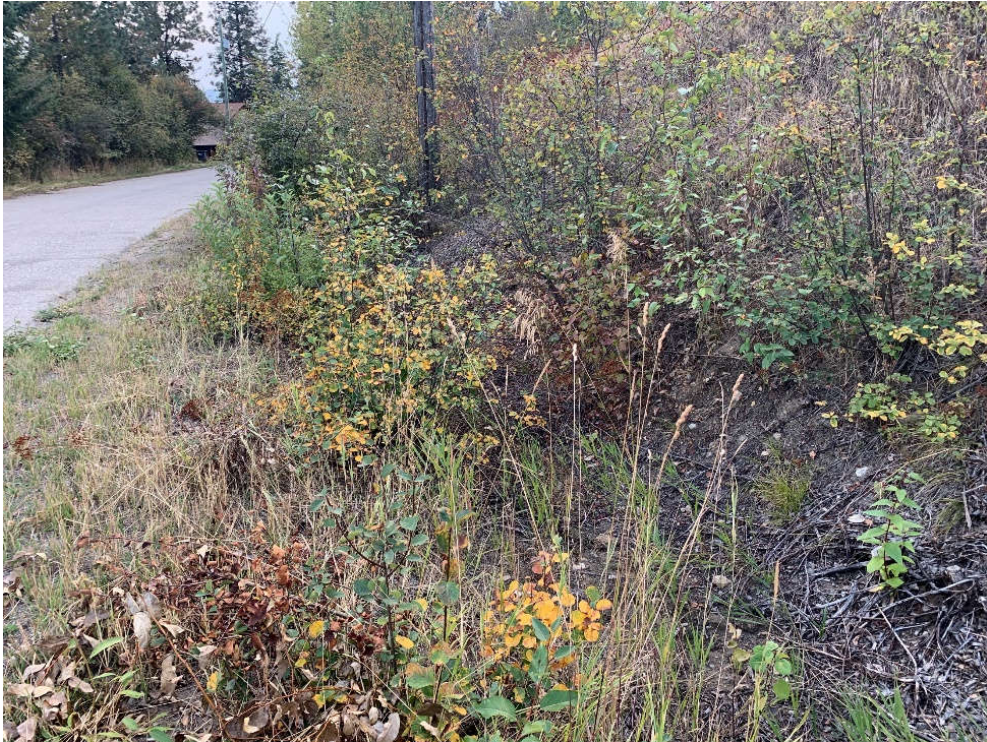
**Photograph 15.** View south of ditch on the side of Herbert Road. The ditch was dry and overgrown with vegetation during all site visits (September 28, 2022).

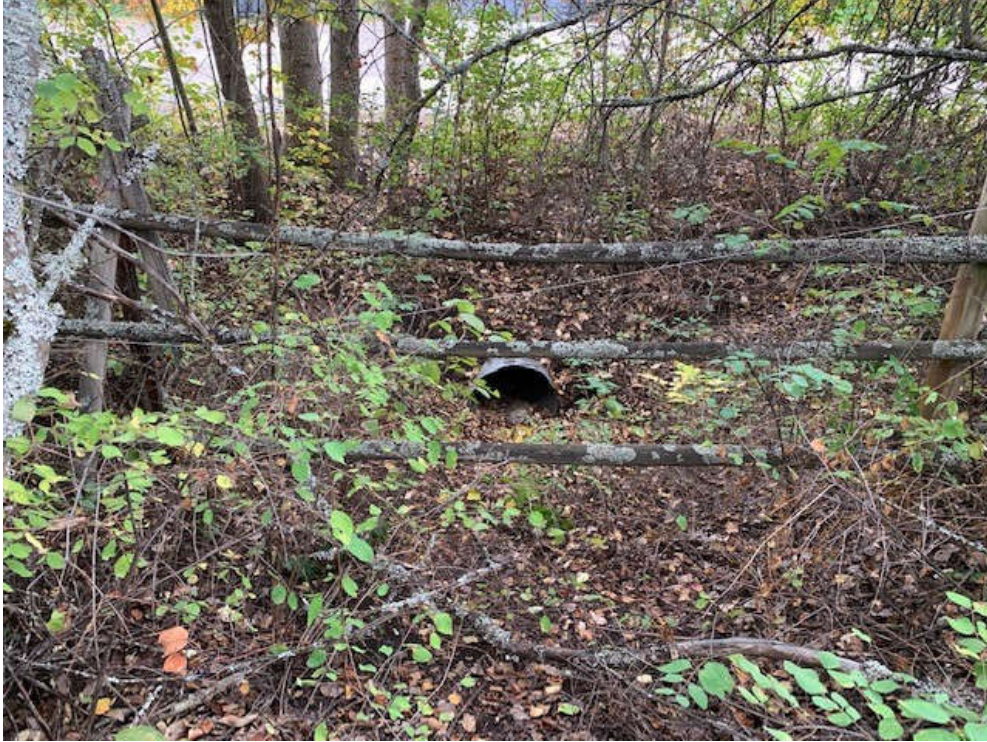
**Photograph 17.** Downslope view of the culvert inlet at Herbert Road (September 21, 2022).

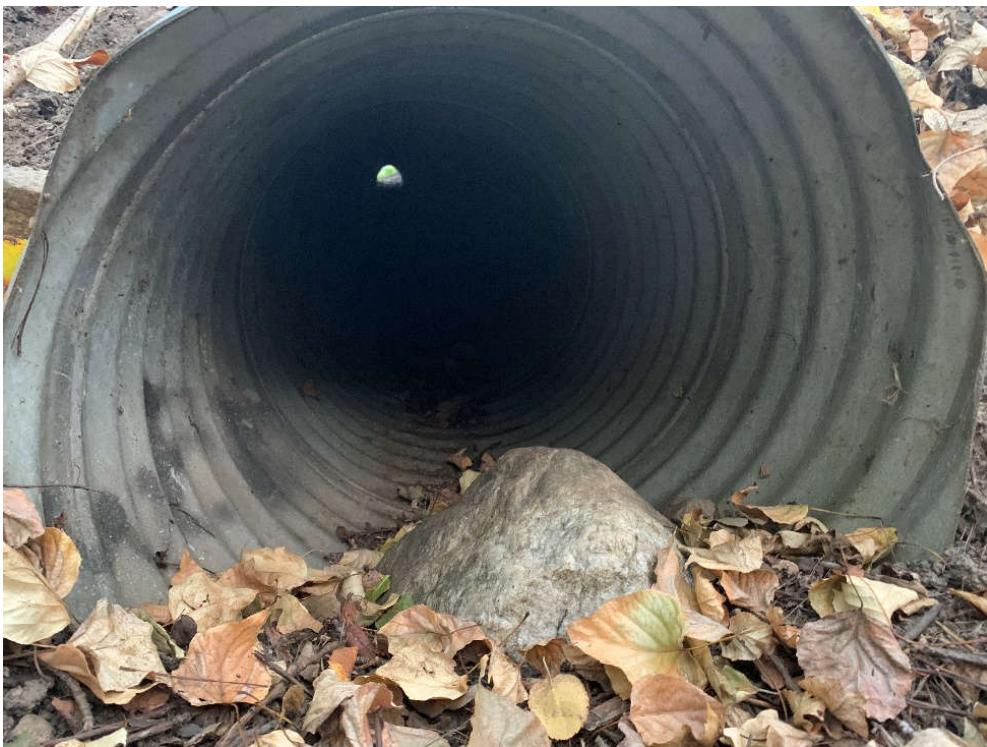
**Photograph 18.** Downstream view of the culvert inlet (September 28, 2022).

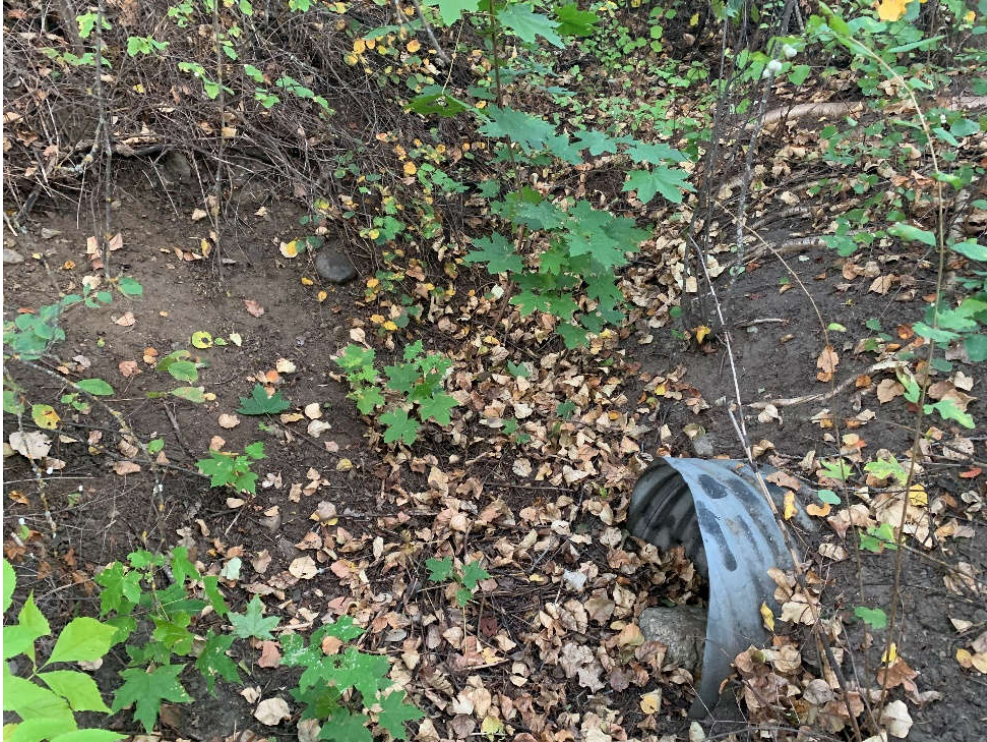
**Photograph 19.** View of the culvert inlet at Herbert Road (September 28, 2022).

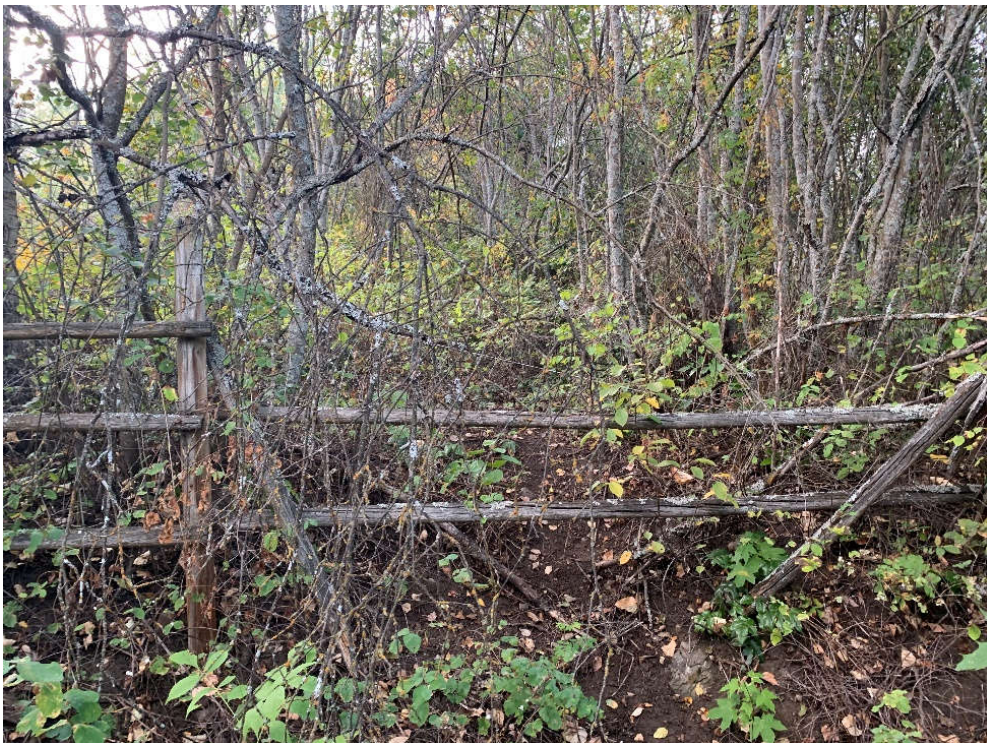
**Photograph 20.** View upslope of densely vegetated area upslope of culvert inlet (September 28, 2022).

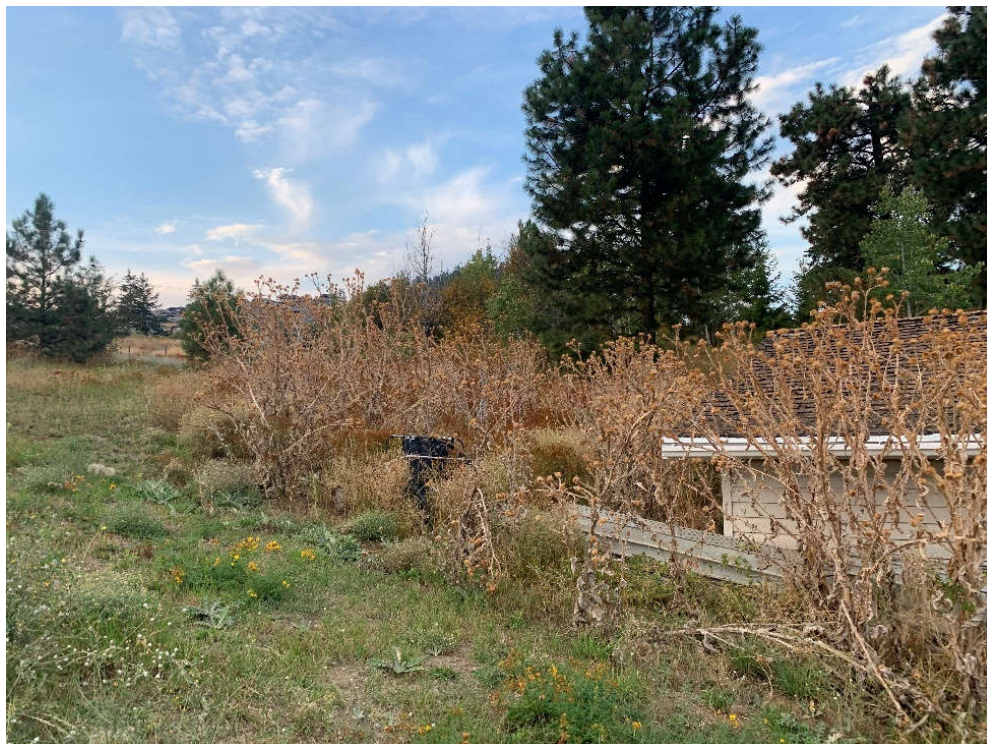
**Photograph 26.** View of the disturbed area (Canada thistle and other non-native species) on the portion of the Property south of the house on the lower portion of the Property (September 28, 2022).

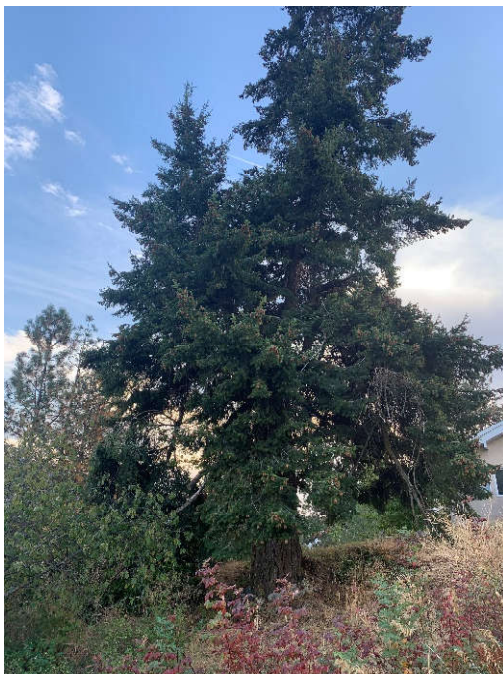
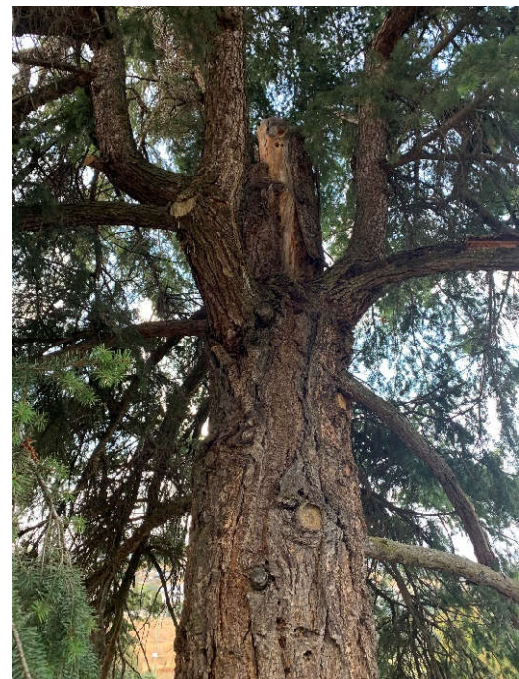
Several mature ponderosa pine and Douglas fir trees were noted in the central portion of the Property between the two houses. One large Douglas fir near the driveway access to the upper house off of Bates Road has several cavities in the lower portion of the trunk. No other snags or nests were observed during the field visits. No active nests were noted at the time of site visits, but this area could contain both ground and cavity nesting species at appropriate times of the year.

**Photograph 30.** Large Douglas fir tree with multiple cavities near the driveway of the house on the upper portion of the Property (September 28, 2022).

Proposed development should limit disturbance to trees or other vegetation as much as feasible. Any trees removed by construction must be compensated for with native vegetation at a rate of 3:1 as per the City's guidelines (City of Vernon, 2012). A list of recommend shrubs and trees for replanting efforts are provided in Table 10. Staking from plants located on site could be the most effective method for ensuring planting success. All planted vegetation should be monitored in subsequent years to ensure success.

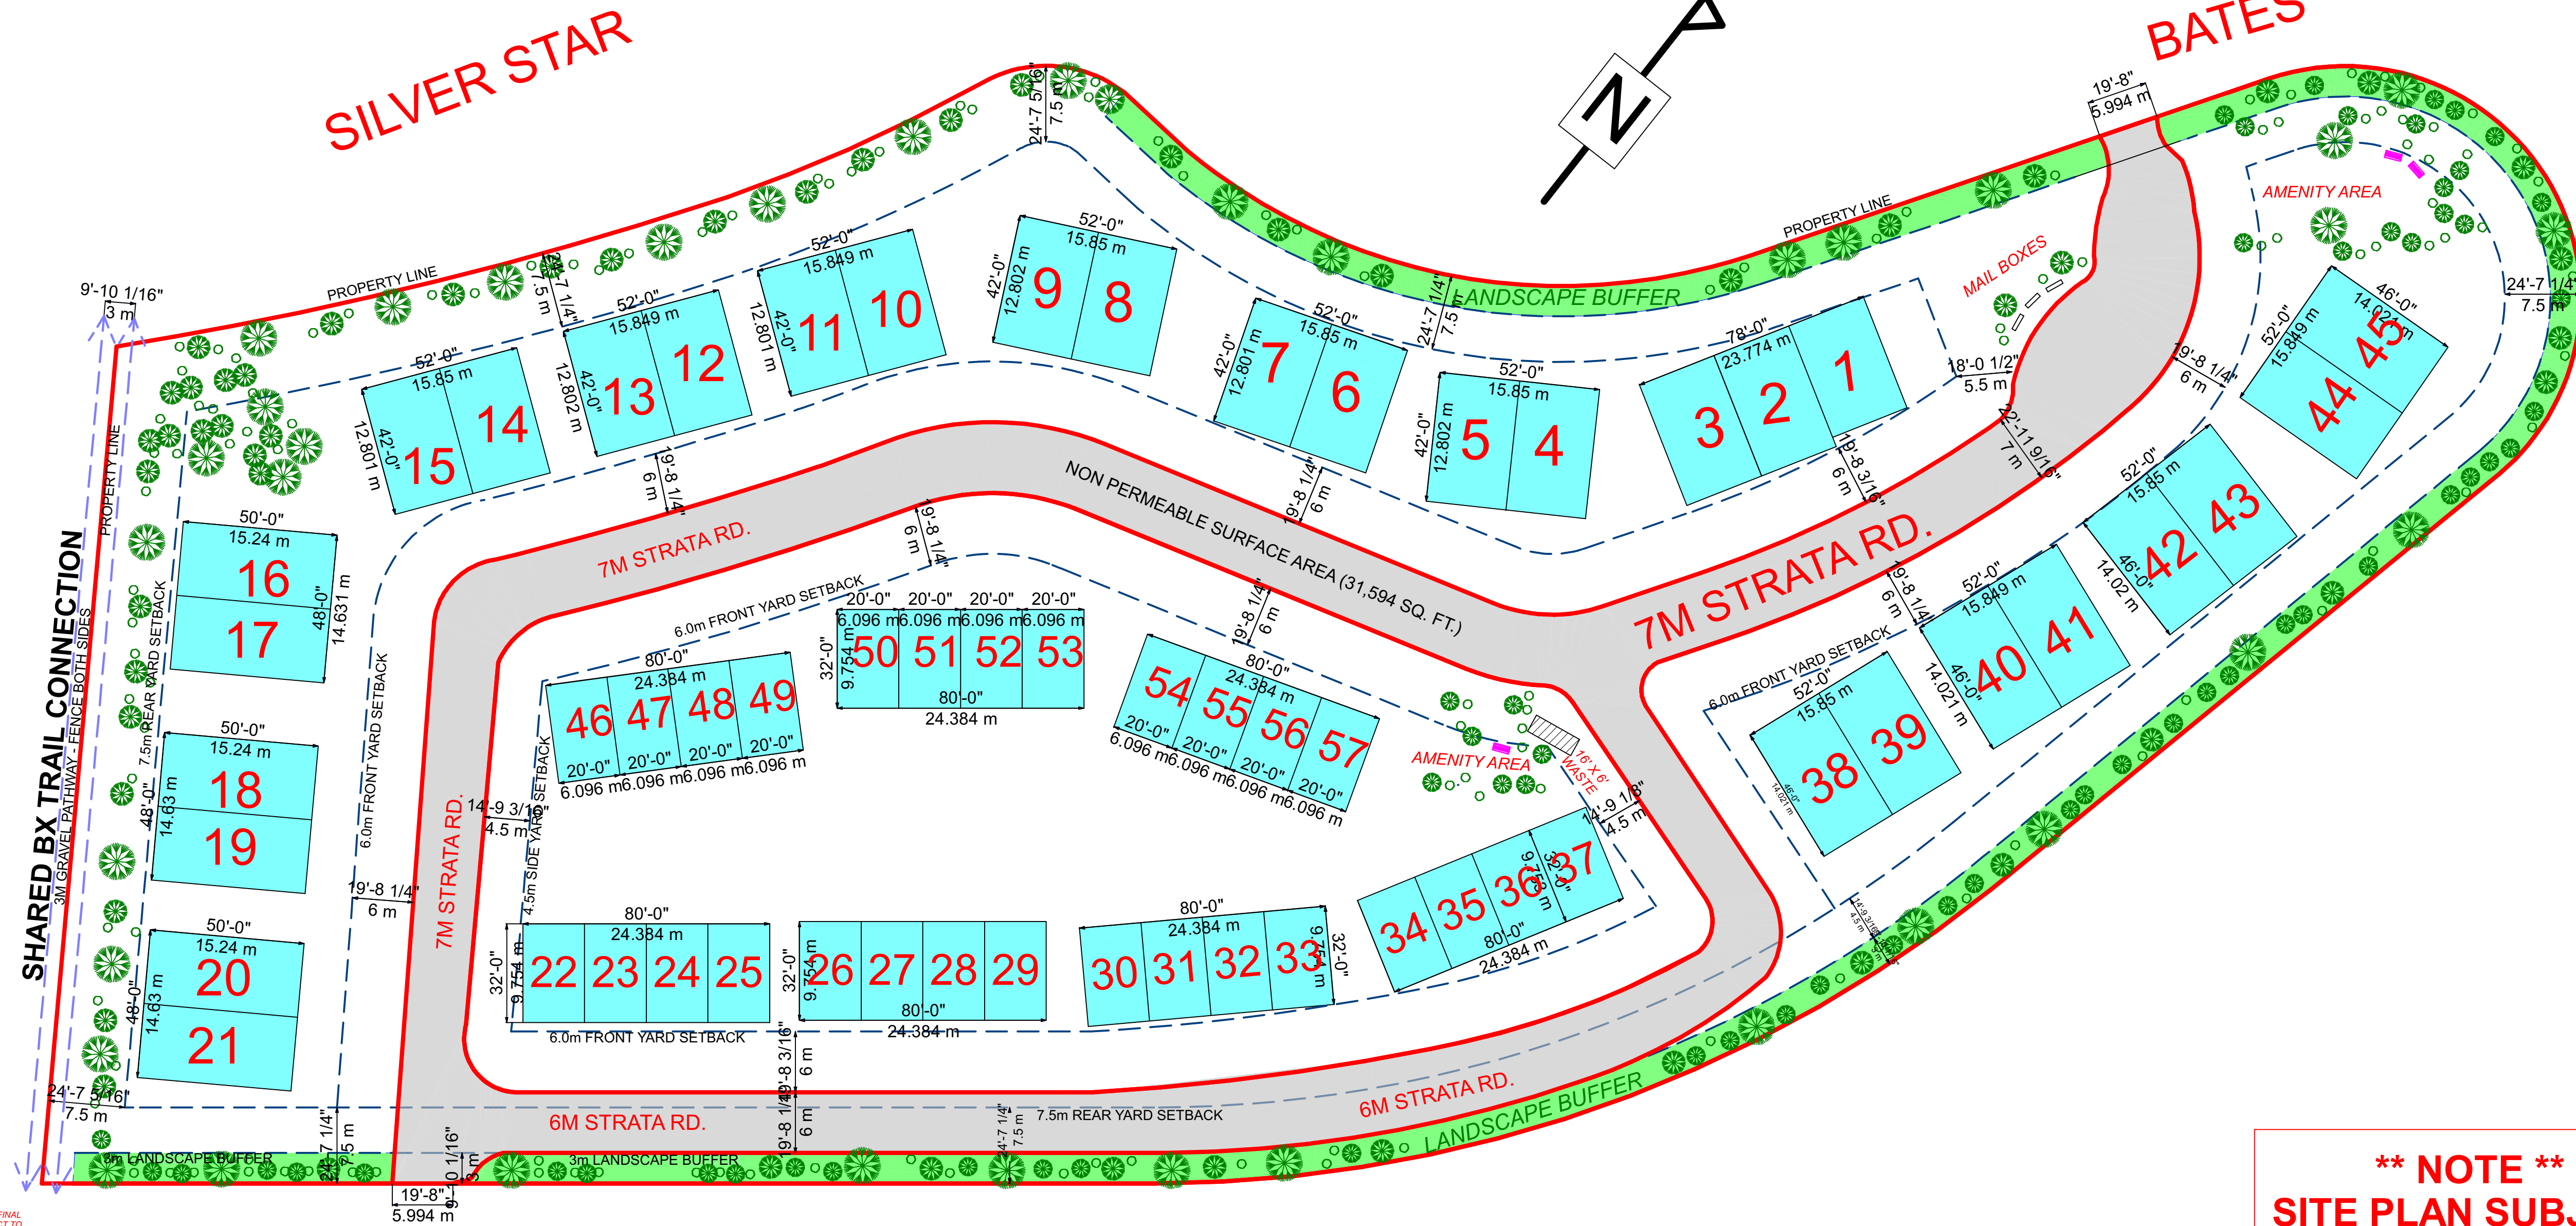
**SITE PLAN**  
SCALE: 1/32" = 1'

**\*\* NOTE \*\***  
**SITE PLAN SUBJECT TO CHANGE, SITE SURVEY REQUIRED**
