SUBJECT: HISTORIC O'KEEFE RANCH FACILITY CONDITION ASSESSMENT

Facility Condition Assessment

O'Keefe Ranch
Near Vernon, B.C
City of Vernon
Building Condition Assessment Report
Mechanical

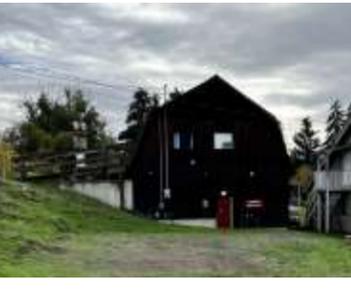
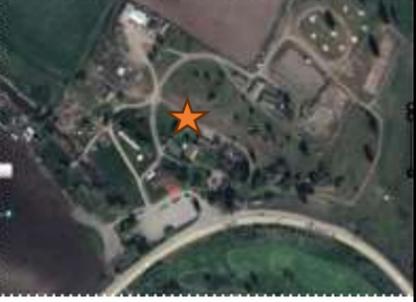
Stagecoach Depot

A Substructure	A10 Foundation	A1010 Standard Foundations	Concrete foundation/retaining wall sloped with grade.	Fair	Minor cracking.	Continue monitoring for changes.	N/A	N/A	
		A1030 Slab on Grade	Upper patio is slab on grade.	Fair	Some organic growth and minor cracking.	No Recommendation.	N/A	N/A	
	A20 Basement Construction	A2020 Basement Walls	See A1010.		See A1010.	See A1010.	N/A	See A1010.	
B Shell	B10 Superstructure	B1010 Floor Construction	Concrete slab on grade and wood framed.	Fair	No comment on condition.	No Recommendation.	N/A	N/A	
		B1020 Roof Construction	Hip roof. Wood framed.	Fair	No comment on condition.	No Recommendation.	N/A	N/A	
	B20 Exterior Enclosure	B2010 Exterior Walls	Board and batten cladding with horizontal wood cladding on gable ends.	Fair	Cladding stained at base up to half height.	Repair cladding.	3D	See Cladding Program.	
		B2020 Exterior Windows	Wood frame fixed windows.	Fair	No comment on condition.	No Recommendation.	N/A	N/A

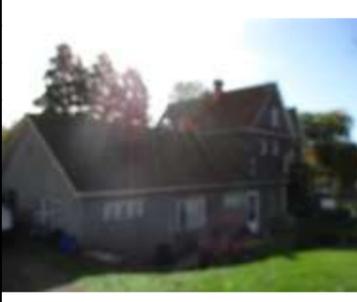
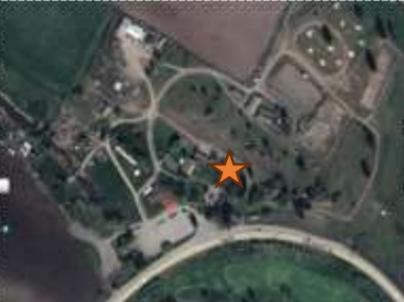
Caretaker's House

Other Names	1886 built.	A			\$ 5,000		\$ 5,000			
Description	1896 Log House removed, addition added, roofline altered.	B					\$ -			
Single-storey addition to the O'Keefe House with concrete basement. Wood framed with stone veneer cladding. Aluminum framed windows and doors. Cedar shake roof.	1900 single storey addition.	C					\$ -

1910 central hot water heating and hardwood flooring.	D			\$ 17,600		\$ 17,600			
	1989 mosr recent roof replacment.	E				\$ -				
	1994 stucco reclad.	F				\$ -				
	1997 porch repaired	G		\$ 8,000		\$ 8,000				
		Total		\$ -	\$ 22,600	\$ -	\$ 30,600			
Level 1	Level 2	Level 3	Assessment							
Major Group Elements	Group Elements	Individual Elements	Building Component	Condition	Comments	Recommended Action	Priority Ranking	Probable Cost		
A Substructure	A10 Foundation	A1010 Standard Foundations	Concrete masonry units. Two 2'x2' concrete pillars. Wood trellis above grade. Stone pedestal footings.	Poor	Parging is mostly gone. Brick has freeze/thaw damage. Trellis deteriorated. Stone walls in good condition.	See A1010 on O'Keefe House sheet.	3B	N/A		
	A20 Basement Construction	A2020 Basement Walls	CMU basement wall.	Fair	Water damage in corner of CMU wall.	Repair leak through CMU wall and add perimeter drainage. See G2030 at building 4A.	3C	\$ 5,000

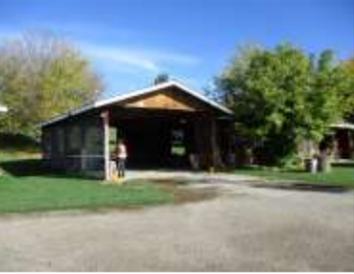
Pavilion

Other Names	Construction date unknwn.	A					\$ -			
n/a		B					\$ -			
Description		C					\$ -			
Wood post and beam structure with engineered trusses and asphalt shingle roof. Wood half wall at some locations around the perimeter. Houses stage and picnic tables. Concrete slab-on-grade floor.		D					\$ -			
		E					\$ -			
		F					\$ -			
		G					\$ -			
		Total		\$ -	\$ -	\$ -				
Level 1	Level 2	Level 3	Assessment							
Major Group Elements	Group Elements	Individual Elements	Building Component	Condition	Comments	Recommended Action	Priority Ranking	Probable Cost		
A Substructure	A10 Foundation	A1020 Special Foundations	Pressure-treated buried posts. Embedded plate steel saddle connection for posts near stage.	Fair	Water staining at base of buried posts.	No Recommendation.	N/A	N/A

B Shell	B10 Superstructure	B1010 Floor Construction	Concrete slab on grade.	Good	Concrete slab in good condition.	No Recommendation.	N/A	N/A		
		B1020 Roof Construction	Post and beam construction. Engineered trusses at 4' o/c. Plywood sheathing.	Fair	Water staining on soffit.	Add eavestroughs and downspouts.	4D	See Roof Maintenance Program.		
	B20 Exterior Enclosure	B2010 Exterior Walls	Wood plank half walls with mesh upper half. Hardie panels behind stage. Wood plank on gable end.	Good	Posts and wood members stained at east side.	No Recommendation.	N/A	N/A		
	B30 Roofing	B3010 Roof Coverings	Asphalt shingle.	Good	Fascia in good condition. No rainwater management.	No Recommendation.	N/A	N/A		
D Services	D40 Fire Protection	D4030 Fire Protection Specialties	Fire extinguisher.	Fair	No comment on condition.	No Recommendation.				
	D50 Electrical	D5010 Electrical Service & Distribution	100A single phase service sub-fed from adjacent building.	Fair	Service appears adequate.	Maintain circuit breakers (maintenance).	2D	N/A

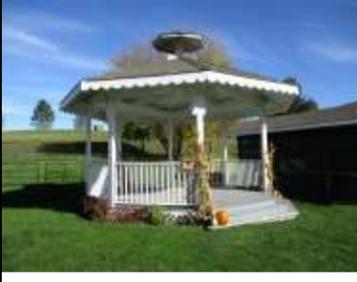
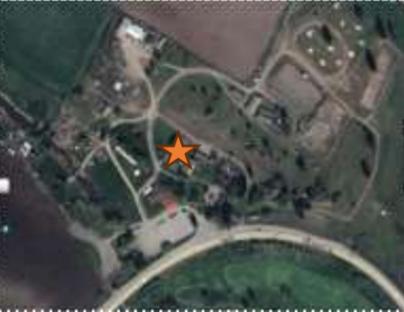
Gazebo

Other Names	1986 constructed.	A					\$ -			
n/a	1987 relocated to present location.	B					\$ -			
Description	2008 reconstructed.	C					\$ -			
White painted wood post and beam construction with asphalt shingle roof.		D					\$ -			
		E					\$ -			
		F					\$ -			
		G					\$ -			
		Total	\$ -	\$ -	\$ -	\$ -

Level 1	Level 2	Level 3	Assessment					
Major Group Elements	Group Elements	Individual Elements	Building Component	Condition	Comments	Recommended Action	Priority Ranking	Probable Cost
A Substructure	A10 Foundation	A1020 Special Foundations	Wood sleeper foundations and decorative wood lattice.	Fair	Foundation is in fair condition.	No Recommendation.	N/A	N/A
B Shell	B10 Superstructure	B1010 Floor Construction	Wood framed.	Fair	No comment on condition.	No Recommendation.	N/A	N/A
		B1020 Roof Construction	White painted post and beam with wood rafters and wood plank sheathing.	Fair	3 posts with checking and 1 beam with cracking.	Repair posts (maintenance). Continue to monitor for changes.	N/A	N/A
	B30 Roofing	B3010 Roof Coverings	Asphalt shingle roof and wood fascia.	Good	Fascia deteriorated at cupola.	Repair and paint fascia (maintenance).	3D	See Roof Maintenance Program.
C Interiors	C10 Interior Construction	C1030 Fittings	White painted wood guardrail.	Good	No comment on condition.	No Recommendation.	N/A	N/A

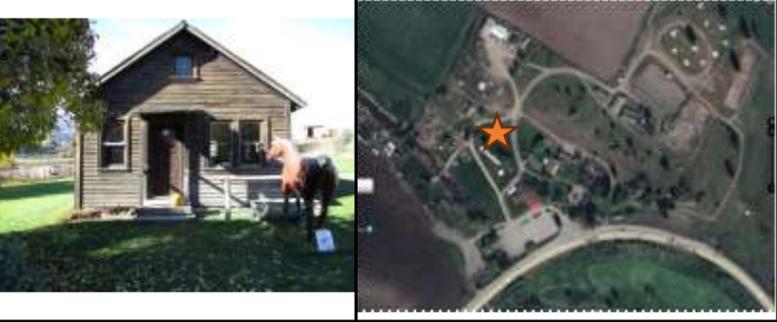
Cowboy Bunkhouse

Other Names	1941 constructed. 1980s modified.	Programs have not been included in OPC Summary. Refer to Program Summary page at beginning of the report.	A				\$ -	
Ford House			B				\$ -	
Description			C				\$ -	
Wood framed single-storey structure with wood siding. Concrete foundation wall. Cedar shake roof. Wood awning at West elevation. Wood framed windows and doors.			D				\$ -	
			E				\$ -	
			F				\$ -	
			G				\$ -	
				Total	\$ -	\$ -	\$ -	
Level 1	Level 2	Level 3	Assessment					
Major Group Elements	Group Elements	Individual Elements	Building Component	Condition	Comments	Recommended Action	Priority Ranking	Probable Cost
A Substructure	A10 Foundation	A1010 Standard Foundations	Stone and concrete foundation with openings for air circulation.	Poor	Spalling.	Continue monitoring for changes.	N/A	N/A

B Shell	B10 Superstructure	B1010 Floor Construction	Wood rafters.	Fair	No comment on condition.	No Recommendation.	N/A	N/A
		B1020 Roof Construction	2x4 wood joists at 24" o/c with 1x8 strapping.	Fair	No comment on condition.	No Recommendation.	N/A	N/A
	B20 Exterior Enclosure	B2010 Exterior Walls	Wood horizontal cladding. 2x4 wood framing at 16" o/c.	Poor	Previous temporary patches with mesh and some rotted boards.	Upgrade patches to metal or repair cladding.	3E	See Cladding Program.
		B2020 Exterior Windows	Mix of hung and fixed windows. Wood frame.	Poor	Poor seals and aged trim.	Repair and paint.	4D	See Window and Door Program.
		B2030 Exterior Doors	Painted wood doors and wood trim. Some glass panes.	Poor	Some organic growth on trims and paint peeling.	Repair and paint.	4D	See Window and Door Program.
	B30 Roofing	B3010 Roof Coverings	Cedar shake shingles roof with eavestroughs and downspouts and wood fascia.	Poor	Organic growth.	Replace roof.	4C	See Roof Replacement and Maintenance Programs.

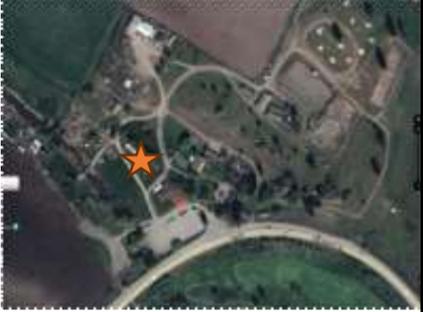
Bird Pens

Level 1	Level 2	Level 3	Assessment					
Major Group Elements	Group Elements	Individual Elements	Building Component	Condition	Comments	Recommended Action	Priority Ranking	Probable Cost
A Substructure	A10 Foundation	A1020 Special Foundations	Buried wood posts.	Good	Posts at high risk for rot. Water staining at base.	No Recommendation.	N/A	N/A
B Shell	B10 Superstructure	B1010 Floor Construction	Soil.		No comment on condition.	No Recommendation.	N/A	N/A
		B1020 Roof Construction	2x6 rafters. Post and beam construction.	Good	No comment on condition.	No Recommendation.	N/A	N/A
	B20 Exterior Enclosure	B2010 Exterior Walls	Wire mesh over wood frame and wood plank half wall at south.	Good	No comment on condition.	No Recommendation.	N/A	N/A
		B2030 Exterior Doors	Wood frame and wire mesh.	Good	No comment on condition.	No Recommendation.	N/A	N/A
G Sitework	B30 Roofing	B3010 Roof Coverings	Sheet metal roof.	Good	Overhang is appropriate.	No Recommendation.	N/A	N/A

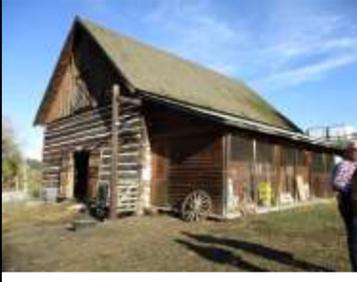
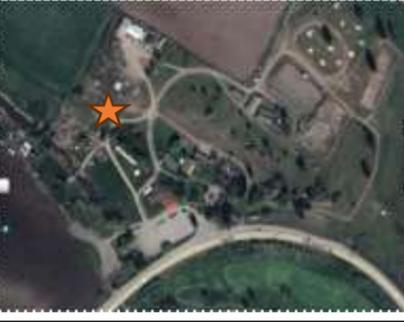
Log Barn

Major Group Elements	Group Elements	Individual Elements	Building Component	Condition	Comments	Recommended Action	Priority Ranking	Probable Cost		
A Substructure	A10 Foundation	A1020 Special Foundations	Stone pedestals and grade beams. Buried post for West elevation lean-to.	Good	Foundations are in good condition.	No Recommendation.	N/A	N/A		
		A1030 Slab on Grade	Concrete slab on grade for East elevation lean-to.	Fair	No fill under the slab at South end.	Add fill to support slab. See A1010 at buildings 4A, 20 & 34.	3D	\$ 25,000		
B Shell	B10 Superstructure	B1010 Floor Construction	2x8 wood stringers on center beam.	Fair	No comment on condition.	No Recommendation.	N/A	N/A		
		B1020 Roof Construction	Rough cut 2x4 trusses w collar ties and 1"x6" strapping. Approximately 8-10 inch diameter pole beams. Some 2x4 posts. Lean-tos are post and beam construction. West elevation lean-to has diagonal bracing.	Fair	Water staining on underside of wood plank sheathing. Floor in hay loft deflects under human load.	B1020. 1 Roof replacement.		3C	See Roof Replacement and Maintenance Program.

B1020.2 Structural assessment of hay loft. See B1010 at building 4A, B1020 at building 35.		3C	\$ 10,000	
	B20 Exterior Enclosure	B2010 Exterior Walls	Broad axed log with chinking. Vertical and horizontal 1" wood planks on gable ends. Mesh on east lean-to.	Fair	Some planks are loose. Chinking is dry and cracking.	Replace loose boards and repair chinking.	2D	See Cladding Program.		
		B2020 Exterior Windows	Wood fame with wire mesh.	Good	No comment on condition.	No Recommendation.	N/A	N/A		
		B2030 Exterior Doors	Wood doors and frames. Barn door at South elevation.	Good	No comment on condition.	No Recommendation.	N/A	N/A		
	B30 Roofing	B3010 Roof Coverings	Cedar shake shingles roof with eavestroughs, downspouts and wood fascia.	Poor	Cedar shake roof is aged and has organic growth and some broken shingles. Corrugated metal roofs have localized surface corrosion.	See B2010.	N/A	N/A		
C Interiors	C10 Interior Construction	C1010 Partitions	Wood frame and wire mesh.	Fair	No comment on condition.	No Recommendation.	N/A	N/A

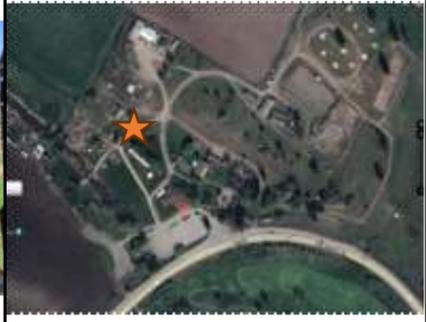
Ye Ol' Feed Shed

B1020 Roof Construction	Wood frame. With 2x4 trusses.	Fair	No comment on condition.	No Recommendation.	N/A	N/A	
	B20 Exterior Enclosure	B2010 Exterior Walls	Wood frame. Vertical wood plank cladding.	Poor	Some boards are loose or broken at the base.	Replace the loose or broken boards.	3E	See Cladding Program.	
		B2020 Exterior Windows	Wood frame with no glass. Sliding wood shutter.	Fair	No comment on condition.	No Recommendation.	N/A	N/A	
		B2030 Exterior Doors	Wood door and trim.	Poor	Wood is splitting, some ad hoc repairs.	Restain and replace door.	2E	See Window and Door Program.	
B30 Roofing	B3010 Roof Coverings	Cedar shake shingle roof with wood fascia.	Fair	Debris from tree. Fascia deteriorated from woodpeckers and rot. Has been previously replaced.	Remove debris and replace fascia.	1C	See Roof Maintenance Program.		
G Sitework	G20 Site Improvements	G2040 Site Development	Decommissioned light pole adjacent.		No comment on condition.	No Recommendation.	N/A	N/A

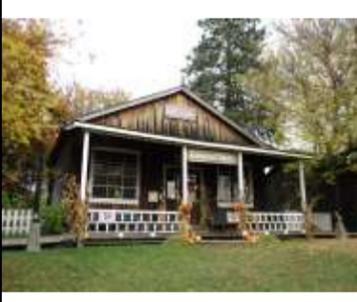
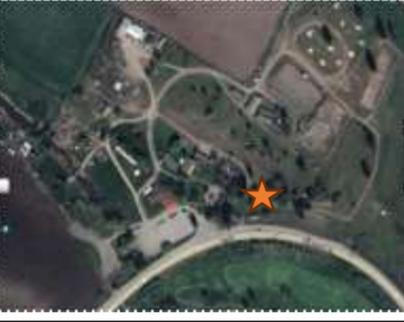
General Store

B Shell	B10 Superstructure	B1010 Floor Construction	2-ply 3x8 North-South spanning beam. 5 1/4"x5 1/4" beam in center of room.	Good	No comment on condition.	No Recommendation.	N/A	N/A	
		B1020 Roof Construction	2x6 wood rafters at 16" o/c with 1"x6" strapping.	Fair	Water staining on soffit.	Clean and paint soffit. Repair roof leaks.	3D	See Roof Maintenance Program.	
	B20 Exterior Enclosure	B2010 Exterior Walls	Wood frame. 1" board and batten cladding.	Good	Aged siding with water staining at base. Some loose battens.	Landscape to provide 4" clearance between cladding and vegetation. Repair or replace loose battens.	3D	See Landscaping and Cladding Programs.	
		B2020 Exterior Windows	Wood frame fixed windows with metal bars over exterior and some stained glass.	Fair	Trim paint peeling.	Repair and paint trim.	2D	See Window and Door Program.	
		B2030 Exterior Doors	Wood door and trim with glass panes.	Fair	Trim paint peeling.	Repair and paint trim.	2D	See Window and Door Program.

B30 Roofing	B3010 Roof Coverings	Cedar shake shingle roof with wood fascia.	Poor	Shingles curling and some organic growth.	Repair and paint fascia.	3D	See Roof Replacement and Maintenance Programs.	
						Roof replacement.	4C	See Roof Replacement and Maintenance Programs.	
	B3020 Roof Openings	New metal chimney.	Fair	No comment on condition.	No Recommendation.	N/A	N/A		
C Interiors	C30 Interior Finishes	C3010 Wall Finishes	Painted wood plank.	Fair	No comment on condition.	No Recommendation.	N/A	N/A	
		C3020 Floor Finishes	1x6 tongue and groove at 16" o/c.	Fair	No comment on condition.	No Recommendation.	N/A	N/A	
		C3030 Ceiling Finishes	Painted wood plank.	Fair	No comment on condition.	No Recommendation.	N/A	N/A	
D Services	D50 Electrical	D5010 Electrical Service & Distribution	30A sub fed from log house underground.	Good	Load centre panel located under counter is adequate.	Maintain circuit breakers (maintenance).	2D	N/A

D5020 Lighting and Branch Wiring	Interior lighting.	Fair	Screw base lamp holders and older decorative fixtures.	Ensure LED lamps are utilized (maintenance).	2E	N/A	
G Sitework	G20 Site Improvements	G2030 Pedestrian Paving	Wood boardwalk from Log House to St. Anne's Church. Wood frame front porch with wood steps and guardrail.	Fair	Pedestrian paving is in fair condition.	No Recommendation.	N/A	N/A	
		G2040 Site Development	White painted picket fence on either side.	Fair	Fence is in fair condition.	No Recommendation.	N/A	N/A	
		G2050 Landscaping	Garden beds on three sides.	Fair	Vegetation touches cladding.	See B2010.	N/A	See B2010.

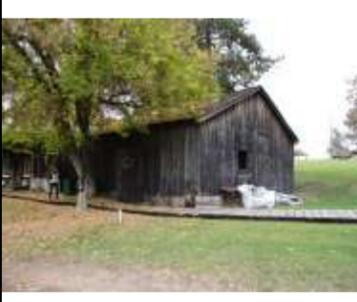
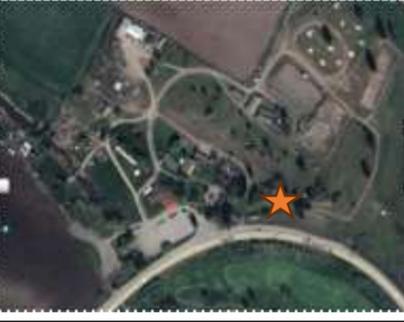
Blacksmith Shop

Level 1	Level 2	Level 3	Assessment					
Major Group Elements	Group Elements	Individual Elements	Building Component	Condition	Comments	Recommended Action	Priority Ranking	Probable Cost
A Substructure	A10 Foundation	A1010 Standard Foundations	Stone foundation wall 10" high by 12" wide with 5" concrete footing and parging on interior.	Good	No comment on condition.	No Recommendation.	N/A	N/A
B Shell	B10 Superstructure	B1010 Floor Construction	Reported 2" concrete slab.	Fair	No comment on condition.	No Recommendation.	N/A	N/A
		B1020 Roof Construction	2x6 rough cut wood rafters. Center beam bearing on column and exterior walls.	Good	No comment on condition.	No Recommendation.	N/A	N/A
	B20 Exterior Enclosure	B2010 Exterior Walls	Board and batten siding with 1x8-12" board and 1x4 battens. 2x4 rough cut wood stud at 16" o/c, cross braced with 2x4 blocking. 2x6 bottom plate and 2x4 top plate.	Poor	Wood pecker holes and water staining at base. Some previous metal patches.	Landscape to provide 4" clearance between cladding and vegetation. Repair woodpecker holes.	3D	See Landscaping and Cladding Program.

B2020 Exterior Windows	Wood frame with metal mesh covering. One fixed glass panel window.	Fair	No comment on condition.	No Recommendation.	N/A	N/A
		B2030 Exterior Doors	Wood doors and trim. Glass panel in back door.	Fair	Surface corrosion on hardware. Front door is touching vegetation and rotting at base. Back door is in poor condition and has no handle.	See B2010. repair doors as required.	3E	See Window and Door Program.
	B30 Roofing	B3010 Roof Coverings	Cedar shake shingle with wood fascia.	Fair	Lots of organic growth and debris from tree. Some missing shingles.	Roof replacement.	4C	See Roof Replacement and Maintenance Programs.
B3020 Roof Openings		Metal chimney.	Good	Potential fire hazard with no flashing at base of chimney.	Add flue flashing at base of chimney. See B3020 at building 4A.	4B	\$ 5,000	
C Interiors	C30 Interior Finishes	C3010 Wall Finishes	Painted plywood	Good	No comment on condition.	No Recommendation.	N/A	N/A

D30 HVAC	D3040 Distribution Systems	Forge Venting System	Poor	Except for one system, the forge venting system will need to be replaced.	The systems should be replaced, and appropriate thimbles are needed for the penetrations through the roof.	5C	\$ 18,000
D Services	D40 Fire Protection	D4030 Fire Protection Specialties	Fire extinguisher.	Fair	No comment on condition.	No Recommendation.	N/A	N/A
	D50 Electrical	D5010 Electrical Service & Distribution	60A sub feed underground from Log House.	Good	60A load centre panel is adequate for the current use.	Maintain circuit breakers (maintenance).	2D	N/A
		D5020 Lighting and Branch Wiring	Interior fluorescent lighting.	Fair	Minimal lighting.	Replace lighting with LED as fixtures fail.	2D	N/A
E Equipment & Furnishings	E10 Equipment	E1010 Commercial Equipment	Blacksmithing forges.	Fair	No comment on condition.	No Recommendation.	N/A	N/A
G Sitework	G20 Site Improvements	G2030 Pedestrian Paving	Wood boardwalk from Log House to St. Anne's Church.	Fair	Boardwalk is in fair condition.	No Recommendation.	N/A	N/A

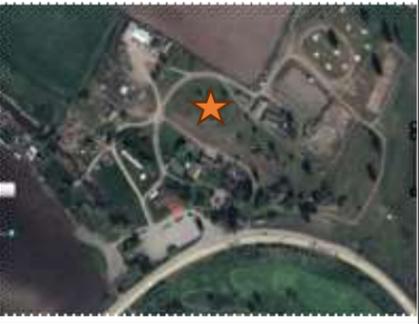
Pump House

A Substructure	A10 Foundation	A1030 Slab on Grade	Standard concrete slab on grade.	Good	Foundation is in generally good condition.	No Recommendation.	N/A	N/A				
B Shell	B10 Superstructure	B1010 Floor Construction	See A1030.	Good	See A1030.	See A1030.	N/A	N/A				
		B1020 Roof Construction	Wood joists.	Fair	Potential repairs required due to roof leak. Potential stud deterioration from leak.	Review and repair with roof and cladding repairs.	N/A	See Roof Maintenance Program.				
	B20 Exterior Enclosure	B2010 Exterior Walls	Wood frame. Board and batten cladding.	Fair	Cladding is aged and touching grade.	Landscape to provide 4" clearance between cladding and vegetation. Repair or replace damaged cladding.	3E	See Landscaping and Cladding Programs.				
		B2030 Exterior Doors	Wood door and frame.	Fair	No comment on condition.	No Recommendation.	N/A	N/A				
		B30 Roofing	B3010 Roof Coverings	Sheet metal roof.	Good	No comment on condition.	No Recommendation.	N/A	N/A

C Interiors	C30 Interior Finishes	C3010 Wall Finishes	Plywood.	Poor	Staining at North-East corner.	Replace plywood and repair roof leaks.	4D	See Cladding Program.				
		C3020 Floor Finishes	See A1030.	Good	See A1030.	See A1030.	N/A	N/A				
		C3030 Ceiling Finishes	Plywood.	Poor	Staining at North-East corner.	See C3010.	N/A	See C3010.				
D Services	D20 Plumbing	D2020 Domestic Water Distribution	The piping systems use galvanized, copper, and plastic piping.		Galvanized piping is no longer approved on domestic water systems. The tanks and recent piping system appear to be functional.	The next time the system needs work, we recommended replacing the galvanized piping with approved domestic water systems.	3D	\$ 2,500				
	D50 Electrical	D5010 Electrical Service & Distribution	Electrical sub-fed from Implement Shed.	Fair	Older style ITE panel replacement breakers will be difficult to obtain.	Replace panel.	3D	\$ 1,500

D5020 Lighting and Branch Wiring	Lighting.	Fair	Fluorescent.	Replace with LED when fixture fails (maintenance).	2D	N/A				
		D5090 Other Electrical Systems	Generator input.	Fair	Manual transfer switch for connection of portable generator.	No Recommendation.	N/A	N/A

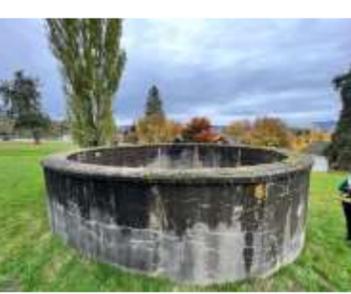
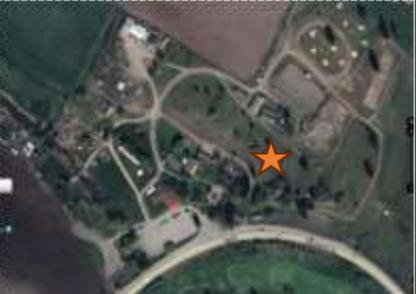
Water Cisterns

A20 Basement Construction	A2020 Basement Walls	Concrete cistern.	Fair	At East cistern: crack through wall near west side, pour joint at half height is cracked. Concrete cap is in fair condition.	Remove vegetation and clean (maintenance).	N/A	N/A	
B Shell	B10 Superstructure	B1020 Roof Construction	Collar tied wood trusses at cover.	Fair	Minor staining	Roof replacement.	2D	See Roof Replacement and Maintenance Programs.	
	B20 Exterior Enclosure	B2010 Exterior Walls	Approximately 2x4 wood frame with double layer of horizontal wood cladding on cover.	Fair	Cladding near grade has minor deterioration and is buried at north elevation.	Repair and paint cladding.	3E	See Cladding Program.	
		B2020 Exterior Windows	Wood framed opening with wood shutter.	Fair	Shutters are aged.	Repair shutters.	3E	See Window and Door Program.	
	B30 Roofing	B3010 Roof Coverings	Cedar shake shingle roof with wood fascia.	Fair	Sheathing is water damaged and splitting in some locations. Some organic growth.	See B1020.	N/A	See B1020.

C Interiors	C30 Interior Finishes	C3010 Wall Finishes	Parging layer.	Fair	Shrinkage cracking in both cisterns. East cistern has spalling, efflorescence, delaminations, and vegetation growth. No mortar joint deterioration.	See A2020.	N/A	See A2020.	
G Sitework	G20 Site Improvements	G2050 Landscaping	Trees near West cistern.		No comment on condition.	No Recommendation.	N/A	N/A

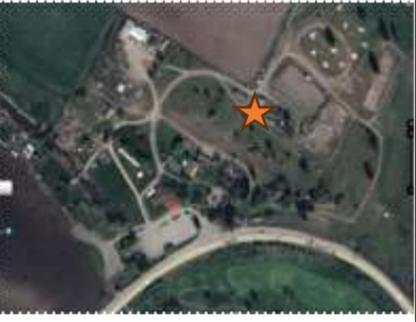
SPALLUMCHEEN PIONEER POWER CLUB DISPLAY #2

Level 1	Level 2	Level 3	Assessment					
Major Group Elements	Group Elements	Individual Elements	Building Component	Condition	Comments	Recommended Action	Priority Ranking	Probable Cost
A Substructure	A10 Foundation	A1010 Standard Foundations	Pressure-treated embedded posts.	Fair	Water staining at base.	No Recommendation.	N/A	N/A
		B1010 Floor Construction	Soil.		No comment on condition.	No Recommendation.	N/A	N/A
B Shell	B10 Superstructure	B1020 Roof Construction	Engineered trusses with steel tie downs. Pole barn construction with poles at 15' o/c.	Fair	Notched poles in bearing. Some cracking in beams and some poles checking.	Add new strap anchors. Continue monitoring for changes. See A1010 at buildings 28 & 29, B1020 at building 30, G2040 at building 36.	2B	\$ 6,000
		B30 Roofing	B3010 Roof Coverings	Cedar shake shingle roof with wood fascia and horizontal wood cladding at gable ends.	Poor	Shingles in fair to poor condition with some organic growth. Sheathing stained.	Roof replacement.	3C

D Services	D50 Electrical	D5010 Electrical Service & Distribution	100A single phase panel.	Good	Panel is located in weather protective wooden cabinet	No Recommendation.	N/A	N/A
		D5020 Lighting and Branch Wiring	Lighting.	Fair	Residential style chandelier fixtures.	Utilize LED lamps (maintenance).	2D	N/A

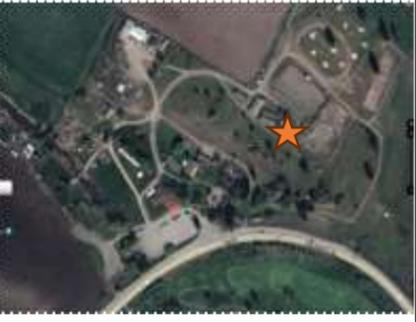
Implement Shed #2

Level 1	Level 2	Level 3	Assessment					
Major Group Elements	Group Elements	Individual Elements	Building Component	Condition	Comments	Recommended Action	Priority Ranking	Probable Cost
A Substructure	A10 Foundation	A1020 Special Foundations	18 concrete blocks with mix of posts bearing on concrete in some locations and steel saddle connection.	Good	Surface corrosion on steel connections.	Clean steel connection. See A1010 at building 28, B1020 at buildings 27 & 30, G2040 at building 36.	2D	\$ 6,000
B Shell	B10 Superstructure	B1010 Floor Construction	Soil.		No comment on condition.	No Recommendation.	N/A	N/A
		B1020 Roof Construction	Engineered trusses and 1x6 strapping.	Fair	No comment on condition.	No Recommendation.	N/A	N/A
	B20 Exterior Enclosure	B2010 Exterior Walls	8x8 post and beam construction with mix of board and batten and vertical wood plank cladding.	Fair	Cladding is aged.	No Recommendation.	N/A	N/A

B30 Roofing	B3010 Roof Coverings	Cedar shake shingle roof with wood fascia.	Poor	Substantial organic growth on North elevation. Sheathing stained. Fascia in very poor condition.	Roof replacement.	4C
G Sitework	G20 Site Improvements	G2040 Site Development	Post and beam lean-to at back for animals with concrete footings and steel saddle connection. Plywood cladding and sheet metal roof.	Poor	Plywood is aged.	No Recommendation under current use.	N/A	N/A
		G2050 Landscaping	Plantings at back corner.		Vegetation touches grade.	Landscape to provide clearance.	2E	See Landscaping Program.

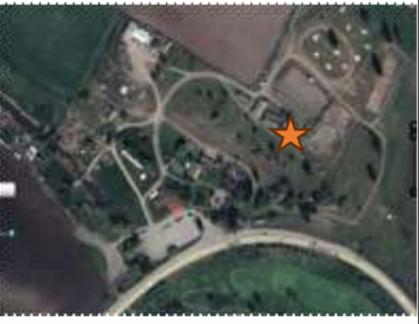
Tack Shed

Level 1	Level 2	Level 3	Assessment					
Major Group Elements	Group Elements	Individual Elements	Building Component	Condition	Comments	Recommended Action	Priority Ranking	Probable Cost
A Substructure	A10 Foundation	A1020 Special Foundations	Retrofit concrete piles with collar tie connection between post and pile and decorative rope.	Good	The connection is unconventional but appears to be sufficient.	No Recommendation.	N/A	N/A
B Shell	B10 Superstructure	B1010 Floor Construction	Slab on grade in tack room, else soil.	Good	No comment on condition.	No Recommendation.	N/A	N/A
		B1020 Roof Construction	Pole barn construction with notched pole in bearing acting as "beam" and some straps toe-nailed in at ends. Engineered wood trusses at 4'6" o/c in barn and wood rafters in tack room.	Fair	Normal weathering of poles.	Add new strap anchors. See A1010 at buildings 28 & , B1020 at building 27, G2040 at building 36.	2B	\$ 6,000

B20 Exterior Enclosure	B2010 Exterior Walls	Sheet metal cladding on tack room.	Good	No comment on condition.	No Recommendation.	N/A	N/A
		B2030 Exterior Doors	Wood frame OSB doors.	Good	No comment on condition.	No Recommendation.	N/A	N/A
	B30 Roofing	B3010 Roof Coverings	Sheet metal roof. Horizontal wood plank cladding on gable ends.	Fair	Debris on roof.	Clear roof.	1D	See Roof Maintenance Program.
		B3020 Roof Openings	Wood frame skylight in tack room.	Fair	No comment on condition.	No Recommendation.	N/A	N/A
C Interiors	C10 Interior Construction	C1030 Fittings	2-rail wood fence around perimeter.	Good	No comment on condition.	No Recommendation.	N/A	N/A
	C30 Interior Finishes	C3010 Wall Finishes	Painted plywood.	Good	No comment on condition.	No Recommendation.	N/A	N/A
		C3020 Floor Finishes	Painted plywood.	Good	No comment on condition.	No Recommendation.	N/A	N/A
G Sitework	G20 Site Improvements	G2050 Landscaping	Coniferous tree adjacent.		No comment on condition.	No Recommendation.	N/A	N/A

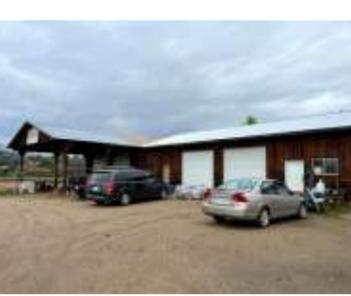
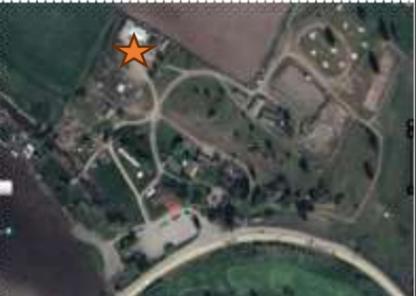
Spallumcheen Pioneer Power Club Clubhouse

G			\$ 6,000		\$ 6,000			
		Total			\$ -	\$ 35,600	\$ 500	\$ 36,100		
Level 1	Level 2	Level 3	Assessment							
Major Group Elements	Group Elements	Individual Elements	Building Component	Condition	Comments	Recommended Action	Priority Ranking	Probable Cost		
A Substructure	A10 Foundation	A1030 Slab on Grade	Standard slab on grade.	Fair	Cracking in concrete floor in SPPC bathroom.	Continue monitoring for changes.	N/A	N/A		
	B10 Superstructure	B1010 Floor Construction	See A1030.	Fair	See A1030.	See A1030.	N/A	See A1030.		
B Shell		B1020 Roof Construction	Wood frame.		No comment on condition.	No Recommendation.	N/A	N/A		
	B20 Exterior Enclosure	B2010 Exterior Walls	Wood frame. Board and batten cladding.	Fair	Some battens missing and water staining at base.	Replace missing battens.	3E	See Cladding Program.		
		B2020 Exterior Windows	Wood frame and metal slider windows.	Good	No comment on condition.	No Recommendation.	N/A	N/A

B2030 Exterior Doors	5 garage doors (two with electric openers). Mix of wood and fiberglass doors, all wood frame.	Fair	Some garage doors not fully sealed and weather stripping weathered. Minor damage to garage doors.	No Recommendation.	N/A	N/A		
B30 Roofing	B3010 Roof Coverings	Sheet metal roof with wood fascia.	Fair	From various eras, previous patch on maintenance side. Vegetation on fascia.	No Recommendation.	N/A	N/A			
C Interiors	C10 Interior Construction	C1010 Partitions	Wood frame.	Good	No comment on condition.	No Recommendation.	N/A	N/A		
		C1020 Interior Doors	Wood door and frame.	Fair	No comment on condition.	No Recommendation.	N/A	N/A		
		C3010 Wall Finishes	Mix of painted plywood and drywall.	Fair	No comment on condition.	No Recommendation.	N/A	N/A		
	C30 Interior Finishes	C3030 Ceiling Finishes	Drywall.	Good	Failing at joints in SPPC garage.	Retape joints and repaint (maintenance).	N/A	N/A

D Services	D20 Plumbing	D2010 Plumbing Fixtures	Lavatories and water closets.	Fair	Lavatories and water closets are in fair condition but are still serviceable. The existing fixtures should provide good service for the near future.	No Recommendation.	N/A	N/A		
		D2020 Domestic Water Distribution	Original piping systems are copper.	Fair	D2020.1 The insulation is in poor condition or missing in certain locations. The domestic water piping should provide good service for the near future.	D2020.1 The operators should look for pinhole leaks from time to time.	3C	\$ 100		
					D2020.2 Consideration should be made for upgrades to the existing insulation to save energy.	D2020.2 Consideration should be made for upgrades to the existing insulation to save energy.	1E	\$ 500		
D2030 Sanitary Waste	Sanitary waste systems are not visible.	Fair	Based on the age of the building, sanitary drainage piping should provide good service for the near future.	The system is at an age where blockages could occur, so should be inspected and cleaned from time to time. Repairs if needed could be completed for the location at hand. There is no need for wholesale piping upgrades in the near future.	3D	\$ 300

D Services	D20 Plumbing	D2090 Other Plumbing Systems	Domestic Water Heater	Poor	The Domestic hot water heater is nearing the end of its service life and is need of replacement. This gas fired appliances has not been installed in a room that is fire rated. The Water heater has not been provided with a drain pan.	D2090.1 The domestic water heater should be replaced soon.	4C	\$	5,500			
					D2090.2 Consideration should be made to provide the water heater with a drain pan to catch and direct the water to a drainage system, in the event of a leak in the tank.	4C	\$	500				
					D2090.3 Consideration should be made to build a fire rated room that would house the domestic water heater.	2B	\$	10,000				
	D30 HVAC	D3020 Heat Generating Systems	Furnace	Poor	The facility has a natural gas connection and pressure regulation station.	Fair	Gas piping does not appear to have the appropriate protective coatings.	The owner will want to engage a technician to ensure the systems are configured to code.	2C	\$	500

D5090 Other Electrical Systems	Emergency lighting.	Fair	Minimal emergency lighting installed.	Test emergency lighting regularly.	2D		N/A
G Sitework	G20 Site Improvements	G2040 Site Development	Lean-tos around building of post and beam and pole barn construction with buried post footings and sheet metal roofs. Front shelter of pressure treated post and beam construction with engineered trusses at 4' o/c. Posts tied to main building.	Fair	One rotted pole at lean-tos. North lean-to roof failed at south corner.	Support and provide new pedestal at rotted poles. Patch roof. See A1010 at buildings 28 & 29, B1020 at buildings 27 & 30.	4D	\$	6,000			
		G2050 Landscaping	Vegetation on 3 sides and garden bed at front.	Fair	No comment on condition.	Landscape to provide clearance between cladding and vegetation.	N/A		See Program.

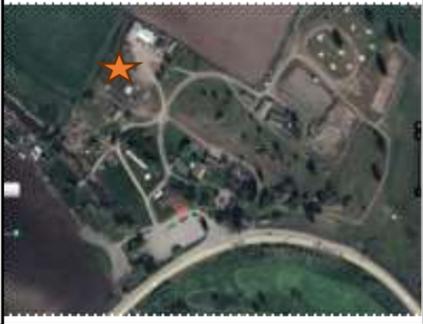
Storage Building

Other Names	n/a		A				\$ -	
Description	Wood framed building with concrete slab on grade foundation and cedar shake roof. Board and batten siding and wood doors.		B				\$ -	
			C				\$ -	
			D				\$ -	
			E				\$ -	
			F				\$ -	
			G				\$ -	
		Total	\$ -	\$ -	\$ -	\$ -		
Level 1	Level 2	Level 3	Assessment					
Major Group Elements	Group Elements	Individual Elements	Building Component	Condition	Comments	Recommended Action	Priority Ranking	Probable Cost
A Substructure	A10 Foundation	A1030 Slab on Grade	Standard slab on grade.	Fair	No comment on condition.	No Recommendation.	N/A	N/A
B Shell	B10 Superstructure	B1010 Floor Construction	Wood frame with plywood front covered deck.	Fair	No comment on condition.	No Recommendation.	N/A	N/A

B1020 Roof Construction	Engineered trusses at 4' o/c.	Fair	No comment on condition.	No Recommendation.	N/A	N/A
	B20 Exterior Enclosure	B2010 Exterior Walls	Board and batten cladding and OSB sheathing.	Fair	Siding is wet and touches grade. Sheathing is exposed on South	Landscape to provide 4" clearance between vegetation and cladding.	5E	See Landscaping Program.
		B2030 Exterior Doors	Wood door and trim.	Fair	No comment on condition.	No Recommendation.	N/A	N/A
	B30 Roofing	B3010 Roof Coverings	Sheet metal roof.	Fair	No comment on condition.	No Recommendation.	N/A	N/A
G Sitework	G20 Site Improvements	G2050 Landscaping	Vegetation surrounding.	Fair	Vegetation touches cladding.	See B2010.	N/A	See B2010.

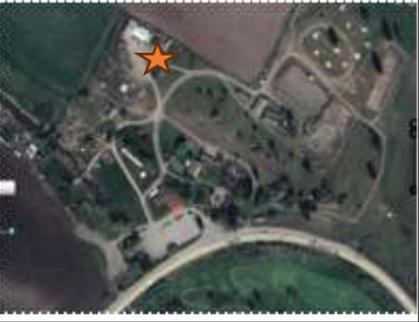
Storage Shed

Other Names	Construction date unknown.	A					\$ -			
n/a		B					\$ -			
Notes		C					\$ -			
Pole barn style shed used as storage.		D					\$ -			
		E					\$ -			
		F					\$ -			
		G					\$ -			
		Total		\$ -	\$ -	\$ -				
Level 1	Level 2	Level 3	Assessment							
Major Group Elements	Group Elements	Individual Elements	Building Component	Condition	Comments	Recommended Action	Priority Ranking	Probable Cost		
A Substructure	A10 Foundation	A1010 Standard Foundations	Buried posts.	Fair	No comment on condition.	No Recommendation.	N/A	N/A		
B Shell	B10 Superstructure	B1010 Floor Construction	Soil.		No comment on condition.	No Recommendation.	N/A	N/A

B1020 Roof Construction	Pole barn with notched poles in bearing for beams and engineered trusses at 2' o/c.	Fair	Condition commensurate of its age.	No Recommendation.	N/A	N/A		
	B30 Roofing	B3010 Roof Coverings	Cedar shake shingle roof with wood fascia. Plywood sheathing on gable ends.	Poor	Staining underside of soffit. Sheathing missing on South elevation. Shingles missing loose and curled. Fascia missing in some locations.	Roof replacement.	5D	See Roof Replacement and Maintenance Programs.		
C Interiors	C10 Interior Construction	C1030 Fittings	Wood racks for storage.	Fair	No comment on condition.	No recommendation.	N/A	N/A		
G Sitework	G20 Site Improvements	G2050 Landscaping	Vegetation surrounding.	Fair	No comment on condition.	No Recommendation.	N/A	N/A

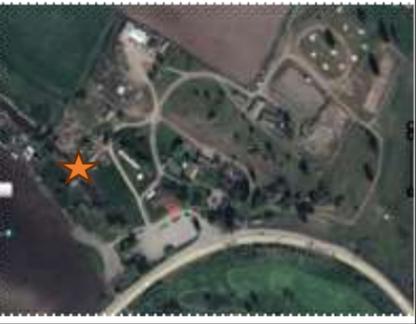
Foot Bridge

n/a				B				\$ -		
Description				C				\$ -		
Single span steel girder bridge with a wood deck supported on concrete lock block abutments				D				\$ -		
		E					\$ -			
		F					\$ -			
		G					\$ -			
		Total			\$ -	\$ -	\$ -			
Level 1	Level 2	Level 3		Assessment						
Major Group Elements	Group Elements	Individual Elements	Building Component	Condition	Comments	Recommended Action	Priority Ranking	Probable Cost		
A Substructure	A10 Foundation	A1020 Special Foundations	Concrete lock block abutments.	Good	No comment on condition.	No Recommendation.	N/A	N/A		
B Shell	B10 Superstructure	B1010 Floor Construction	Wood Deck.	Good	No comment on condition.	No Recommendation.	N/A	N/A		
F Special Construction & Demolition	F10 Special Construction	F1010 Special Structures	Steel girders.	Good	No comment on condition.	No Recommendation.	N/A	N/A

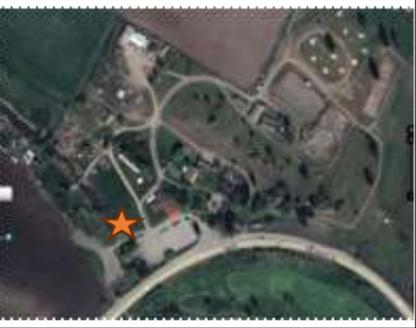
Decommissioned Vehicle Bridge

n/a				B	\$ 125,000						\$ 125,000
Description				C							\$ -
Single span timber bridge. Log stringers bear on log sills and gabion abutments.				D							\$ -
		E						\$ -			
		F						\$ -			
		G						\$ -			
		Total		\$ 125,000	\$ -	\$ -					
Level 1	Level 2	Level 3		Assessment							
Major Group Elements	Group Elements	Individual Elements	Building Component	Condition	Comments	Recommended Action	Priority Ranking	Probable Cost			
A Substructure	A10 Foundation	A1010 Standard Foundations	Stone Gabion abutments.	Fair	No comment on condition.	No Recommendation.	N/A	N/A			
B Shell	B10 Superstructure	B1010 Floor Construction	Log stringers. And wood deck.	Poor	Deflected at midspan. Rotted beams and deck.	Decommission and dispose of bridge.	4B	\$ 125,000

F Special Construction & Demolition	F10 Special Construction	F1010 Special Structures	Guard logs	Poor	Signs of impact damage and not marked.	See B1010.		See B1010.

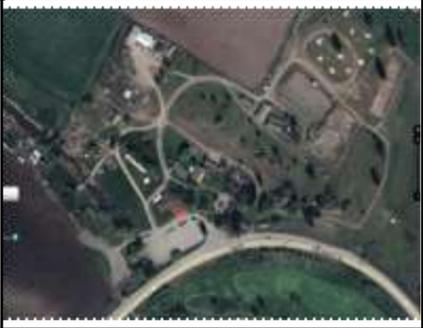
Fences

Other Names	Unknown	A					\$ -			
n/a		B					\$ -			
Description		C					\$ -			
Wood rail, barbed wire, smooth wire, chicken wire, picket and metal rail fences can be found through out the complex.		D					\$ -			
		E					\$ -			
		F					\$ -			
		G					\$ -			
		Total		\$ -	\$ -	\$ -				
Level 1	Level 2	Level 3	Assessment							
Major Group Elements	Group Elements	Individual Elements	Building Component	Condition	Comments	Recommended Action	Priority Ranking	Probable Cost		
G Sitework	G20 Site Improvements	G2040 Site Development	Fencing	Fair	The fencing is an a functioning state but requires a continued maintenance program to continue to operate.	Fence Maintenance Program	5D	See Fence Maintenance Program.

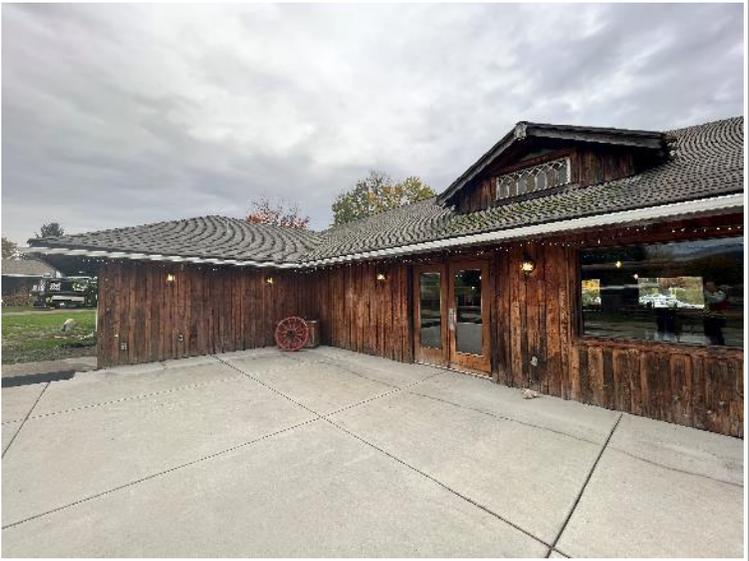
<p data-bbox="1078 1524 1166 1554">Photo 2</p>

1: Visitor Center:
Porch post not connected to the ground.

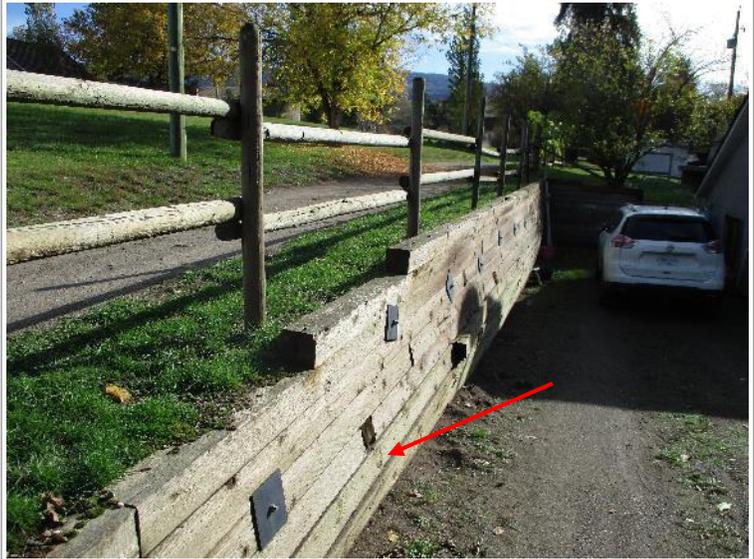
Photo 23

4B: Caretaker's House:
Wood retaining wall at driveway.

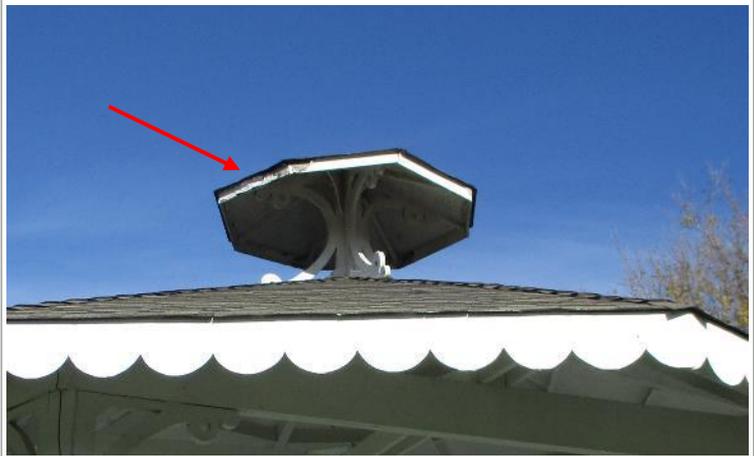
Photo 28

6: Gazebo:
Deteriorated fascia at cupola.

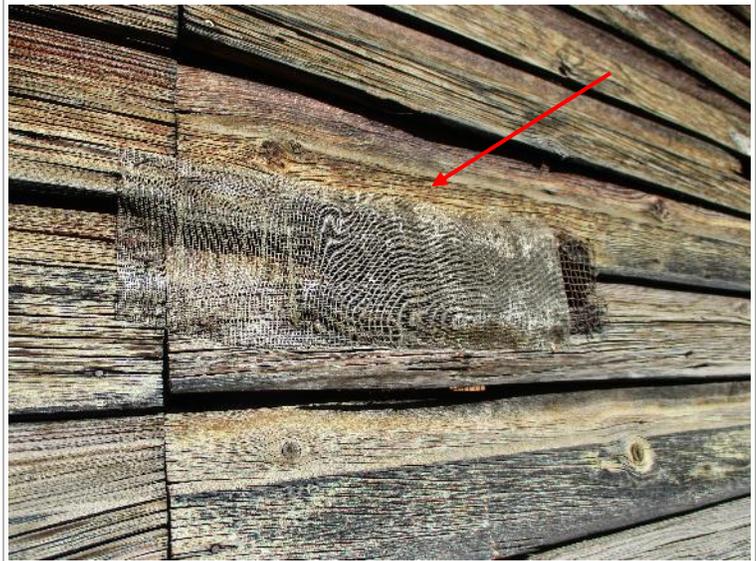
Photo 33

8: Cowboy Bunkhouse:
Mesh cladding patch.

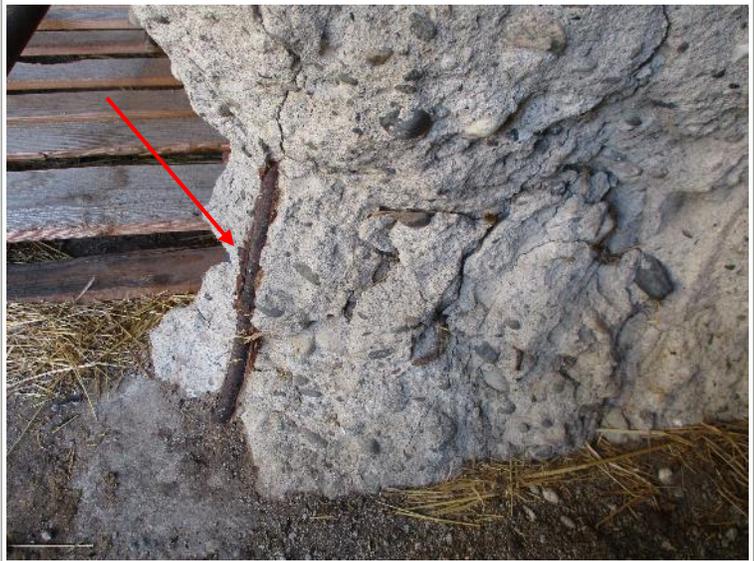
Photo 41

12: Hay Shed:
Eroded concrete and exposed rebar.

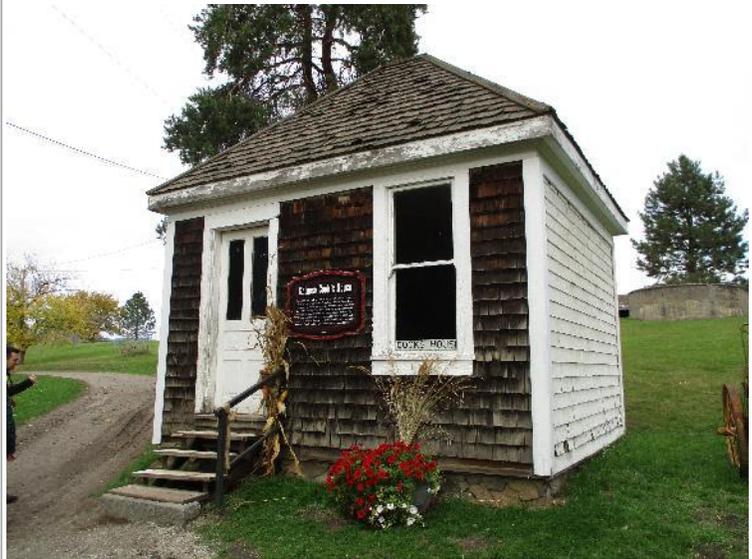
Photo 47

15: Chinese Cook's House:
General view of South elevation.

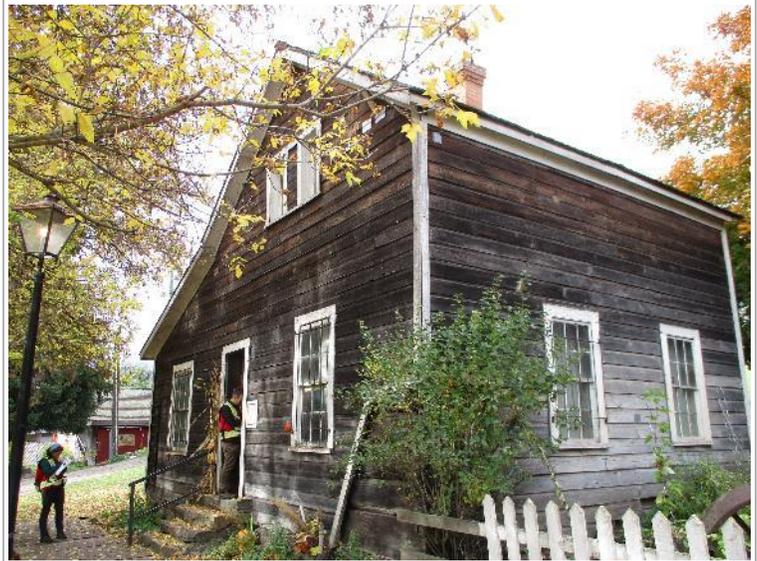
Photo 50

16: Log House:
General view of South-East corner.

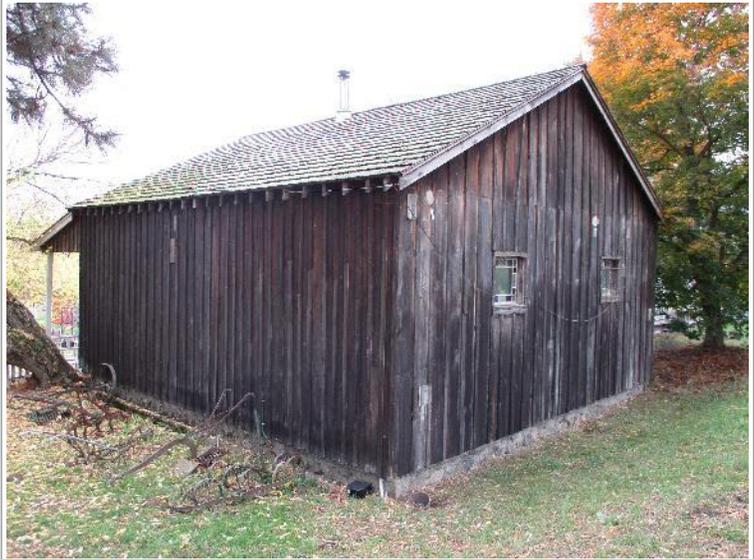
Photo 54

17: General Store:
General view of North-East corner.

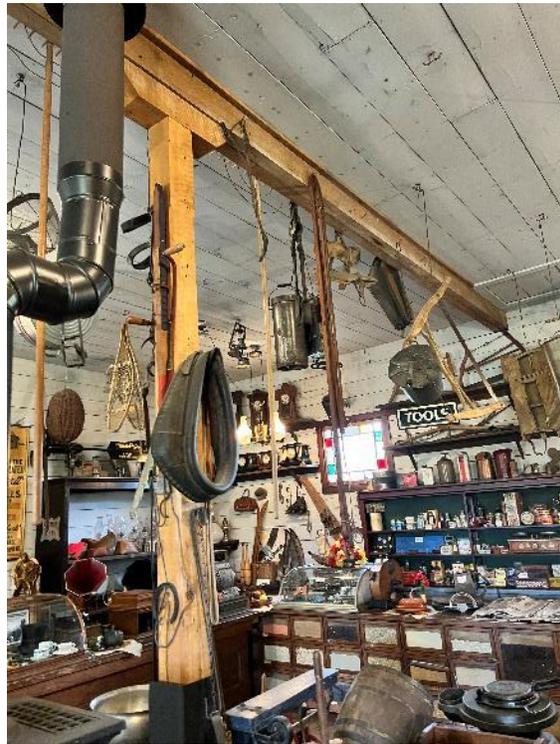
Photo 55

17: General Store:
Interior exposed structure.

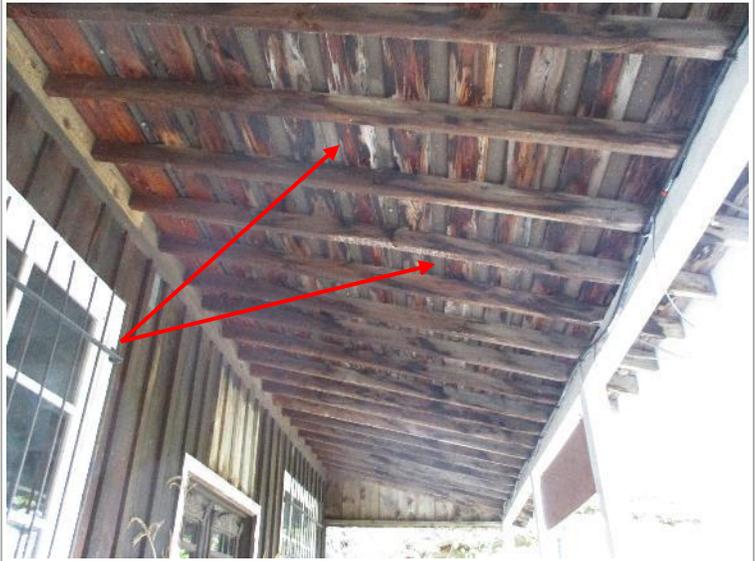
Photo 56

17: General Store:
Water-stained soffit.

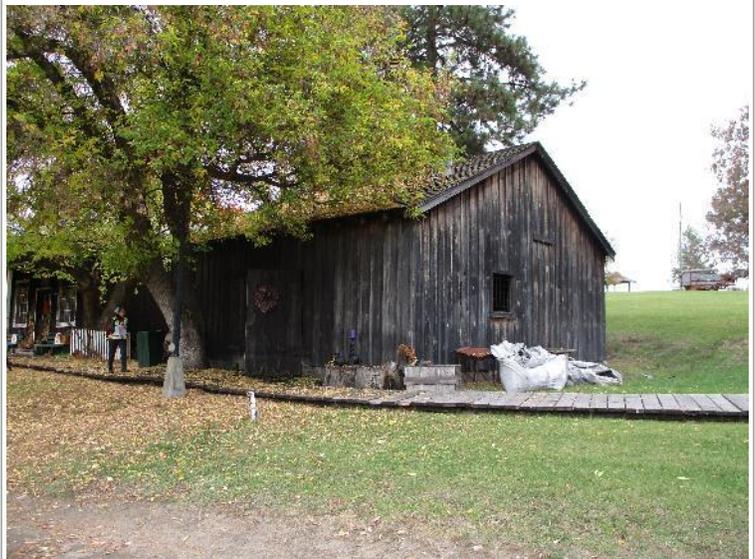
Photo 57

18: Blacksmith Shop:
General view of South-East corner.

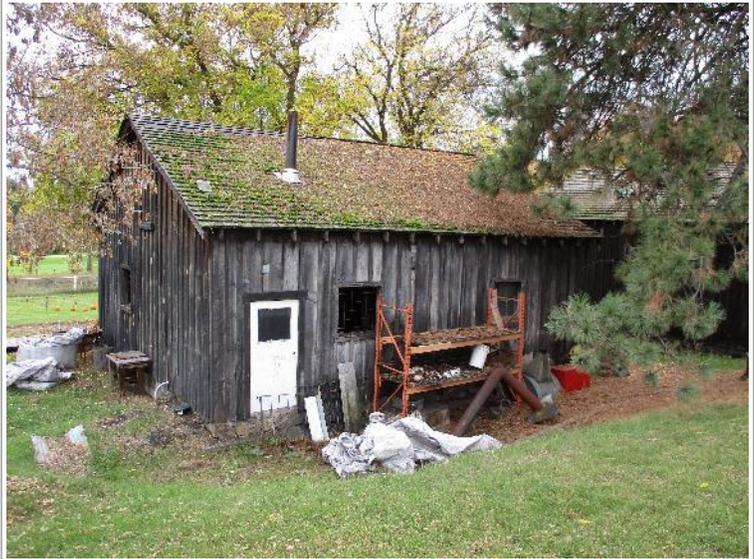
Photo 58

18: Blacksmith Shop:
General view of North elevation and roof.

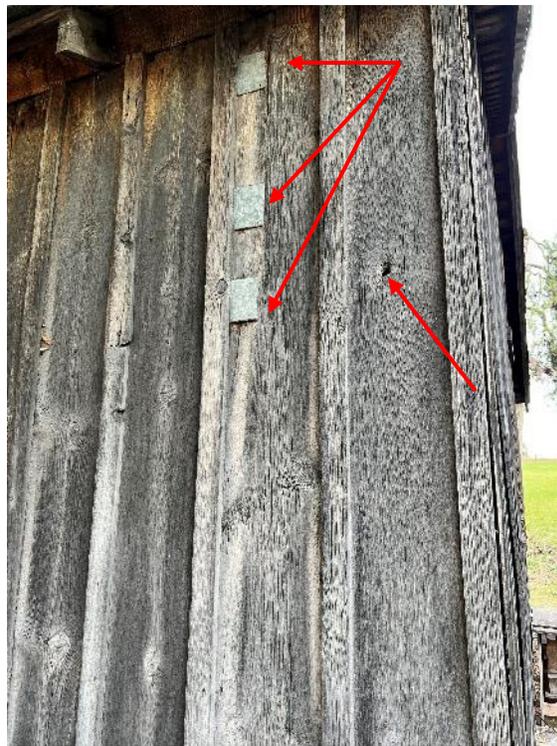
Photo 59

18: Blacksmith Shop:
Woodpecker hole and previous metal patches.

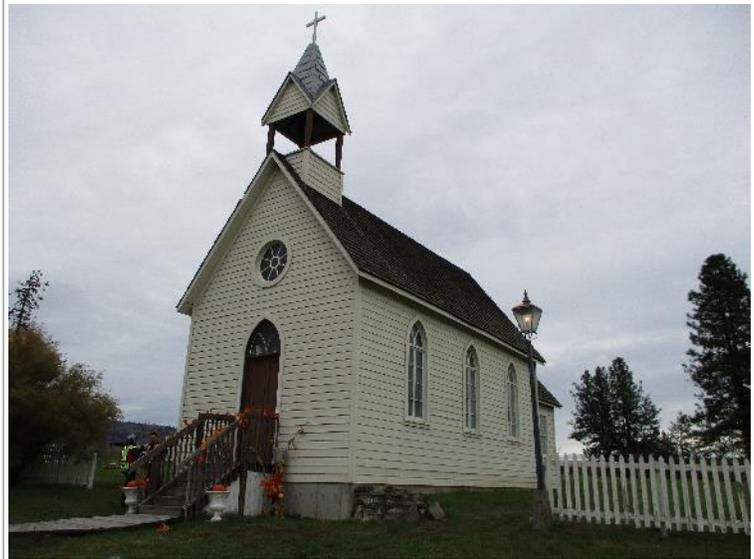
Photo 65

21: St. Anne's Church:
General view of South and East elevations.

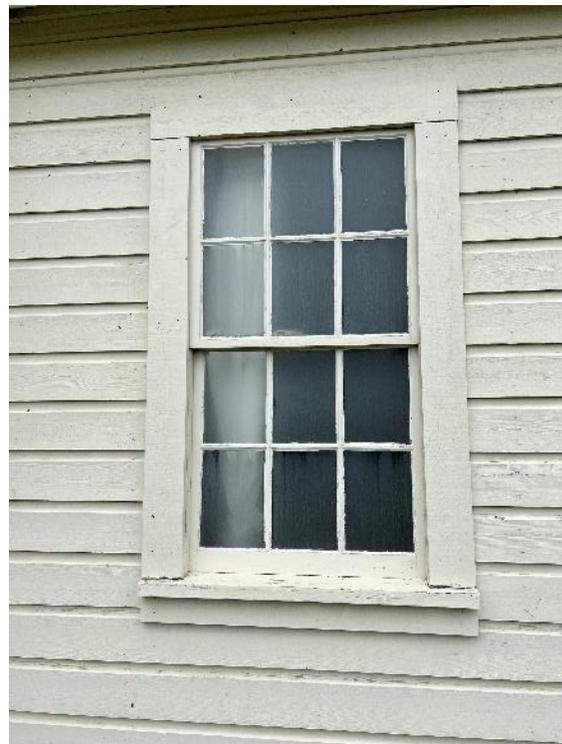
Photo 67

21: St. Anne's Church:
Typical condition of windows.

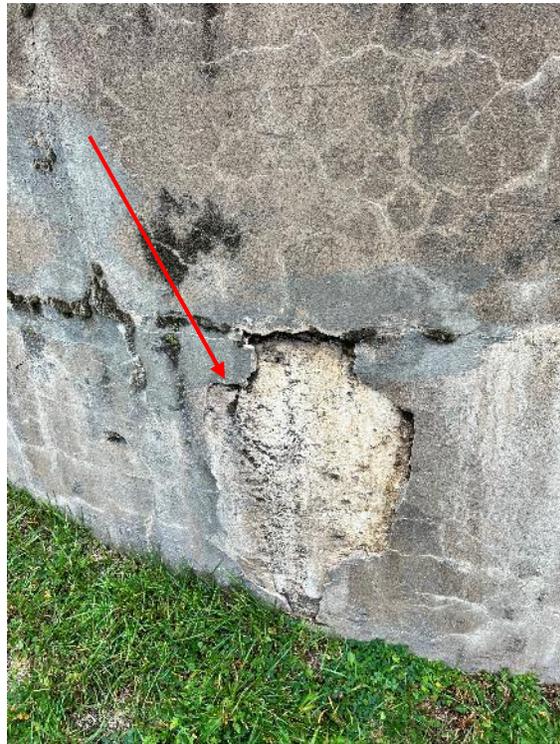
Photo 75

25: Water Cisterns:
Spalled parking at East uncovered cistern.

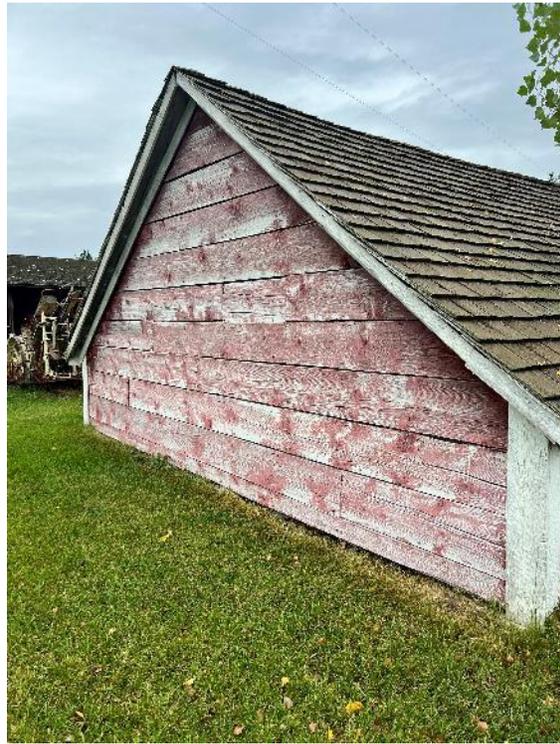
Photo 76

25: Water Cisterns:
General view of West covered cistern South
elevation of cover.

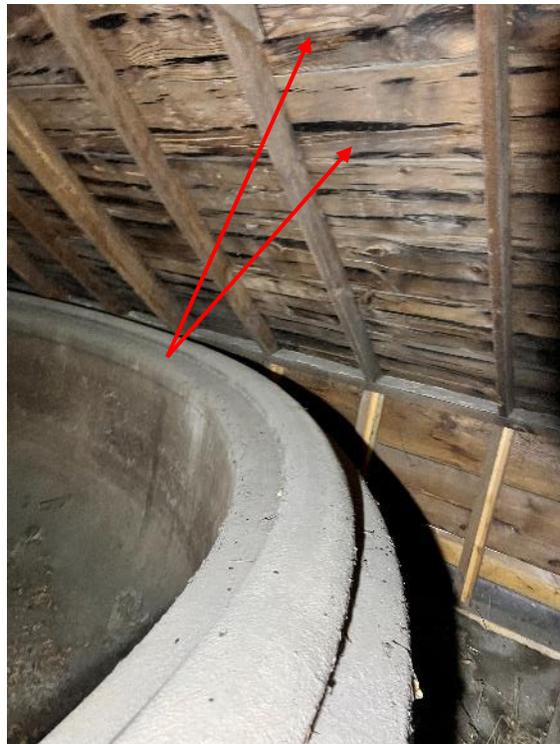
Photo 77

25: Water Cisterns:
Water staining on underside of West cover
roof sheathing.
