SUBJECT: HISTORIC O'KEEFE RANCH FACILITY CONDITION ASSESSMENT

Facility Condition Assessment

O'Keefe Ranch
Near Vernon, B.C
City of Vernon
Building Condition Assessment Report
Mechanical

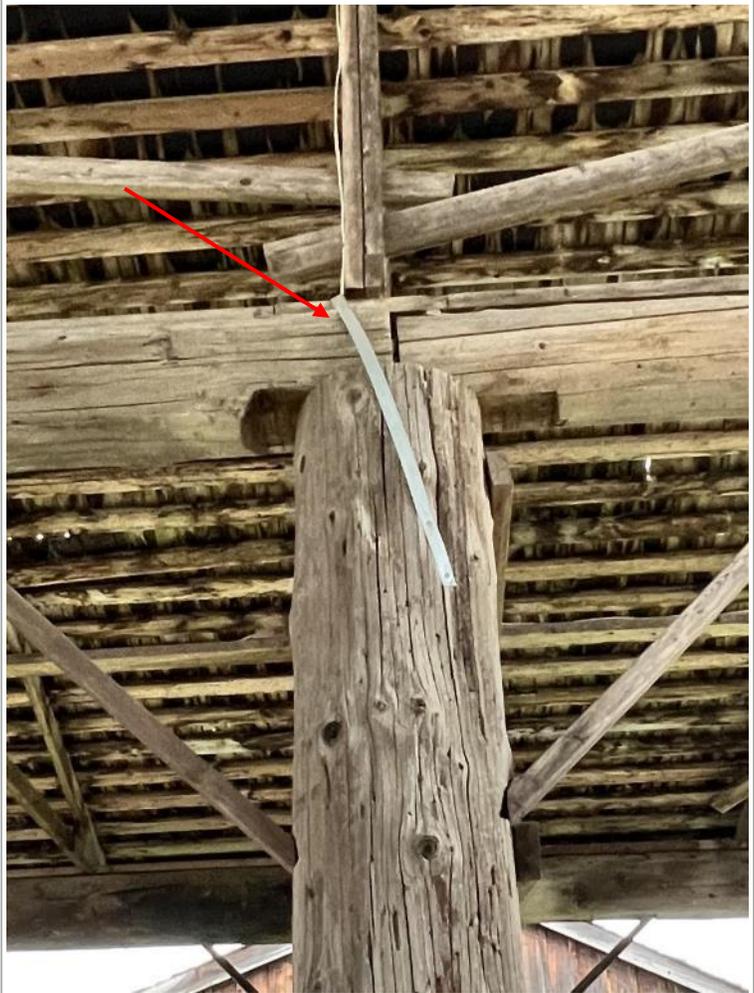
Photo 80

27: Spallumcheen Pioneer Power Club
Display #2:
Toe-nailed steel tie.

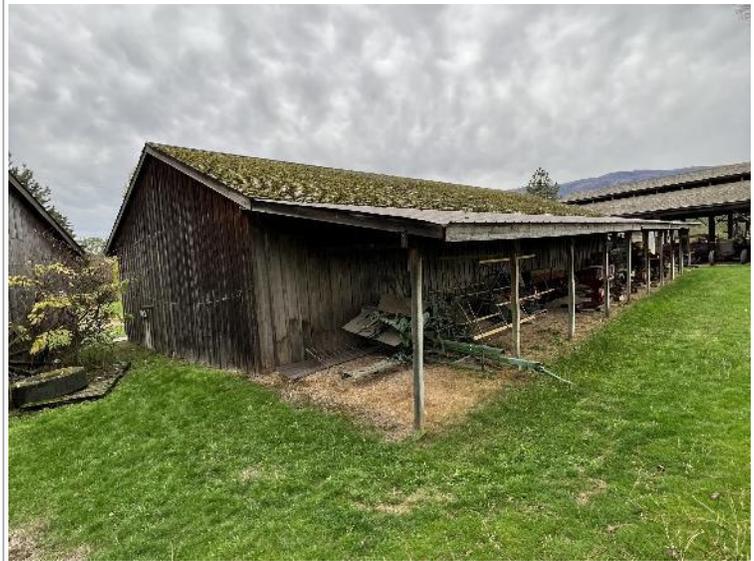
Photo 82

28: Implement Shed #1:
General view of North elevation.

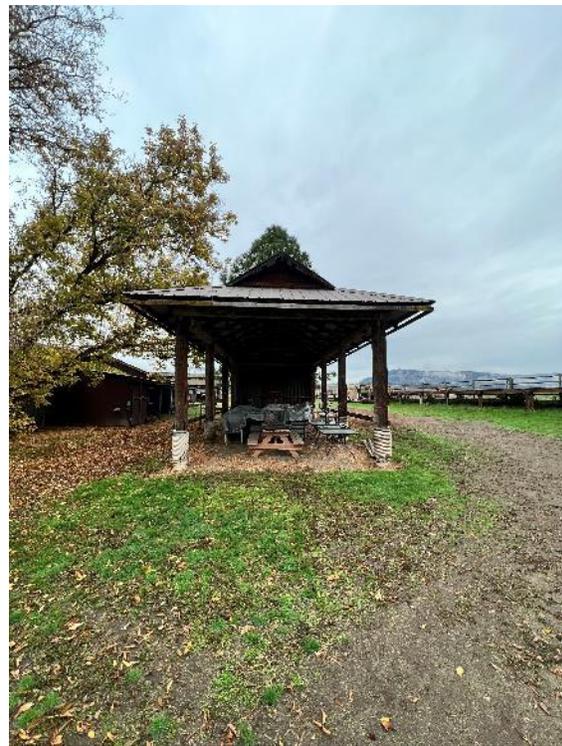
Photo 86

30: Tack Shed:
General view of East elevation.

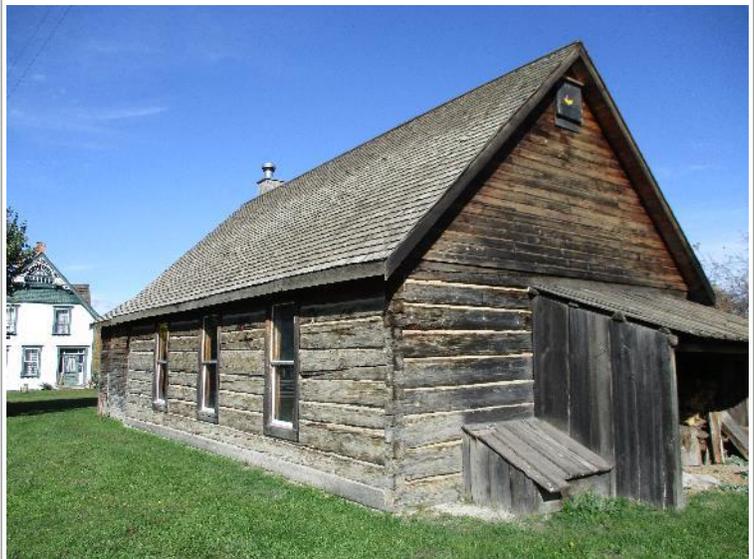
Photo 90

33: Balmoral School House:
General view from South-East corner.

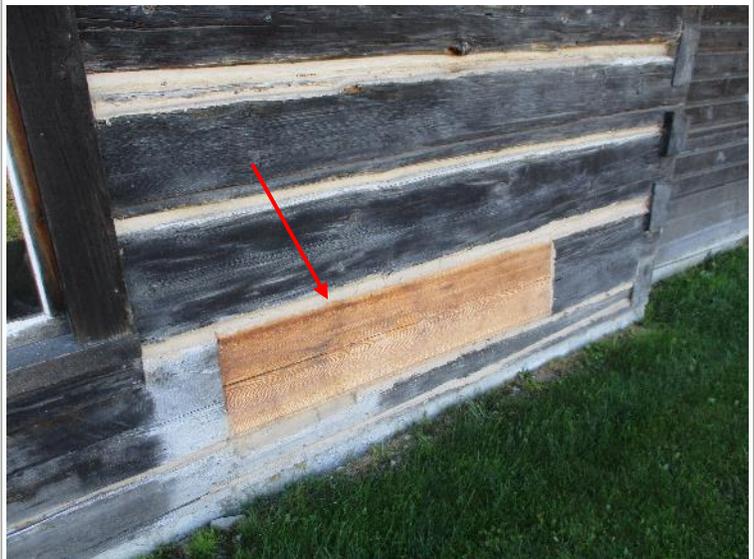
Photo 92

33: Balmoral School House:
Previous patch repair at south elevation.

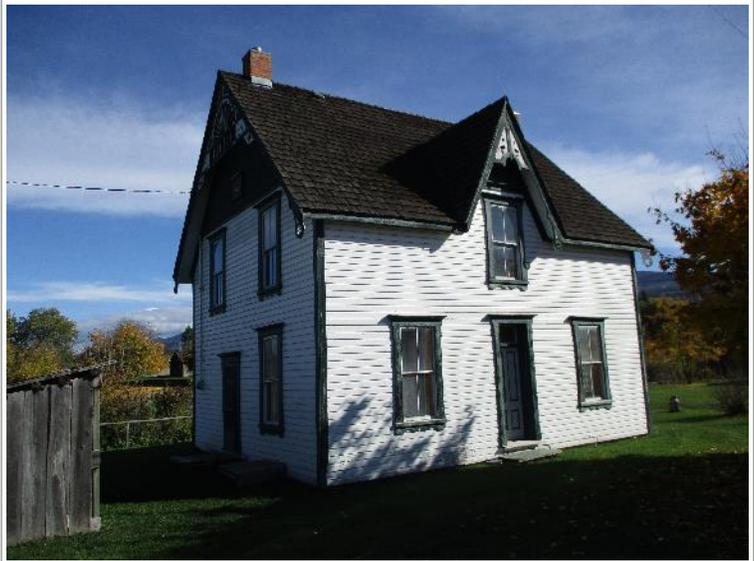
Photo 93

34: Schubert House:
General view of South and West elevations.

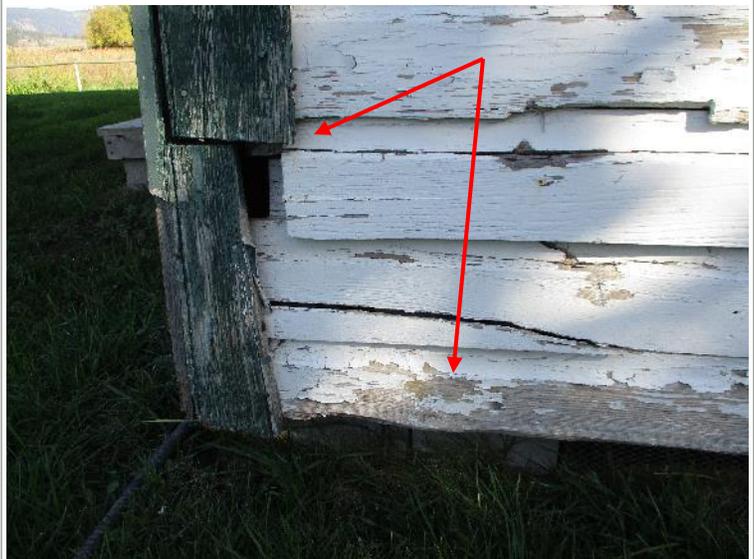
Photo 96

34: Schubert House:
Deteriorated cladding.

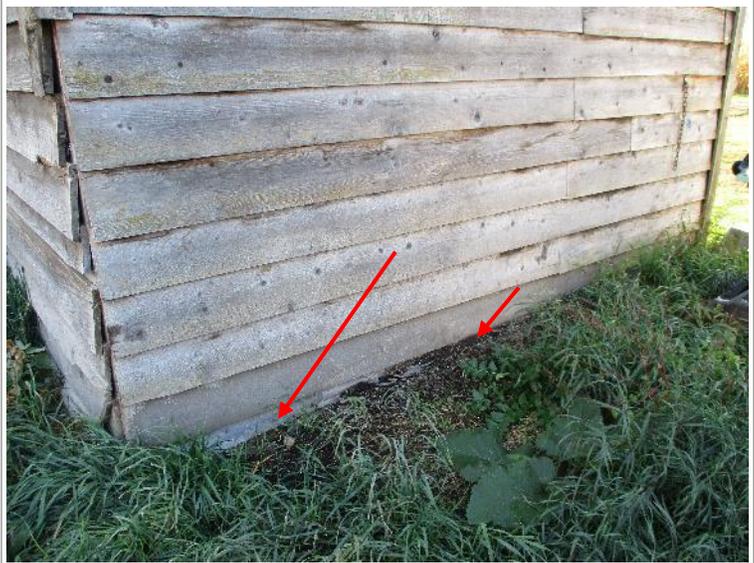
Photo 99

35: Schubert Barn:
Deteriorated cladding and vapour barrier at
North-West corner.

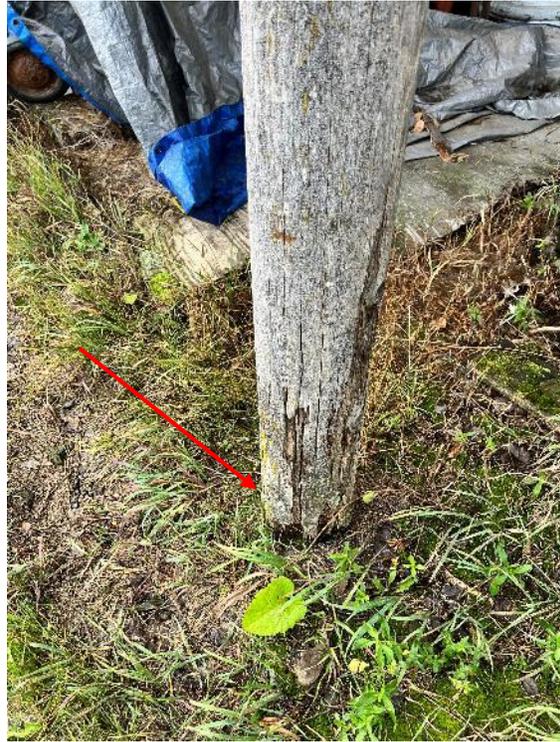
Photo 101

36: Spallumcheen Pioneer Power Club
Clubhouse:
Rotted buried post at North lean-to.

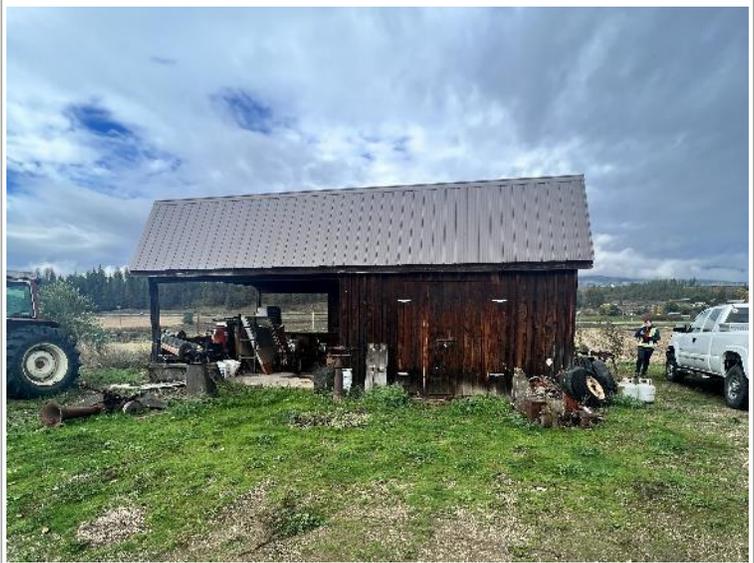
Photo 103

37: Storage Building:
General view of East elevation.

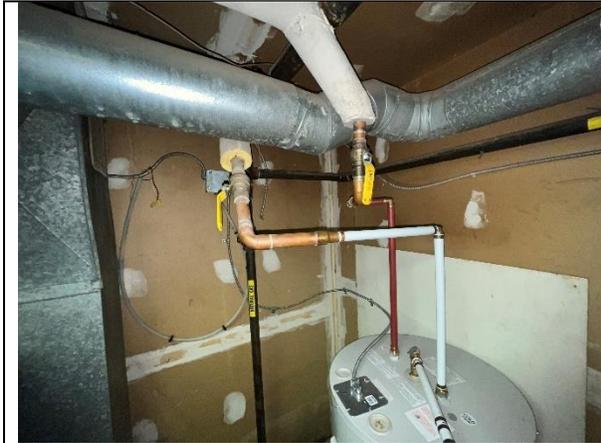
D2020 - Domestic Water Distribution

- Original piping systems are copper systems. Recent upgrades have used approved plastic piping systems.
- The insulation is in poor condition or missing in certain locations.
- Some elbows witnessed look suspiciously to be made with asbestos.

- The domestic water piping should provide good service for the near future. Nonetheless, the operators should look for pinhole leaks from time to time. Risk Rank 3C.
- Consideration should be made for upgrades to the existing insulation to save energy. Risk Rank 1E.
- The piping system should be assessed by a hazardous materials professional to determine if there is asbestos on these systems. Risk Rank 3B

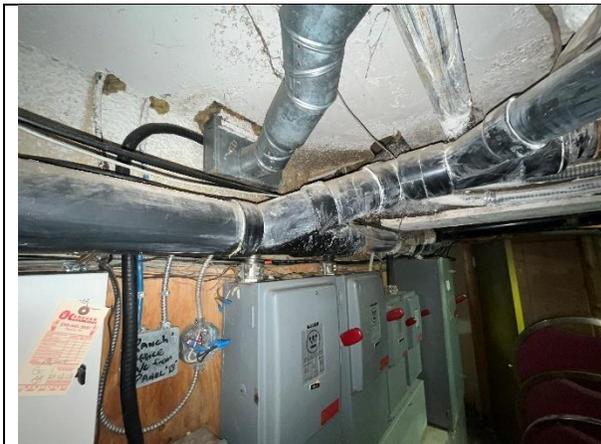
D2030 – Sanitary Waste

- Sanitary waste systems utilize ABS piping systems where visible. Buried piping and piping within the walls were not reviewed.

- The sanitary drainage piping should provide good service for the near future. However, the system is at an age where blockages could occur, so should be inspected and cleaned from time to time. Repairs if needed could be completed for the location at hand. There is no need for wholesale piping upgrades in the near future. Risk Rank 3D.

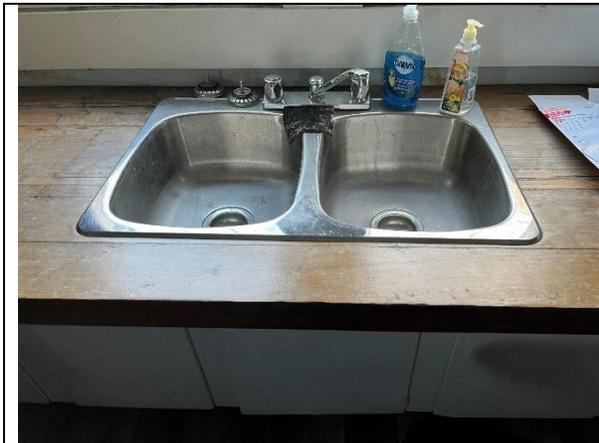
D2010 - Plumbing Fixtures

- Sink is in good condition.

- The existing fixtures should provide good service for the near future. Risk Rank 2E.
- Consideration should be made to provide hot water to both public washrooms for improved hand washing hygiene. Risk Rank 3D.

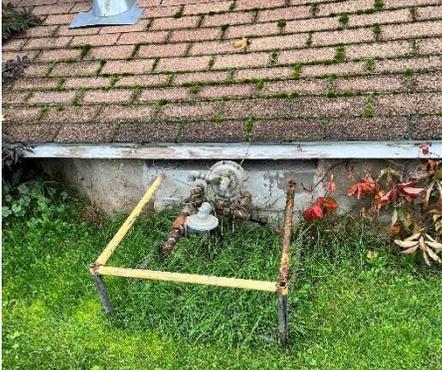
D3010 – Energy Supply

<p>Observations:</p> <ul style="list-style-type: none">• The facility has a natural gas connection and pressure regulation station.• Gas piping does not appear to have the appropriate protective coatings.
	<p>Recommendations:</p> <ul style="list-style-type: none">• The Owner will want to engage a technician to ensure the systems are configured to Code. Risk Rank 2C.

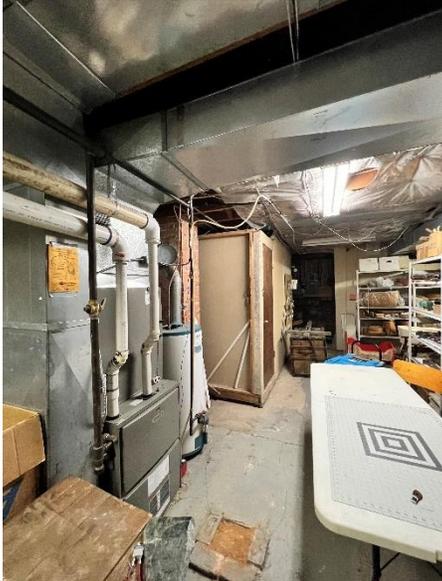
D3020 – Heat Generation Systems

<p>Observations:</p> <ul style="list-style-type: none">• The furnace was upgraded with sealed combustion energy efficient unit about 12 years ago.• The gas fired appliances have not been installed in a room that is fire rated.
	<p>Recommendations:</p> <ul style="list-style-type: none">• No upgrades to the system are anticipated in the near future. Risk Rank 2D.• Consideration should be made to build a fire rated room that would house the furnaces and domestic water heater. Risk Rank 2B.

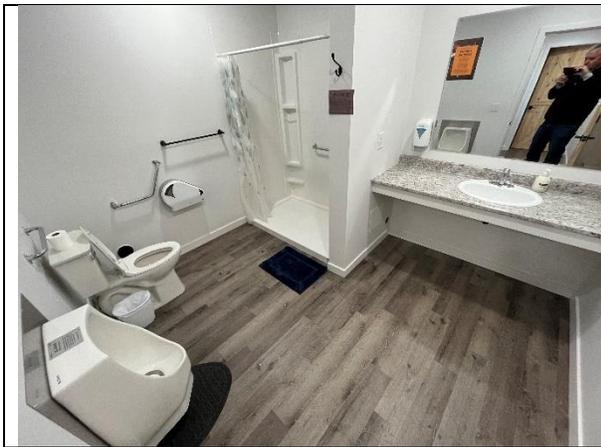
D2010 - Plumbing Fixtures

- Lavatories, urinal, shower and water closets are new and well appointed.

- The existing fixtures should provide good service for the near future. Risk Rank 2E.
- Consideration should be made to provide hot water to both public washrooms for improved hand washing hygiene. Risk Rank 3D.

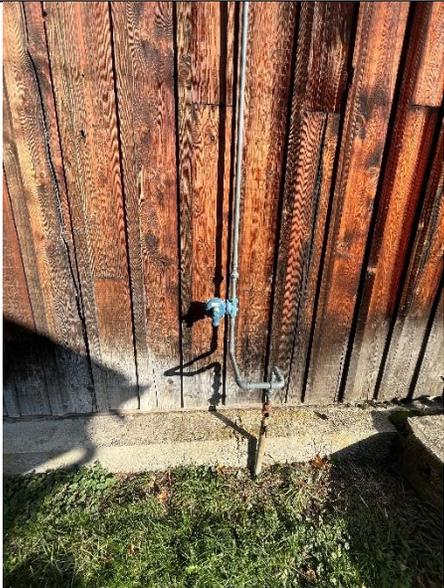
D3010 – Energy Supply

<p>Observations:</p> <ul style="list-style-type: none"> The facility has a natural gas connection and pressure regulation station.
	<p>Recommendations:</p> <ul style="list-style-type: none"> The system should provide good service for the near future. Risk Rank 1D.

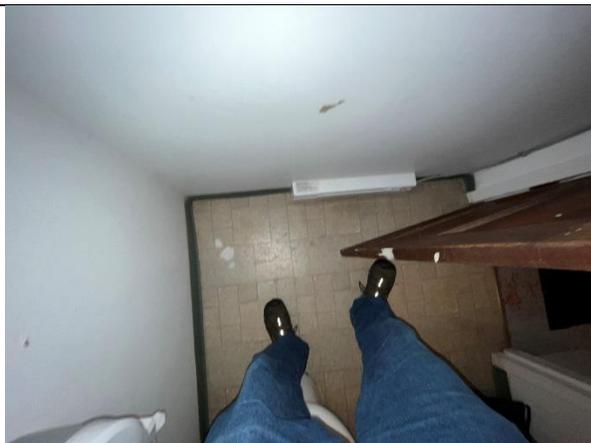
D3020 – Heat Generation Systems

<p>Observations:</p> <ul style="list-style-type: none"> Most areas are unheated. Occupied areas use baseboard electric heaters.
	<p>Recommendations:</p> <ul style="list-style-type: none"> No recommendations

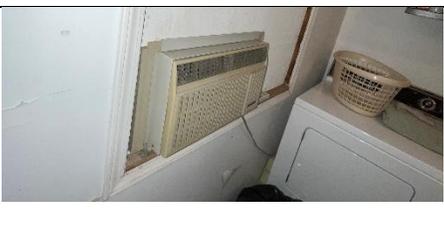
D3030 – Cooling Generation Systems

<p>Observations:</p> <ul style="list-style-type: none"> Cooling is provided by a single window mounted air conditioning unit.
	<p>Recommendations:</p> <ul style="list-style-type: none"> If the unit fails, replacement units are readily available and relatively inexpensive. Risk Rank 3E

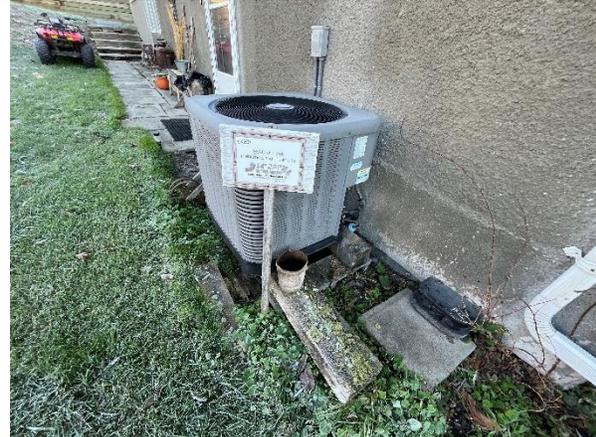
D3030 – Cooling Generation Systems

<p>Observations:</p> <ul style="list-style-type: none"> Cooling is provided by a single Rheem five-ton cooling capacity condensing unit. The unit was manufactured in 2016.
	<p>Recommendations:</p> <ul style="list-style-type: none"> The unit is 1/3 through its service life and should provide good service for the near future. Risk Rank 2D

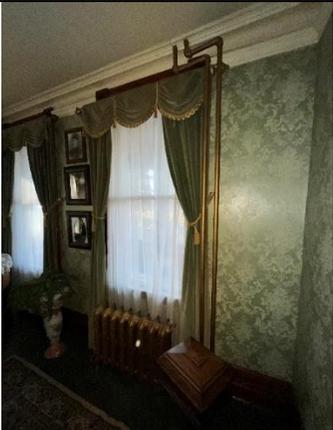
D3040 – Heat Distribution Systems

<p>Observations:</p> <ul style="list-style-type: none"> • Steel uninsulated piping is used for the hydronic heating systems. If the hot water heating system gets above 140°F, the bare pipe can scald bare skin in seconds. It appears that these systems are well barricaded from the public, to avoid an inadvertent incident. <p>Recommendations:</p> <ul style="list-style-type: none"> • The system should provide good service for the near future. Risk Rank 1D. • Care should continue to be made to keep the public from touching the heating piping and terminal units while the systems are hot.
--	---

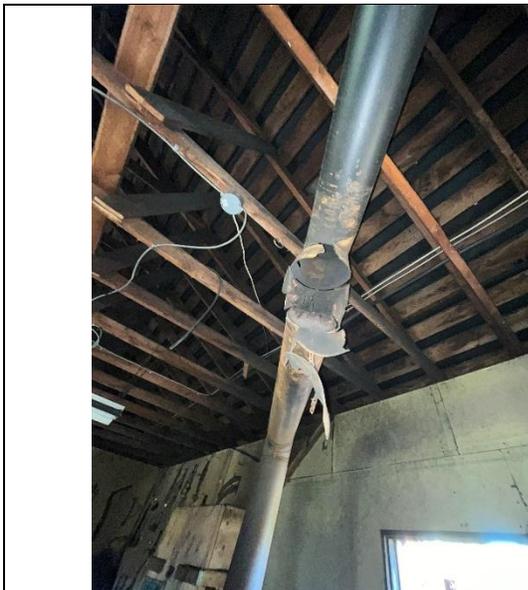
D3040 – Forge Venting Systems

- Except for one system, the forge venting system will need to be replaced.

- The systems should be replaced, and appropriate thimbles are needed for the penetrations through the roof. Risk Rank 5C.

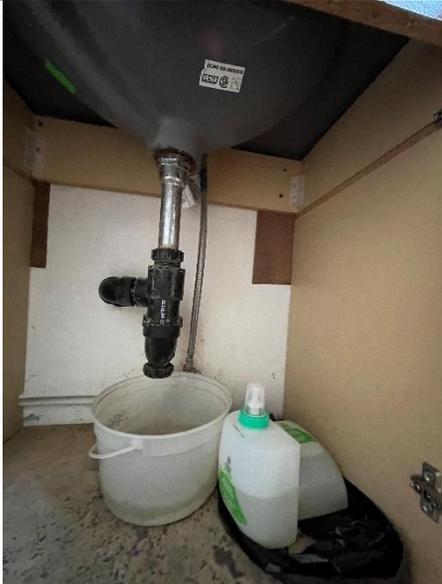
D2020 - Domestic Water Distribution and Sanitary Waste

<p>Observations:</p> <ul style="list-style-type: none">• Original piping systems are not visible. The systems are not likely to be very old as the washrooms seem to be a recent renovation to the building.• Sanitary waste systems utilize ABS piping systems where visible. Buried piping and piping within the walls were not reviewed.
	<p>Recommendations:</p> <ul style="list-style-type: none">• The domestic water piping should provide good service for the near future. Risk Rank 2E.• The sanitary drainage piping should provide good service for the near future. Risk Rank 2E.

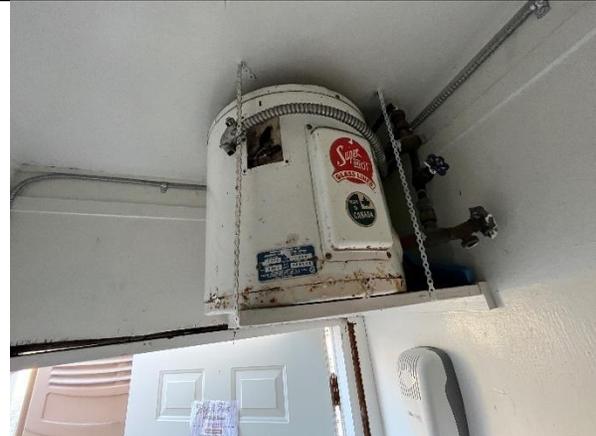
D2090 - Domestic Water Heater

<p>Observations:</p> <ul style="list-style-type: none">• The electric domestic hot water heater is nearing the end of its service life.
	<p>Recommendations:</p> <ul style="list-style-type: none">• The domestic water heater should be replaced relatively soon. Risk Rank 3D.

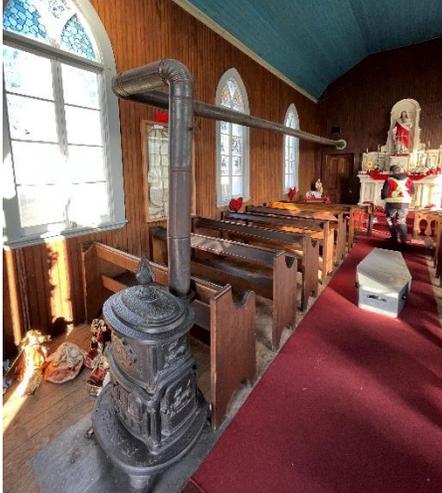
<p>Observations:</p> <ul style="list-style-type: none"> The wood fired pot belly stove is not in use. The chimney for this unit has been reconfigured to serve the furnace mentioned above.
	<p>Recommendations:</p> <ul style="list-style-type: none"> Refer to discussion in Executive Summary.

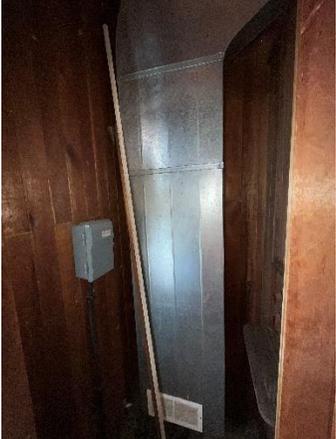
D3040 – Air Distribution Systems

<p>Observations:</p> <ul style="list-style-type: none"> The supply duct systems are in good shape considering the age of the system.
	<p>Recommendations:</p> <ul style="list-style-type: none"> At most, an internal inspection of the duct and a duct cleaning every 5 years or so. Risk Rank 3E.

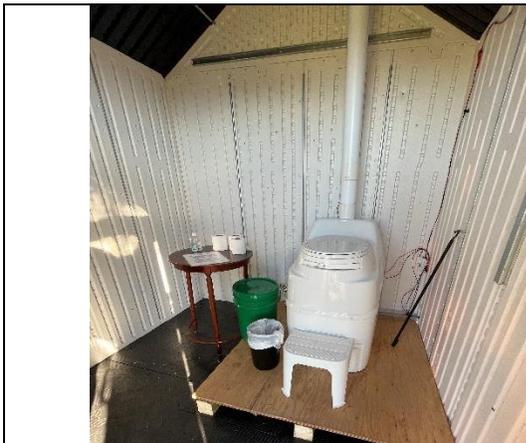
D2010 - Plumbing Fixtures

- The water closets are a purpose-built composting type unit.
- The system appears to be functional. Composting toilets are generally not considered a “high volume” system.

- As the glamping site becomes more popular, the operator may need to add more toilet systems to keep up with demand.

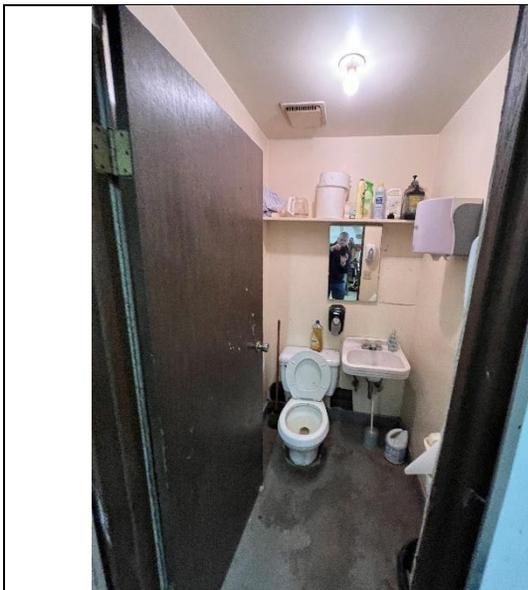
D2010 - Plumbing Fixtures

- Lavatories and water closets are in fair condition but are still serviceable.

- The existing fixtures should provide good service for the near future. Risk Rank 2E.

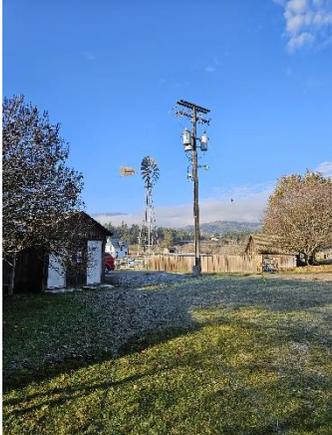
<p>Observations:</p> <ul style="list-style-type: none"> BC Hydro overhead power line and 3 phase transformer bank with secondary DIP feeding the visitor’s centre.
	<p>Recommendations:</p> <ul style="list-style-type: none"> N/A. Equipment owned and maintained by BC Hydro.

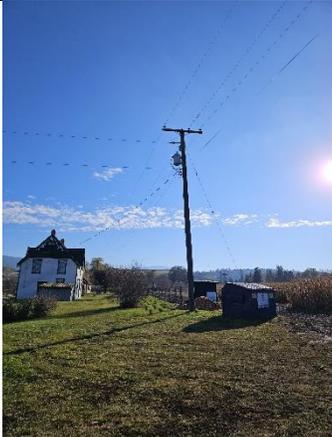
<p>Observations:</p> <ul style="list-style-type: none"> BC Hydro overhead power line near where it enters the site by the Schubert Barn. Three phase line continues on to the Visitor’s Centre and single phase tap continues on to the rest of the site. Single phase overhead secondary service to Schubert House.
	<p>Recommendations:</p> <ul style="list-style-type: none"> N/A. Equipment owned and maintained by BC Hydro.

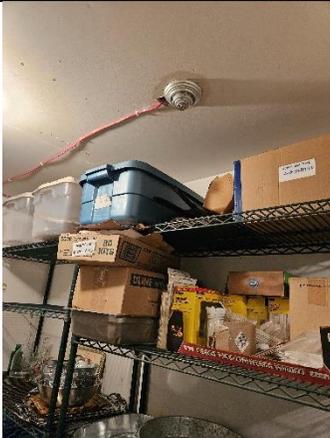
<p>Observations:</p> <ul style="list-style-type: none">• Building has a fire alarm system with minimal fire detectors.
	<p>Recommendations:</p> <ul style="list-style-type: none">• Continue annual verification and testing of fire alarm system.• Adding fire alarm devices could improve early detection of fires but not required by code.

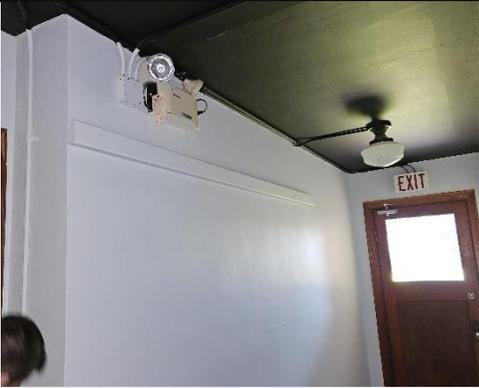
<p>Observations:</p> <ul style="list-style-type: none">• Minimal but acceptable level of emergency lighting and exit signage. No fire alarm system.
	<p>Recommendations:</p> <ul style="list-style-type: none">• Continue annual checks of EM lighting.

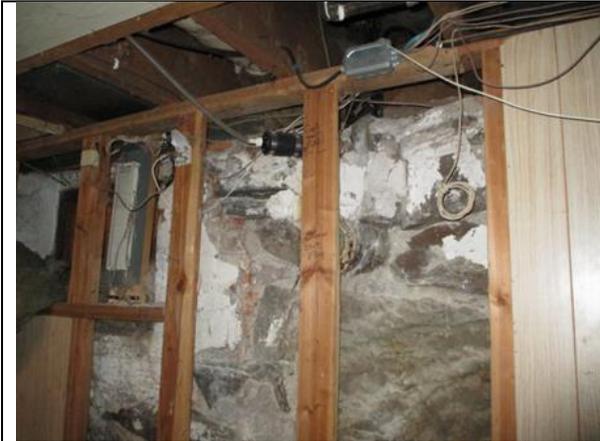
- Communications wiring and branch circuit wiring in basement is very messy.

- Clean up and support wiring in basement.

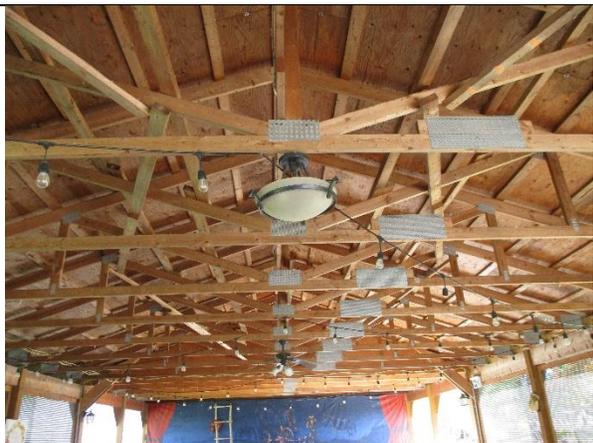
<p>Observations:</p> <ul style="list-style-type: none">• Screw base residential fixtures and string light suitable for location as long as no water spraying is done
	<p>Recommendations:</p> <ul style="list-style-type: none">• Ensure LED lamps are utilized. Weatherproof outdoor rated lights could be considered as an upgrade.• Continue to maintain emergency lighting battery packs.

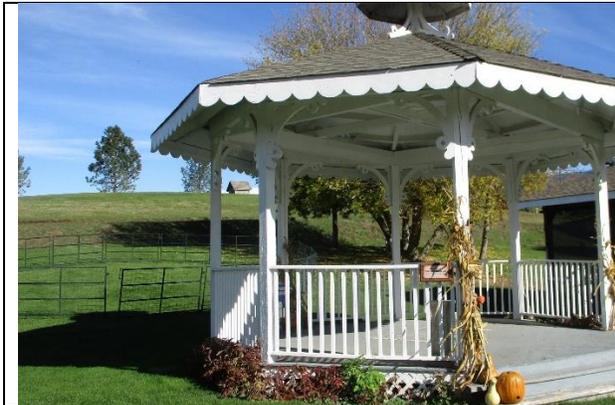
- Single lighting circuit fed from Pavilion

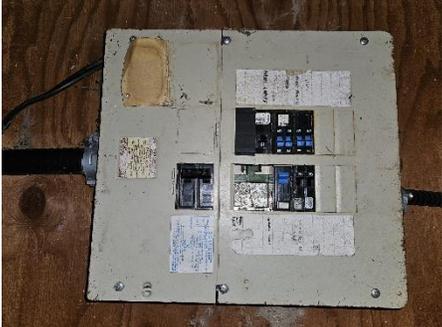
<p>Observations:</p> <ul style="list-style-type: none">• 60A-120/240V single phase panel sub-fed from another building is adequate <p>Recommendations:</p> <ul style="list-style-type: none">• The systems should be replaced, and appropriate thimbles are needed for the penetrations through the roof. Risk Rank 5C.
---	---

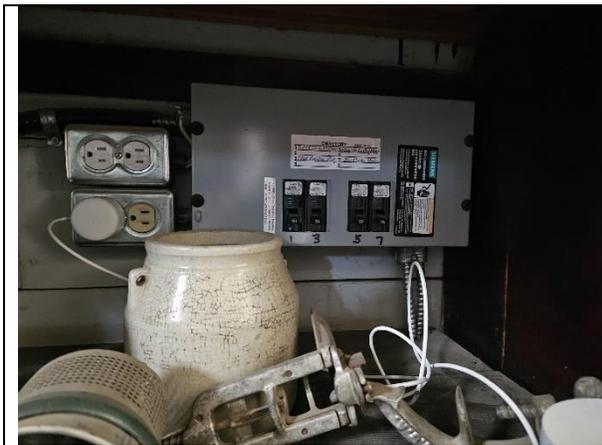
- 30A-120/240V single phase load centre located under the counter is sub-fed from the Log House service and is adequate for the usage.

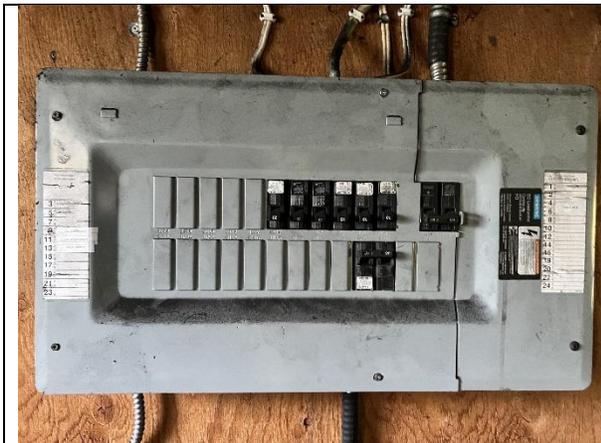
- Panel is sub-fed from the Log House at 60A-120/240V single phase and appears adequate for the useage.

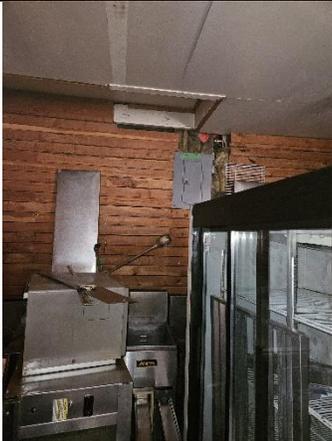
Observations: <ul style="list-style-type: none">• 120/240V load centre panel is fed from the Carriage Shed service.
	Recommendations: <ul style="list-style-type: none">• N/A

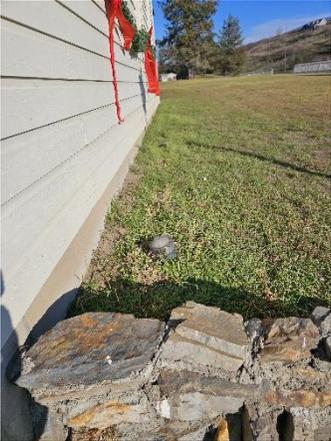
<p>Observations:</p> <ul style="list-style-type: none">• Exterior in ground lights are proud of the ground. <p>Recommendations:</p> <ul style="list-style-type: none">• Check that these lights are properly installed and protected from equipment damage.
---	---

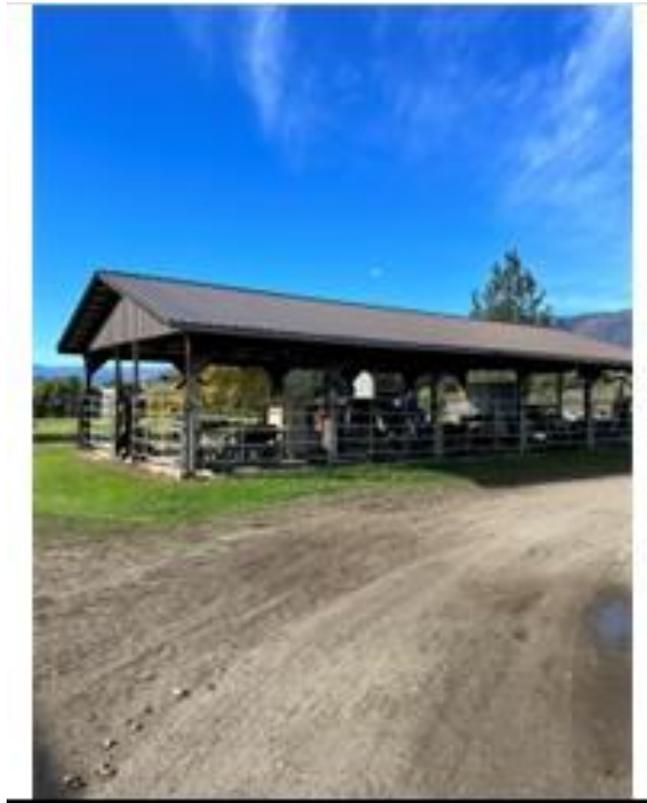
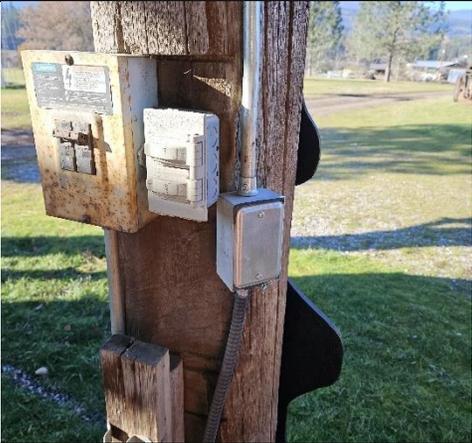
23 SPPC#1

<p>Observations:</p> <ul style="list-style-type: none">• Circuits fed from panel in SPPC#2. Non-weatherproof disconnect switch is exposed to weather and is rusting. <p>Recommendations:</p> <ul style="list-style-type: none">• Replace disconnect switch with weatherproof.
---	---

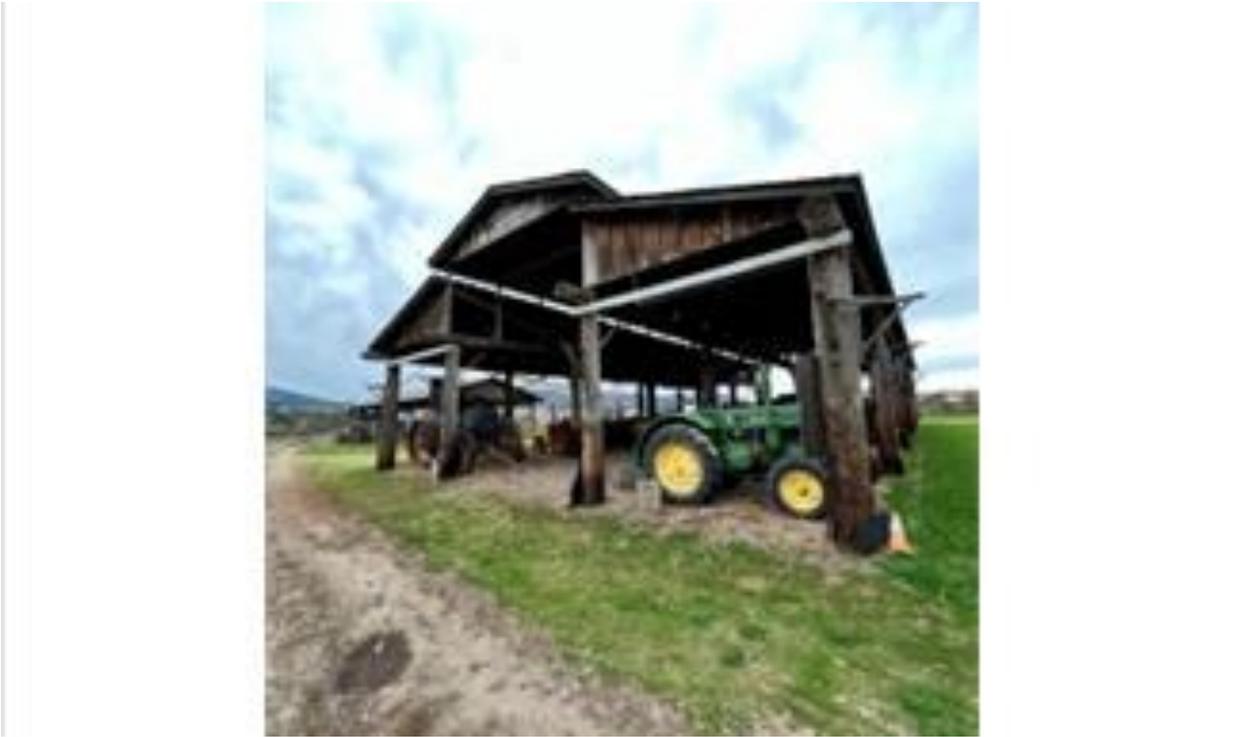
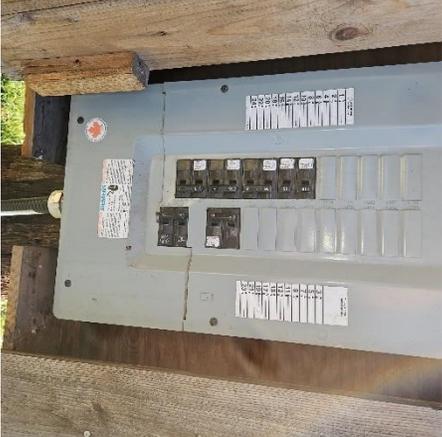
27 SPPC#2

<p>Observations:</p> <ul style="list-style-type: none">• Newer 100A-120/240V single phase panel is located in weather protective wooden cabinet. <p>Recommendations:</p> <ul style="list-style-type: none">• N/A
---	--

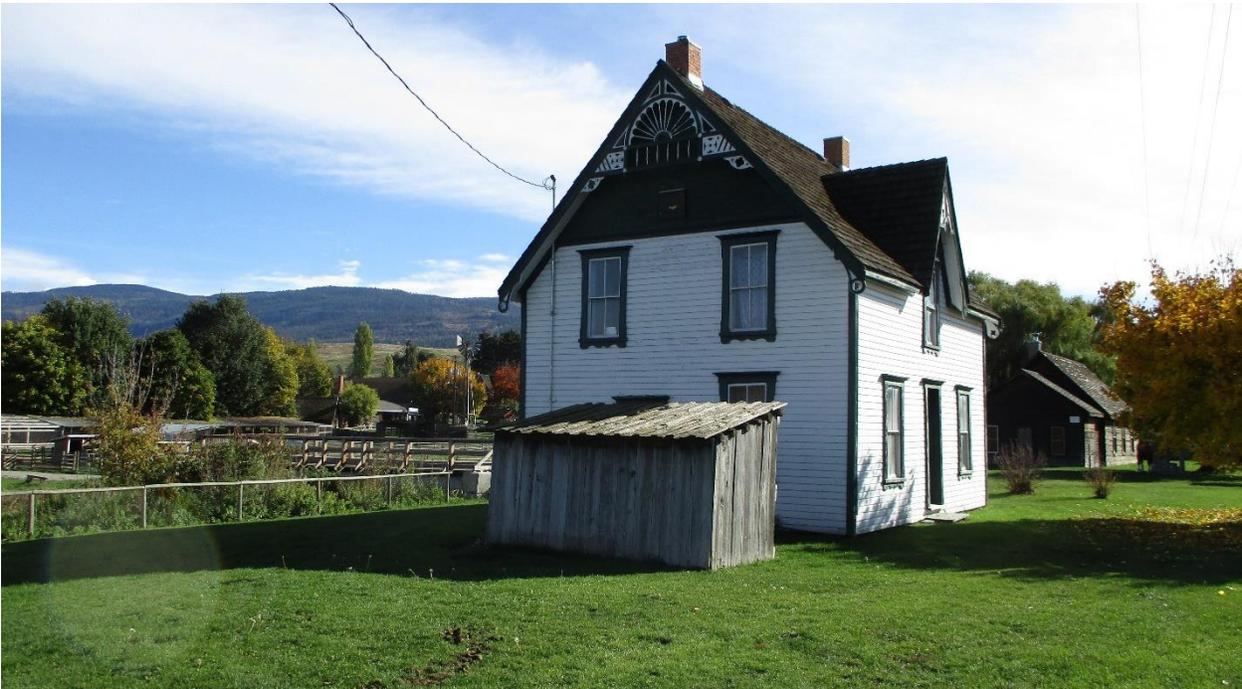
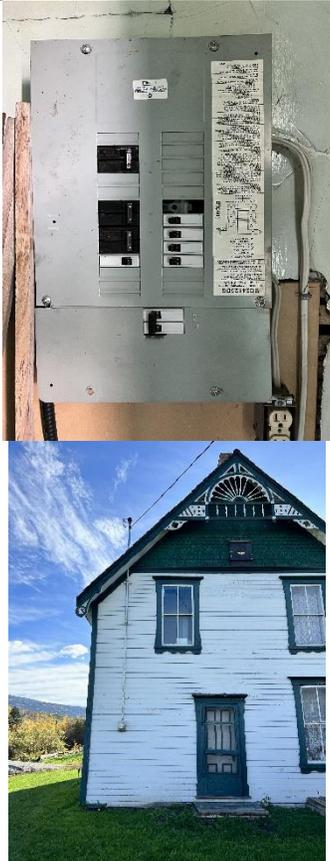
34 Schubert House

<p>Observations:</p> <ul style="list-style-type: none">• 600A-120/240V single phase service BC Hydro overhead service is sufficient for the use <p>Recommendations:</p> <ul style="list-style-type: none">• Provide missing breaker fillers.
--	--

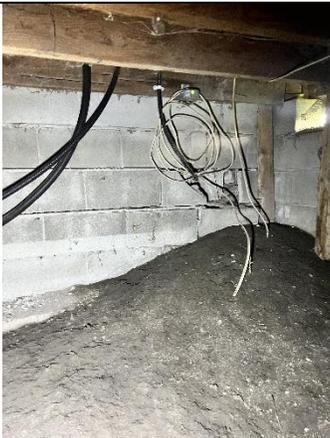
<p>Observations:</p> <ul style="list-style-type: none">• Wiring appears to be standard NMD-90 cable throughout. <p>Recommendations:</p> <ul style="list-style-type: none">• Wiring in crawlspace should be cleaned up.
---	--

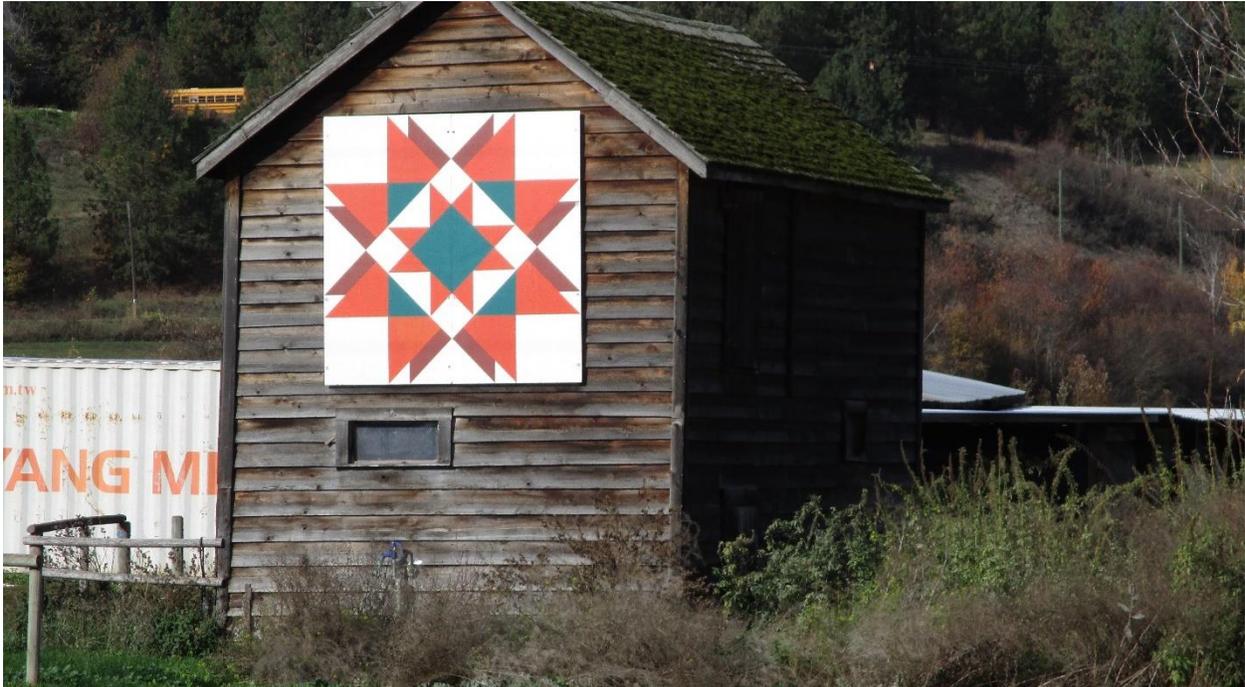
35 Schubert Barn

<p>Observations:</p> <ul style="list-style-type: none">• Single lighting circuit is fed from the house. <p>Recommendations:</p> <ul style="list-style-type: none">• N/A
---	---

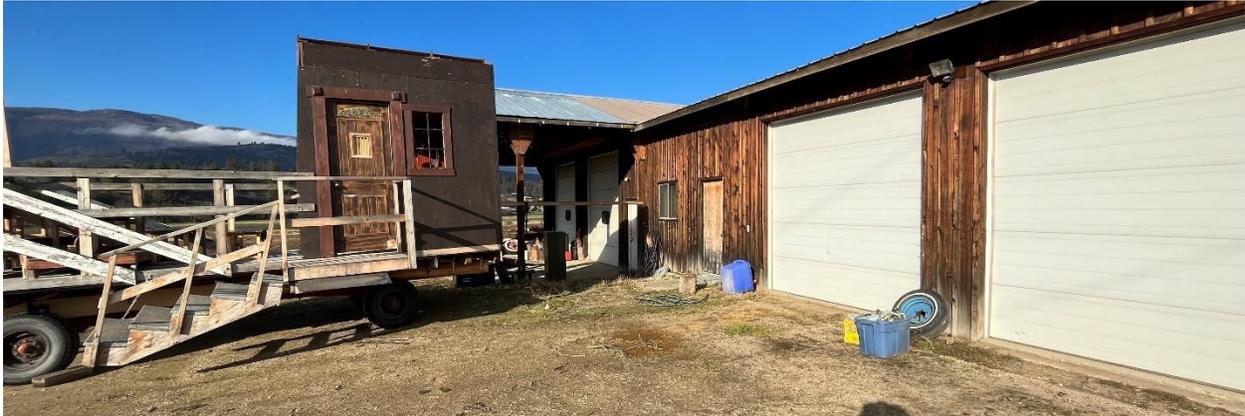
36 SPPC Clubhouse

- 200A 120/240V single phase panel is fed overhead from BC Hydro system.

- Maintain circuit breakers.

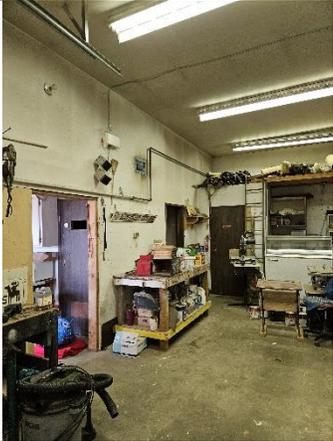
<p>Observations:</p> <ul style="list-style-type: none">• Minimal emergency lighting is installed
	<p>Recommendations:</p> <ul style="list-style-type: none">• Continue to test emergency lighting regularly.

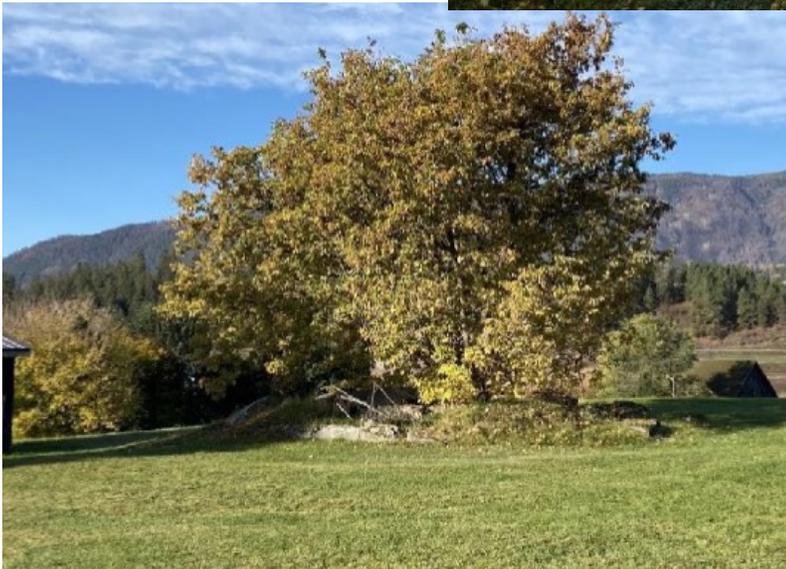
Left: Collapsed concrete cistern
with a tree growing in it
