THE CORPORATION OF THE CITY OF VERNON REPORT TO COUNCIL

SUBJECT: HISTORIC O'KEEFE RANCH FACILITY CONDITION ASSESSMENT

Facility Condition Assessment

At the City of Vernon's request Read Jones Christoffersen Ltd. (RJC) has completed a Facility Condition Assessment (FCA) at the Historic O'Keefe Ranch located at 9380 BC-97 near Vernon, BC per our proposal dated September 14, 2023. The FCA forms part of Phase 1 of the overall services. Phase 1 also includes preparation of Statements of Significance (SoS).

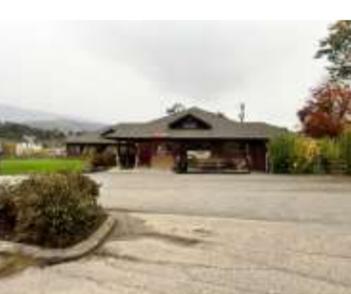
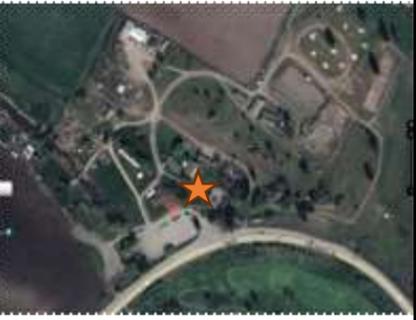
Visitor Center

E					\$ -			
		F					\$ -			
		G					\$ -			
		Total	\$ 35,000	\$ 35,400	\$ 51,000	\$ 121,400				
Level 1	Level 2	Level 3	Assessment							
Major Group Elements	Group Elements	Individual Elements	Building Component	Condition	Comments	Recommended Action	Priority Ranking	Probable Cost		
A Substructure	A10 Foundation	A1010.1 Standard Foundations	Concrete foundation wall.	Poor	Efflorescence and water staining at the base of the wall.	A1010.1 Hazardous Materials Assessment. See A1010 at buildings 2, B1020 at building 4A.	4B	\$ 10,000		
		A1020 Special Foundations	Wood foundation on grade at the exterior washrooms.	Fair	No comment on condition.	A1010.2 Add perimeter drainage and extend RWL.	4B	\$ 25,000		
		A1030 Slab on Grade	Concrete slab on grade patio at North-West of the building.	Fair	Minor cracking.	No Recommendation.	N/A	N/A		
	A20 Basement Construction	A2020 Basement Walls	See A1010.	Poor	See A1010.	No Recommendation.	N/A	See A1010.

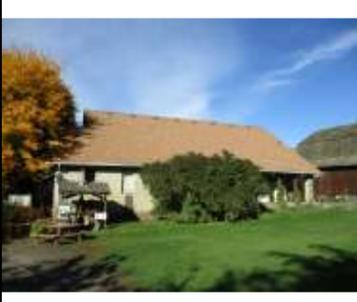
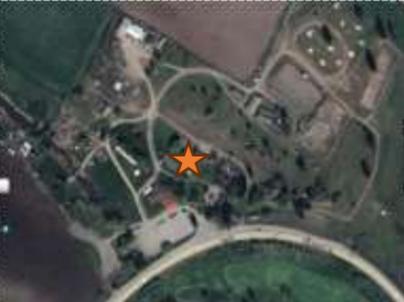
Greenhow Museum

Other Names	1893 foundations built. 1941 constructed.	Where projects have scope occurring at multiple buildings the full project cost has been included in each sheet and has not been split by building. Numbers affected by these "duplicate" costs are in red. Programs have not been included in OPC Summary. Refer to Program Summary page at beginning of the report. Where scopes have been summarized into one project in the report OPC, numbers are reported in green.	A	\$ 25,000			\$ 25,000		
Greenhow House			B	\$ 25,000			\$ 25,000		
Description			C				\$ -		
Two-storey wood frame building with stone and concrete basement. Cedar shake shingle roof. Wood framed doors and windows. Stucco siding.			D		\$ 19,400	\$ 1,000	\$ 20,400

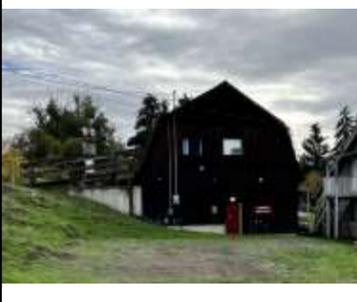
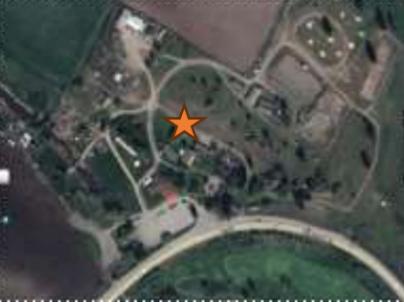
Stagecoach Depot

A Substructure	A10 Foundation	A1010 Standard Foundations	Concrete foundation/retaining wall sloped with grade.	Fair	Minor cracking.	Continue monitoring for changes.	N/A	N/A	
		A1030 Slab on Grade	Upper patio is slab on grade.	Fair	Some organic growth and minor cracking.	No Recommendation.	N/A	N/A	
	A20 Basement Construction	A2020 Basement Walls	See A1010.		See A1010.	See A1010.	N/A	See A1010.	
B Shell	B10 Superstructure	B1010 Floor Construction	Concrete slab on grade and wood framed.	Fair	No comment on condition.	No Recommendation.	N/A	N/A	
		B1020 Roof Construction	Hip roof. Wood framed.	Fair	No comment on condition.	No Recommendation.	N/A	N/A	
	B20 Exterior Enclosure	B2010 Exterior Walls	Board and batten cladding with horizontal wood cladding on gable ends.	Fair	Cladding stained at base up to half height.	Repair cladding.	3D	See Cladding Program.	
		B2020 Exterior Windows	Wood frame fixed windows.	Fair	No comment on condition.	No Recommendation.	N/A	N/A

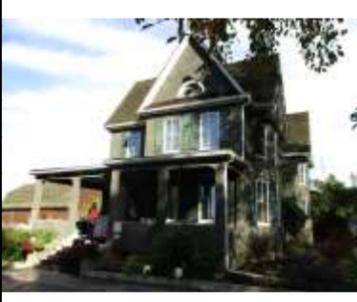
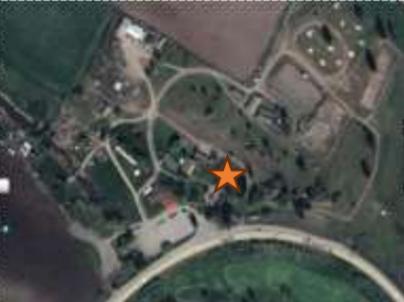
O'Keefe House

1910 central hot water heating and hardwood flooring.	D			\$ 10,000	\$ 2,000	\$ 12,000			
	1989 most recent roof replacement.	E					\$ -			
	1994 stucco reclad.	F					\$ -			
	1997 porch repaired	G			\$ 5,000		\$ 5,000			
	Total			\$ 5,000	\$ 55,000	\$ 16,000	\$ 81,000			
	Level 1	Level 2		Level 3	Assessment					
	Major Group Elements	Group Elements	Individual Elements	Building Component	Condition	Comments	Recommended Action	Priority Ranking	Probable Cost	
A Substructure	A10 Foundation	A1010 Standard Foundations	Stone foundation wall and clay brick masonry columns. Two 2'x2' concrete pillars. Wood trellis above grade.	Poor	Parging is mostly gone. Brick has freeze/thaw damage. Trellis deteriorated. Stone walls in good condition.	Provide temporary support and repair brick foundation columns. See A1010 at buildings 20 & 34, A1030 at building 11.	3B	\$ 25,000		
	A20 Basement Construction	A2020 Basement Walls	Basement below kitchen and crawlspace below rest of building. See A1010 for construction.	Fair	See A1010.	See A1010.	N/A	N/A

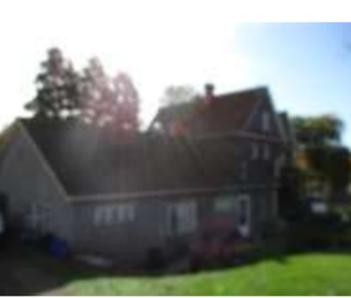
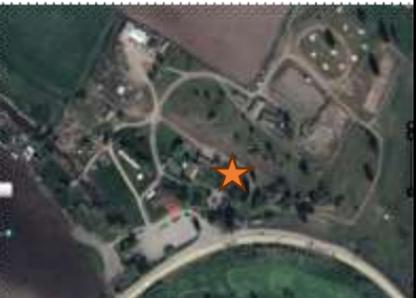
Caretaker's House

1910 central hot water heating and hardwood flooring.	D			\$ 17,600		\$ 17,600			
	1989 mosr recent roof replacment.	E				\$ -				
1994 stucco reclad.	F					\$ -				
1997 porch repaired	G		\$ 8,000			\$ 8,000				
	Total		\$ -	\$ 22,600	\$ -	\$ 30,600				
Level 1	Level 2	Level 3	Assessment							
Major Group Elements	Group Elements	Individual Elements	Building Component	Condition	Comments	Recommended Action	Priority Ranking	Probable Cost		
A Substructure	A10 Foundation	A1010 Standard Foundations	Concrete masonry units. Two 2'x2' concrete pillars. Wood trellis above grade. Stone pedestal footings.	Poor	Parging is mostly gone. Brick has freeze/thaw damage. Trellis deteriorated. Stone walls in good condition.	See A1010 on O'Keefe House sheet.	3B	N/A		
	A20 Basement Construction	A2020 Basement Walls	CMU basement wall.	Fair	Water damage in corner of CMU wall.	Repair leak through CMU wall and add perimeter drainage. See G2030 at building 4A.	3C	\$ 5,000

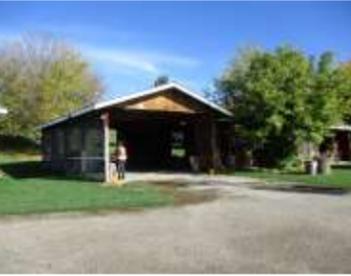
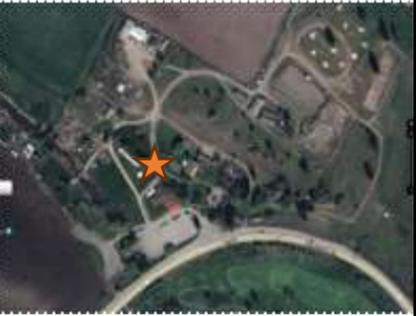
Pavilion

Other Names	Construction date unknwn.	A					\$ -			
n/a		B					\$ -			
Description		C					\$ -			
Wood post and beam structure with engineered trusses and asphalt shingle roof. Wood half wall at some locations around the perimeter. Houses stage and picnic tables. Concrete slab-on-grade floor.		D					\$ -			
		E					\$ -			
		F					\$ -			
		G					\$ -			
		Total		\$ -	\$ -	\$ -				
Level 1	Level 2	Level 3	Assessment							
Major Group Elements	Group Elements	Individual Elements	Building Component	Condition	Comments	Recommended Action	Priority Ranking	Probable Cost		
A Substructure	A10 Foundation	A1020 Special Foundations	Pressure-treated buried posts. Embedded plate steel saddle connection for posts near stage.	Fair	Water staining at base of buried posts.	No Recommendation.	N/A	N/A

B Shell	B10 Superstructure	B1010 Floor Construction	Concrete slab on grade.	Good	Concrete slab in good condition.	No Recommendation.	N/A	N/A		
		B1020 Roof Construction	Post and beam construction. Engineered trusses at 4' o/c. Plywood sheathing.	Fair	Water staining on soffit.	Add eavestroughs and downspouts.	4D	See Roof Maintenance Program.		
	B20 Exterior Enclosure	B2010 Exterior Walls	Wood plank half walls with mesh upper half. Hardie panels behind stage. Wood plank on gable end.	Good	Posts and wood members stained at east side.	No Recommendation.	N/A	N/A		
	B30 Roofing	B3010 Roof Coverings	Asphalt shingle.	Good	Fascia in good condition. No rainwater management.	No Recommendation.	N/A	N/A		
D Services	D40 Fire Protection	D4030 Fire Protection Specialties	Fire extinguisher.	Fair	No comment on condition.	No Recommendation.				
	D50 Electrical	D5010 Electrical Service & Distribution	100A single phase service sub-fed from adjacent building.	Fair	Service appears adequate.	Maintain circuit breakers (maintenance).	2D	N/A

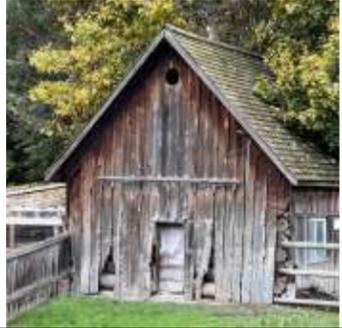
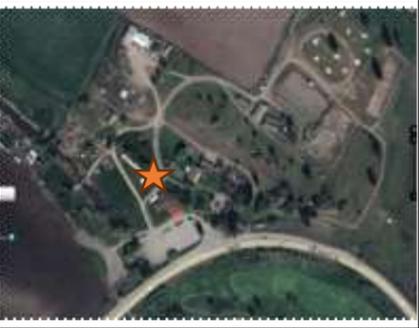
Pioneer Cabin

B Shell	B10 Superstructure	B1010 Floor Construction	See A1030.	Good	See A1030.	No Recommendation.	N/A	N/A	
		B1020 Roof Construction	Wood rafters.	Fair	Roof structure was not accessible for review.	No Recommendation.	N/A	N/A	
	B20 Exterior Enclosure	B2010 Exterior Walls	Split log w/ chinking and V-notched corners. Board and batten cladding.	Poor	Cladding touching grade and failing on south walls. Chinking failing.	Repair or replace cladding.	4C	See Cladding Program.	
		B2020 Exterior Windows	Single pane fixed windows with wood trim.	Fair	One window boarded over and one with mesh covering.	No Recommendation.	N/A	N/A	
		B2030 Exterior Doors	Wood doors and trim.	Fair	Doors aged but functional.	No Recommendation.	N/A	N/A	
	B30 Roofing	B3010 Roof Coverings	Cedar shake shingles roof with eavestroughs and downspouts and wood fascia.	Poor	Roof in fair to poor condition with organic growth. Fascia in varying condition.	Clear debris from roof and cut back overhanging tree. Replace roof.	3C	See Roof Replacement and Maintenance Programs.

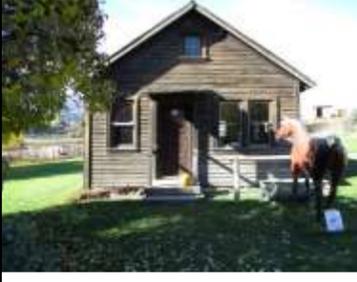
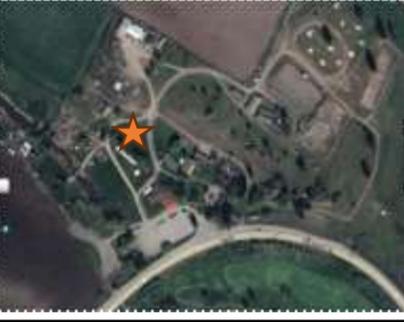
Cowboy Bunkhouse

Other Names	1941 constructed. 1980s modified.			A				\$ -		
Description	Wood framed single-storey structure with wood siding. Concrete foundation wall. Cedar shake roof. Wood awning at West elevation. Wood framed windows and doors.			B				\$ -		
				C				\$ -		
				D				\$ -		
				E				\$ -		
				F				\$ -		
				G				\$ -		
				Total	\$ -	\$ -	\$ -			
Level 1	Level 2	Level 3	Assessment							
Major Group Elements	Group Elements	Individual Elements	Building Component	Condition	Comments	Recommended Action	Priority Ranking	Probable Cost		
A Substructure	A10 Foundation	A1010 Standard Foundations	Stone and concrete foundation with openings for air circulation.	Poor	Spalling.	Continue monitoring for changes.	N/A	N/A

B Shell	B10 Superstructure	B1010 Floor Construction	Wood rafters.	Fair	No comment on condition.	No Recommendation.	N/A	N/A		
		B1020 Roof Construction	2x4 wood joists at 24" o/c with 1x8 strapping.	Fair	No comment on condition.	No Recommendation.	N/A	N/A		
	B20 Exterior Enclosure	B2010 Exterior Walls	Wood horizontal cladding. 2x4 wood framing at 16" o/c.	Poor	Previous temporary patches with mesh and some rotted boards.	Upgrade patches to metal or repair cladding.	3E	See Cladding Program.		
		B2020 Exterior Windows	Mix of hung and fixed windows. Wood frame.	Poor	Poor seals and aged trim.	Repair and paint.	4D	See Window and Door Program.		
		B2030 Exterior Doors	Painted wood doors and wood trim. Some glass panes.	Poor	Some organic growth on trims and paint peeling.	Repair and paint.	4D	See Window and Door Program.		
	B30 Roofing	B3010 Roof Coverings	Cedar shake shingles roof with eavestroughs and downspouts and wood fascia.	Poor	Organic growth.	Replace roof.	4C	See Roof Replacement and Maintenance Programs.

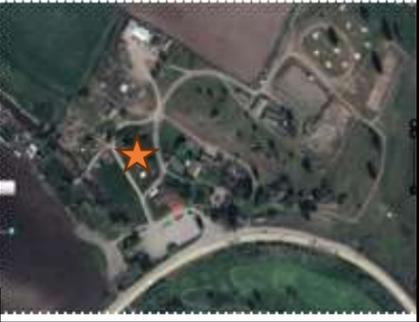
Windmill #1

n/a				B				\$ -		
Description				C				\$ -		
Galvanized metal frame wind mill installed on a wood platform. Appears to be connected to a decommissioned well.				D				\$ -		
		E					\$ -			
		F					\$ -			
		G					\$ -			
		Total		\$ -	\$ -	\$ -	\$ -			
Level 1	Level 2	Level 3		Assessment						
Major Group Elements	Group Elements	Individual Elements	Building Component	Condition	Comments	Recommended Action	Priority Ranking	Probable Cost		
A Substructure	A10 Foundation	A1020 Special Foundations	Wood platform sleeper.	Fair	Wood is in direct contact with soil.	Monitor and repair foundations as required.	N/A	N/A		
B Shell	B20 Exterior Enclosure	B2010 Exterior Walls	Galvanized steel frame with bolted connections.	Good	Connections show minor sings of corrosion.	No Recommendation.	N/A	N/A

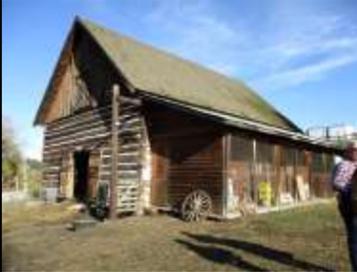
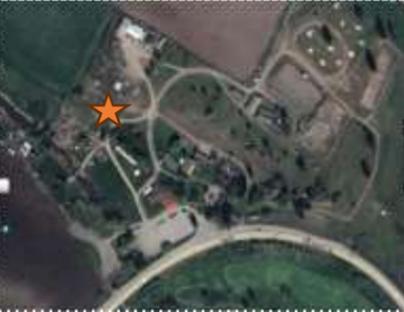
Log Barn

Other Names	1890 constructed circa. 1989 rebuilt.	Where projects have scope occurring at multiple buildings the full project cost has been included in each sheet and has not been split by building. Numbers affected by these "duplicate" costs are in red.	A		\$ 25,000		\$ 25,000		
n/a			B		\$ 10,000		\$ 10,000		
Notes	Log cabin with attic accessed from exterior. Stone pedestal foundation. Lean-tos on either side for livestock or storage. Wood framed cedar shake roof. Loft used for hay storage.	Programs have not been included in OPC Summary. Refer to Program Summary page at beginning of the report.	C				\$ -		
			D				\$ -		
			E				\$ -		
			F				\$ -		
			G				\$ -		
			Total	\$ -	\$ 35,000	\$ -	\$ 35,000

Level 1	Level 2	Level 3	Assessment					
Major Group Elements	Group Elements	Individual Elements	Building Component	Condition	Comments	Recommended Action	Priority Ranking	Probable Cost
A Substructure	A10 Foundation	A1020 Special Foundations	Stone pedestals and grade beams. Buried post for West elevation lean-to.	Good	Foundations are in good condition.	No Recommendation.	N/A	N/A
		A1030 Slab on Grade	Concrete slab on grade for East elevation lean-to.	Fair	No fill under the slab at South end.	Add fill to support slab. See A1010 at buildings 4A, 20 & 34.	3D	\$ 25,000
B Shell	B10 Superstructure	B1010 Floor Construction	2x8 wood stringers on center beam.	Fair	No comment on condition.	No Recommendation.	N/A	N/A
		B1020 Roof Construction	Rough cut 2x4 trusses w collar ties and 1"x6" strapping. Approximately 8-10 inch diameter pole beams. Some 2x4 posts. Lean-tos are post and beam construction. West elevation lean-to has diagonal bracing.	Fair	Water staining on underside of wood plank sheathing. Floor in hay loft deflects under human load.	B1020. 1 Roof replacement.	3C	See Roof Replacement and Maintenance Program.

B20 Exterior Enclosure	B2010 Exterior Walls	Broad axed log with chinking. Vertical and horizontal 1" wood planks on gable ends. Mesh on east lean-to.	Fair	Some planks are loose. Chinking is dry and cracking.	Replace loose boards and repair chinking.	2D	See Cladding Program.
		B2020 Exterior Windows	Wood fame with wire mesh.	Good	No comment on condition.	No Recommendation.	N/A	N/A
		B2030 Exterior Doors	Wood doors and frames. Barn door at South elevation.	Good	No comment on condition.	No Recommendation.	N/A	N/A
	B30 Roofing	B3010 Roof Coverings	Cedar shake shingles roof with eavestroughs, downspouts and wood fascia.	Poor	Cedar shake roof is aged and has organic growth and some broken shingles. Corrugated metal roofs have localized surface corrosion.	See B2010.	N/A	N/A
	C Interiors	C10 Interior Construction	C1010 Partitions	Wood frame and wire mesh.	Fair	No comment on condition.	No Recommendation.	N/A

C30 Interior Finishes		C3020 Floor Finishes	Shiplap floors.	Fair	No comment on condition.	No Recommendation.	N/A	N/A
		C3030 Ceiling Finishes	1" planking.	Fair	No comment on condition.	No Recommendation.	N/A	N/A
D Services	D50 Electrical	D5010 Electrical Service & Distribution	60A single phase panel sub-fed underground from another building	Fair	Service is adequate.	Maintain circuit breakers (maintenance).	2D	N/A
		D5020 Lighting and Branch Wiring	Lighting is generally screw based lamp holders. Wiring is NMWU cable.	Fair	A lot of extension cords have been used in a semi-permanent style.	Ensure LED lamps are utilized. Replace extension cords with permanent wiring where required (maintenance).	2D	N/A
G Sitework	G20 Site Improvements	G2040 Site Development	Concrete retaining wall at North.	Fair	Wood portion of retaining wall heaving out at top.	Continue to monitor for changes.	N/A	N/A
		G2050 Landscaping	Animal pens surrounding.	Fair	No comment on condition.	No Recommendation.	N/A	N/A

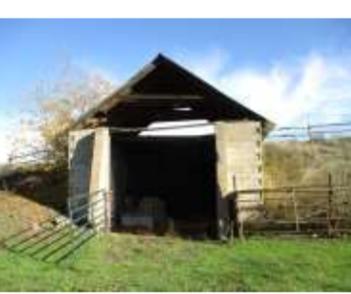
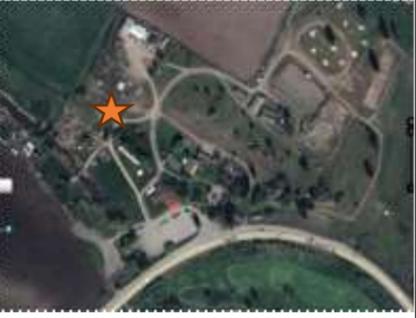
Hay Shed

Other Names	Construction date unknown.	A					\$ -			
Description	Concrete structure with tin roof. Used for hay storage.	B		\$ 25,000			\$ 25,000			
		C					\$ -			
		D					\$ -			
		E					\$ -			
		F					\$ -			
		G					\$ -			
		Total	\$ 25,000	\$ -	\$ -	\$ 25,000				
Level 1	Level 2	Level 3	Assessment							
Major Group Elements	Group Elements	Individual Elements	Building Component	Condition	Comments	Recommended Action	Priority Ranking	Probable Cost		
A Substructure	A10 Foundation	A1010 Standard Foundations	Concrete foundation and wall with concrete buttresses.	Fair	Condition was not visible.	Refer to B2010	3A			
B Shell	B10 Superstructure	B1010 Floor Construction	Soil		No comment on condition.	No Recommendation.	N/A	N/A

B1020 Roof Construction	Stick built trusses with collar ties.	Good	No comment on condition.	No Recommendation.	N/A	N/A		
	B20 Exterior Enclosure	B2010 Exterior Walls	Reinforced buttressed concrete. Tire retaining wall at North.	Poor	Spalled concrete due to freeze/thaw at front and sides. Concrete buttresses spalled. Exposed rebar at buttresses with surface corrosion.	Structural review and concrete repair or decommission.	3A	\$ 25,000		
	B30 Roofing	B3010 Roof Coverings	Sheet metal roof.	Fair	Minor surface corrosion.	Roof replacement.	1C	See Roof Replacement and Maintenance Programs.		
G Sitework	G20 Site Improvements	G2040 Site Development	3-rail wood fence surrounding with metal gate.	Good	Fence and gate are in generally good condition.	No Recommendation.	N/A	N/A		
		G2050 Landscaping	Built into hill. Grade sloped along East and West walls.		No comment on condition.	No Recommendation.	N/A	N/A

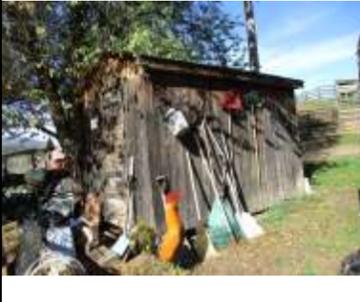
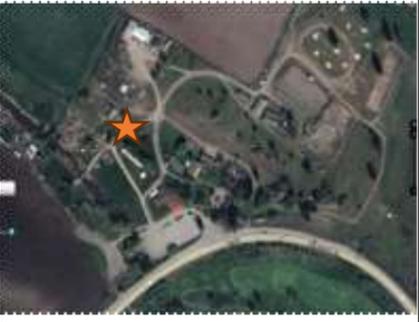
Ye Ol' Feed Shed

Other Names		Construction date unknown.		A				\$ -		
	n/a			B				\$ -		
Description				C				\$ -		
Small wood framed storage building on wood sled foundation with cedar shake shingle roof.				D				\$ -		
				E				\$ -		
				F				\$ -		
				G				\$ -		
			Total	\$ -	\$ -	\$ -				
Level 1	Level 2	Level 3	Assessment							
Major Group Elements	Group Elements	Individual Elements	Building Component	Condition	Comments	Recommended Action	Priority Ranking	Probable Cost		
A Substructure	A10 Foundation	A1020 Special Foundations	Wood skid foundation.	Fair	Foundation is in generally good condition.	No Recommendation.	N/A	N/A		
B Shell	B10 Superstructure	B1010 Floor Construction	Wood frame.	Fair	No access to review.	No Recommendation.	N/A	N/A

B1020 Roof Construction	Wood frame. With 2x4 trusses.	Fair	No comment on condition.	No Recommendation.	N/A	N/A		
	B20 Exterior Enclosure	B2010 Exterior Walls	Wood frame. Vertical wood plank cladding.	Poor	Some boards are loose or broken at the base.	Replace the loose or broken boards.	3E	See Cladding Program.		
		B2020 Exterior Windows	Wood frame with no glass. Sliding wood shutter.	Fair	No comment on condition.	No Recommendation.	N/A	N/A		
		B2030 Exterior Doors	Wood door and trim.	Poor	Wood is splitting, some ad hoc repairs.	Restain and replace door.	2E	See Window and Door Program.		
B30 Roofing	B3010 Roof Coverings	Cedar shake shingle roof with wood fascia.	Fair	Debris from tree. Fascia deteriorated from woodpeckers and rot. Has been previously replaced.	Remove debris and replace fascia.	1C	See Roof Maintenance Program.			
G Sitework	G20 Site Improvements	G2040 Site Development	Decommissioned light pole adjacent.		No comment on condition.	No Recommendation.	N/A	N/A

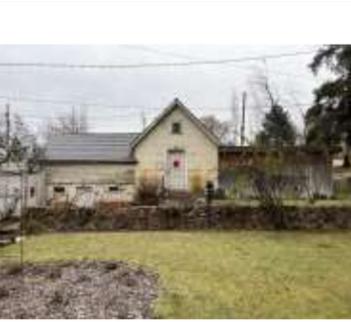
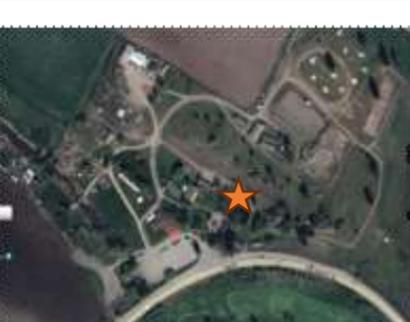
Meat and Dairy Building

Other Names	1890 constructed. 1920s addition.	A		\$ 20,000			\$ 20,000			
n/a	1987 CMU support wall added. 1989 re-roofed.	B		\$ 7,000			\$ 7,000			
Notes	1960s garage added.	C					\$ -			
Composed of three buildings. From East to West: B1 = Dairy Building, B2 = Meat Addition, B3 = Garage Addition. Mostly wood frame, some CMU and masonry. Some sloped cedar shake roof and some flat roof. Wood windows and doors.		D				\$ 2,000	\$ 2,000			
	E					\$ -	\$ -			
	F					\$ -	\$ -			
	G					\$ -	\$ -			
	Total			\$ 27,000	\$ -	\$ 2,000	\$ 29,000

Level 1	Level 2	Level 3	Assessment					
Major Group Elements	Group Elements	Individual Elements	Building Component	Condition	Comments	Recommended Action	Priority Ranking	Probable Cost
A Substructure	A10 Foundation	A1010 Standard Foundations	<u>B1:</u> Clay brick foundation wall at South and West and CMU wall at North and East. New CMU wall at West. <u>B2:</u> Stone foundation with no mortar. <u>B3:</u> Slab on grade with footings.	Poor	<u>B1:</u> At the West the clay masonry wall mortar failing: step cracking, spalling, and heaved in. At the South spalled bricks and paint peeling were noted. At the East concrete is missing at rotted floor joist above. Parging has spalling at the East. At the North a portion of the wall is missing.	Support and repair B1 North and East wall and associated areas in B2.	5B	\$ 20,000
		B1010 Floor Construction	<u>B1:</u> Concrete slab on grade (not original). <u>B2:</u> Wood joists. <u>B3:</u> Concrete slab on grade.	Poor	<u>B2:</u> Wood joists rotted on main floor.	Replace deteriorated joists. See A1010.	5B	See A1010.

B20 Exterior Enclosure	B2020 Exterior Windows	<u>B1:</u> Fixed wood frame windows at South. Openings just below grade at North. <u>B3:</u> Fixed wood frame.	Fair	Paint chipping at trims.	Repair and paint.	3D	See Window and Door Program.
		B2030 Exterior Doors	<u>B1/B2:</u> Wood door. <u>B3:</u> Plywood barn door.	Fair	<u>B1:</u> Door trim deteriorating.	Repair and paint.	3D	See Window and Door Program.
	B30 Roofing	B3010 Roof Coverings	B1/B2: Cedar shake single roof with wood fascia.	Fair	B1/B2: Some loose shingles.	Replace B1/B2 roof.	3C	See Roof Replacement and Maintenance Program.
			<u>B3:</u> Built up roof with one scupper and downspout.	Fair	<u>B3:</u> Organic growth and ponding.	Replace B3 roof and improve drainage.	4C	See Roof Replacement and Maintenance Program.

C Interiors	C10 Interior Construction	C1010 Partitions	<u>B2</u> : Wood frame.	Fair	No comment on condition.	No Recommendation.	N/A	N/A
		C1020 Interior Doors	<u>B2</u> : Wood door and trim.	Fair	No comment on condition.	No Recommendation.	N/A	N/A
	C30 Interior Finishes	C3010 Wall Finishes	<u>B1</u> : N/A <u>B2</u> : Wood plank. <u>B3</u> : Plywood at West, else none.	Fair	No comment on condition.	No Recommendation.	N/A	N/A
		C3020 Floor Finishes	<u>B2</u> : Wood plank.	Fair	No comment on condition.	No Recommendation.	N/A	N/A
		C3030 Ceiling Finishes	<u>B1</u> : White painted 1x12 planks. <u>B2</u> : White painted 1x8 tongue and groove. <u>B3</u> : Wood plank.	Fair	No comment on condition.	No Recommendation.	N/A	N/A
D Services	D50 Electrical	D5010 Electrical Service & Distribution	Circuit fed from mansion overhead.	Poor	Disconnect switch is very old.	Replace disconnect switches.	3D	\$ 2,000
		D5020 Lighting and Branch Wiring	Interior lighting.	Fair	Fluorescent and screw base lamp holders.	Ensure LED lamps are utilized. Replace missing lamps (maintenance).	2D	N/A

G Sitework	G20 Site Improvements	G2030 Pedestrian Paving	Concrete pavers along front. Concrete steps to B1 and B2 front entrances. Steel rail and caps at stair to B2.	Fair	Previous patch repairs at pavers. Stairs to B1 significantly eroded.	Repair concrete stairs to B1.	3B	See A1010.
		G2040 Site Development	Decommissioned light pole adjacent.	Fair	No comment on condition.	No Recommendation.	N/A	N/A
		G2050 Landscaping	Tree adjacent.		No comment on condition.	No Recommendation.	N/A	N/A

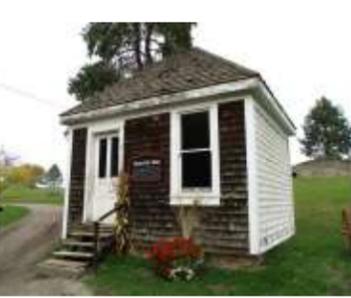
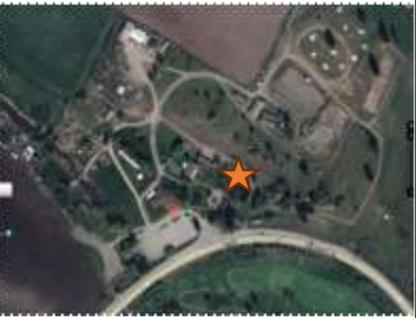
Chinese Cook's House

Other Names	Chinese Bunkhouse	1910s constructed.		A				\$ -	
Description	Small wood framed single-storey, single-room building with cedar shake roof and cladding. Wood framed windows and doors. Rock faced concrete foundation.			B				\$ -	
				C				\$ -	
				D				\$ -	
				E				\$ -	
				F				\$ -	
				G				\$ -	
			Total	\$ -	\$ -	\$ -	\$ -

Level 1	Level 2	Level 3	Assessment					
Major Group Elements	Group Elements	Individual Elements	Building Component	Condition	Comments	Recommended Action	Priority Ranking	Probable Cost
A Substructure	A10 Foundation	A1010 Standard Foundations	Rock faced concrete footing.	Fair	Foundation is in fair condition.	No Recommendation.	N/A	N/A
B Shell	B10 Superstructure	B1010 Floor Construction	Wood frame.	Fair	Floor is overhung of the foundation.	No Recommendation.	N/A	N/A
		B1020 Roof Construction	2x6 rafters at 2' o/c.	Fair	No comment on condition.	No Recommendation.	N/A	N/A
	B20 Exterior Enclosure	B2010 Exterior Walls	Wood shake siding painted white on three sides. 2"x2" horizontal strapping.	Poor	Shingles split, curling, and missing.	Repair deteriorated cladding.	4C	See Cladding Programs.
		B2020 Exterior Windows	Wood frame hung windows.	Poor	No seals. Sills and trim deteriorating.	Repair and paint. Add seals.	4D	See Window and Door Program.

B2030 Exterior Doors	Wood door and frame with glass panes.	Poor	Seals and trim deteriorating.	Repair and paint trim.	4D	See Window and Door Program.
B30 Roofing	B3010 Roof Coverings	Cedar shake shingle roof with wood fascia.	Poor	Shingles curling. Fascia paint chipping.	Roof replacement and maintenance.	4C	See Roof Replacement and Maintenance Programs.	
C Interiors	C30 Interior Finishes	C3010 Wall Finishes	Painted 1"x3" tongue and groove.	Fair	No comment on condition.	No Recommendation.	N/A	N/A
		C3020 Floor Finishes	Painted 1"x3" tongue and groove.	Fair	No comment on condition.	No Recommendation.	N/A	N/A
		C3030 Ceiling Finishes	1"x3" tongue and groove.	Fair	No comment on condition.	No Recommendation.	N/A	N/A
G Sitework	G20 Site Improvements	G2040 Site Development	Wood stairs with steel stringer and handrail.	Fair	Paint on treads is chipping and surface corrosion on stringer. Nailed into cladding at top of stairs.	Provide support at top of stairs.	3B	See Cladding Program.

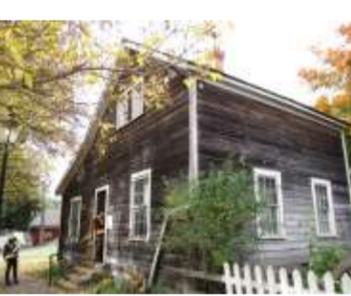
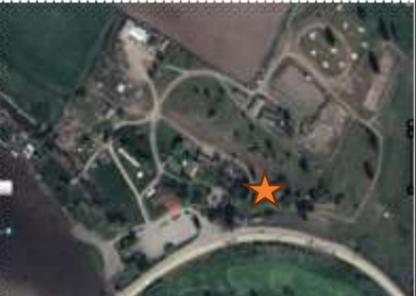
Other Names	1875 constructed.	A					\$ -			
Log Cabin, Original O'Keefe House	1898 moved to current location.	B			\$ 5,000		\$ 5,000			
	1965-1967 restored: new concrete footing, replace sashes and doors, fireplace constructed.	C					\$ -			
Notes	1978 re-roofed, new stairs.	D					\$ -			
Two-storey wood framed building with stone foundation and wood siding. Cedar shake shingle roof. Tin-roofed lean-to off kitchen entrance. Wood frame windows and doors.	1989 lean-to re-roofed.	E					\$ -

F						\$ -			
	G						\$ -			
	Total			\$ -	\$ 5,000	\$ -	\$ 5,000			
Level 1	Level 2	Level 3	Assessment							
Major Group Elements	Group Elements	Individual Elements	Building Component	Condition	Comments	Recommended Action	Priority Ranking	Probable Cost		
A Substructure	A10 Foundation	A1010 Standard Foundations	Stone foundation.	Fair	No signs of distress where visible.	No Recommendation.	N/A	N/A		
	B10 Superstructure	B1010 Floor Construction	Wood joists.	Fair	Stained where buried	Landscape to provide 4" clearance between cladding and vegetation. Monitor for leaking.	3D	See Landscaping Program.		
		B1020 Roof Construction	Wood joists.	Fair	No comment on condition.	No Recommendation.	N/A	N/A		
B Shell	B20 Exterior Enclosure	B2010 Exterior Walls	Split log construction (whip-sawn ponderosa pine). Horizontal wood siding and wood cap on corners.	Poor	Aged cladding with localized metal patches. Corner trim is pulling away in at the south east corner. Water staining at base of cladding.	Repair corner trim. See B1010.	3E	See Cladding Program.

B2020 Exterior Windows	Hung and fixed wood frame windows. Metal bars over some windows.	Poor	Poor seals. Water staining around dorm windows with new flashing.	Repair and paint trim and replace seals.	5D	See Window and Door Program.		
		B2030 Exterior Doors	Wood door and frame. Metal sill at South door.	Fair	No comment on condition.	Repair and paint trim.	4D	See Window and Door Program.		
	B30 Roofing	B3010 Roof Coverings	Cedar shake shingle roof with wood fascia.	Poor	Organic growth. Fascia paint is chipping. Water staining below dormer windows.	Paint fascia.	4D	See Roof Replacement and Maintenance Programs.		
		B3020 Roof Openings	One brick chimney and one stone chimney.	Fair	Spalling at top of brick chimney.	Roof replacement.	3C	See Roof Replacement and Maintenance Programs.		
					Repair chimney. See B3020 at building 34.	2B	\$ 5,000			
C Interiors	C10 Interior Construction	C1010 Partitions	Wood frame.	Good	No comment on condition.	No Recommendation.	N/A	N/A

C1020 Interior Doors	Wood doors and trim.	Fair	No comment on condition.	No Recommendation.	N/A	N/A		
	C20 Stairs	C2010 Stair Construction	Wood construction.	Fair	No comment on condition.	No Recommendation.	N/A	N/A		
	C30 Interior Finishes	C3010 Wall Finishes	Mix of painted wood plank and wallpaper.	Good	No comment on condition.	No Recommendation.	N/A	N/A		
		C3020 Floor Finishes	Mix of wood plank and linoleum.	Poor	Some linoleum peeling or missing.	No Recommendation.	N/A	N/A		
	C3030 Ceiling Finishes	Painted wood plank.	Good	No comment on condition.	No Recommendation.	N/A	N/A			
D Services	D50 Electrical	D5010 Electrical Service & Distribution	100A single phase service from BC Hydro which also sub-feeds the General Store (2P-30) and Blacksmith (2P-60).	Good	Service is adequate.	Maintain breakers (maintenance).	N/A	N/A		
		D5020 Lighting and Branch Wiring	Interior lighting.	Fair	Minimal indoor lighting.	Ensure LED lamps are used (maintenance).	N/A	N/A

G Sitework	G20 Site Improvements	G2030 Pedestrian Paving	Wood boardwalk from Log House to St. Anne's Church. Stone steps with retrofit steel rail. Gravel porch at back entrance.	Fair	Pedestrian paving is in fair condition.	No Recommendation.	N/A	N/A		
		G2040 Site Development	Wood frame lean-to at back with sheet metal roof. White painted picket fence to west.	Poor	Roof is a hazard to pedestrians.	Re-detail to remove sharp edges.	5B	See Roof Maintenance Program.		
		G2050 Landscaping	Garden beds at East and South. Grade sloped from back to front.	Fair	Vegetation touches cladding.	See B1010.	N/A	See B1010.

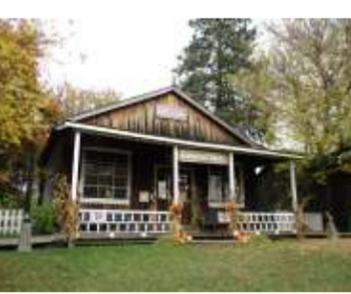
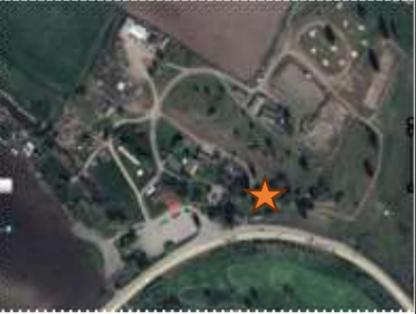
General Store

Other Names	Candy Store, Okanagon Post Office		A				\$ -			
Description			B				\$ -			
Wood framed single-storey building with board and batten siding, stone foundations, and cedar shake single roof. Exposed wood structure inside. Wood front awning over boardwalk and wood steps.			C							\$ -
			D							\$ -
			E							\$ -
			F							\$ -
			G							\$ -
Total	\$ -	\$ -	\$ -	\$ -

Level 1	Level 2	Level 3	Assessment					
Major Group Elements	Group Elements	Individual Elements	Building Component	Condition	Comments	Recommended Action	Priority Ranking	Probable Cost
A Substructure	A10 Foundation	A1010 Standard Foundations	Stone foundation and grade beam. Concrete slab on grade. Deck post has concrete footing.	Good	Foundation is in generally good condition.	No Recommendation.	N/A	N/A
B Shell	B10 Superstructure	B1010 Floor Construction	2-ply 3x8 North-South spanning beam. 5 1/4"x5 1/4" beam in center of room.	Good	No comment on condition.	No Recommendation.	N/A	N/A
		B1020 Roof Construction	2x6 wood rafters at 16" o/c with 1"x6" strapping.	Fair	Water staining on soffit.	Clean and paint soffit. Repair roof leaks.	3D	See Roof Maintenance Program.
	B20 Exterior Enclosure	B2010 Exterior Walls	Wood frame. 1" board and batten cladding.	Good	Aged siding with water staining at base. Some loose battens.	Landscape to provide 4" clearance between cladding and vegetation. Repair or replace loose battens.	3D	See Landscaping and Cladding Programs.

B2020 Exterior Windows	Wood frame fixed windows with metal bars over exterior and some stained glass.	Fair	Trim paint peeling.	Repair and paint trim.	2D	See Window and Door Program.
		B2030 Exterior Doors	Wood door and trim with glass panes.	Fair	Trim paint peeling.	Repair and paint trim.	2D	See Window and Door Program.
	B30 Roofing	B3010 Roof Coverings	Cedar shake shingle roof with wood fascia.	Poor	Shingles curling and some organic growth.	Repair and paint fascia.	3D	See Roof Replacement and Maintenance Programs.
						Roof replacement.	4C	See Roof Replacement and Maintenance Programs.
	B3020 Roof Openings	New metal chimney.	Fair	No comment on condition.	No Recommendation.	N/A	N/A	
C Interiors	C30 Interior Finishes	C3010 Wall Finishes	Painted wood plank.	Fair	No comment on condition.	No Recommendation.	N/A	N/A
		C3020 Floor Finishes	1x6 tongue and groove at 16" o/c.	Fair	No comment on condition.	No Recommendation.	N/A	N/A

C3030 Ceiling Finishes	Painted wood plank.	Fair	No comment on condition.	No Recommendation.	N/A	N/A
D Services	D50 Electrical	D5010 Electrical Service & Distribution	30A sub fed from log house underground.	Good	Load centre panel located under counter is adequate.	Maintain circuit breakers (maintenance).	2D	N/A
		D5020 Lighting and Branch Wiring	Interior lighting.	Fair	Screw base lamp holders and older decorative fixtures.	Ensure LED lamps are utilized (maintenance).	2E	N/A
G Sitework	G20 Site Improvements	G2030 Pedestrian Paving	Wood boardwalk from Log House to St. Anne's Church. Wood frame front porch with wood steps and guardrail.	Fair	Pedestrian paving is in fair condition.	No Recommendation.	N/A	N/A
		G2040 Site Development	White painted picket fence on either side.	Fair	Fence is in fair condition.	No Recommendation.	N/A	N/A
		G2050 Landscaping	Garden beds on three sides.	Fair	Vegetation touches cladding.	See B2010.	N/A	See B2010.

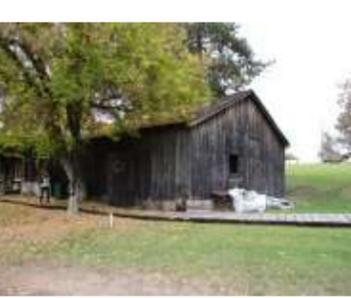
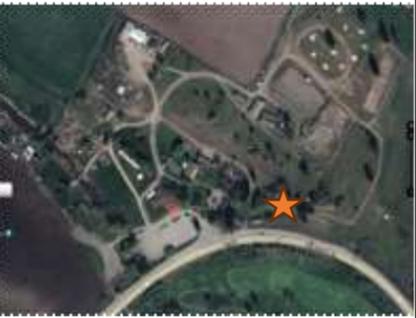
Blacksmith Shop

Other Names	1965 constructed.	A					\$ -				
n/a		B		\$ 5,000			\$ 5,000				
Description	Wood framed single-storey with board and batten siding. Stone foundation and cedar shake shingle roof. Active forges inside. Wood doors.	C					\$ -				
Level 1	Level 2	Level 3		Assessment							
Major Group Elements	Group Elements	Individual Elements		Building Component	Condition	Comments	Recommended Action	Priority Ranking			Probable Cost

A Substructure	A10 Foundation	A1010 Standard Foundations		Stone foundation wall 10" high by 12" wide with 5" concrete footing and parging on interior.	Good	No comment on condition.	No Recommendation.	N/A			N/A
B Shell	B10 Superstructure	B1010 Floor Construction		Reported 2" concrete slab.	Fair	No comment on condition.	No Recommendation.	N/A			N/A
		B1020 Roof Construction		2x6 rough cut wood rafters. Center beam bearing on column and exterior walls.	Good	No comment on condition.	No Recommendation.	N/A			N/A
	B20 Exterior Enclosure	B2010 Exterior Walls	Board and batten siding with 1x8-12" board and 1x4 battens. 2x4 rough cut wood stud at 16" o/c, cross braced with 2x4 blocking. 2x6 bottom plate and 2x4 top plate.	Poor	Wood pecker holes and water staining at base. Some previous metal patches.	Landscape to provide 4" clearance between cladding and vegetation. Repair woodpecker holes.	3D	See Landscaping and Cladding Program.

B2020 Exterior Windows	Wood frame with metal mesh covering. One fixed glass panel window.	Fair	No comment on condition.	No Recommendation.	N/A	N/A			
		B2030 Exterior Doors	Wood doors and trim. Glass panel in back door.	Fair	Surface corrosion on hardware. Front door is touching vegetation and rotting at base. Back door is in poor condition and has no handle.	See B2010. repair doors as required.	3E	See Window and Door Program.			
	B30 Roofing	B3010 Roof Coverings	Cedar shake shingle with wood fascia.	Fair	Lots of organic growth and debris from tree. Some missing shingles.	Roof replacement.	4C	See Roof Replacement and Maintenance Programs.			
B3020 Roof Openings		Metal chimney.	Good	Potential fire hazard with no flashing at base of chimney.	Add flue flashing at base of chimney. See B3020 at building 4A.	4B	\$ 5,000				
C Interiors	C30 Interior Finishes	C3010 Wall Finishes	Painted plywood	Good	No comment on condition.	No Recommendation.	N/A	N/A

D30 HVAC	D3040 Distribution Systems	Forge Venting System	Poor	Except for one system, the forge venting system will need to be replaced.	The systems should be replaced, and appropriate thimbles are needed for the penetrations through the roof.	5C	\$ 18,000			
D Services	D40 Fire Protection	D4030 Fire Protection Specialties	Fire extinguisher.	Fair	No comment on condition.	No Recommendation.	N/A	N/A			
	D50 Electrical	D5010 Electrical Service & Distribution	60A sub feed underground from Log House.	Good	60A load centre panel is adequate for the current use.	Maintain circuit breakers (maintenance).	2D	N/A			
		D5020 Lighting and Branch Wiring	Interior fluorescent lighting.	Fair	Minimal lighting.	Replace lighting with LED as fixtures fail.	2D	N/A			
E Equipment & Furnishings	E10 Equipment	E1010 Commercial Equipment	Blacksmithing forges.	Fair	No comment on condition.	No Recommendation.	N/A	N/A			
G Sitework	G20 Site Improvements	G2030 Pedestrian Paving	Wood boardwalk from Log House to St. Anne's Church.	Fair	Boardwalk is in fair condition.	No Recommendation.	N/A	N/A

G2050 Landscaping	Evergreen tree adjacent.	Fair	No comment on condition.	No Recommendation.	N/A	N/A

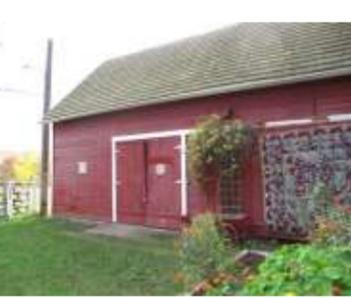
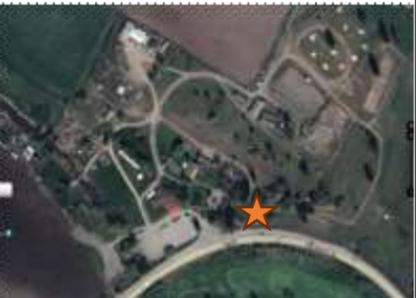
Red Shed

Other Names	1870 original construction. 1915 garage addition.	A					\$ -		
Description	Single-storey wood framed building. Original building was 20' x 30' with a 22' x 20' addition. Cedar shingle roof. Concrete foundation wall. Attic with access by ladder from main floor.	B					\$ -		
		C					\$ -		
		D					\$ -		
		E					\$ -		
		F					\$ -		
		G					\$ -		
		Total		\$ -	\$ -	\$ -			
Level 1	Level 2	Level 3	Assessment						
Major Group Elements	Group Elements	Individual Elements	Building Component	Condition	Comments	Recommended Action	Priority Ranking	Probable Cost	
A Substructure	A10 Foundation	A1010 Standard Foundations	Concrete foundation wall.	Poor	North-West corner concrete has eroded. Cracked in some locations (pre-existing condition). Deflected outwards at South elevation.	Continue monitoring for changes.	N/A	N/A

A20 Basement Construction	A2010 Basement Excavation	Vented crawlspace.	Fair	No comment on condition.	No Recommendation.	N/A	N/A	
B Shell	B10 Superstructure	B1010 Floor Construction	Addition is concrete slab on grade and grease pit. Original room is wood joist.	Fair	Minor cracking.	Continue monitoring for changes.	N/A	N/A	
		B1020 Roof Construction	Wood joists.	Fair	No comment on condition.	No Recommendation.	N/A	N/A	
	B20 Exterior Enclosure	B2010 Exterior Walls	Horizontal red wood siding and white painted wood corner caps.	Fair	Some loose planks.	Replace or repair loose planks.	2E	See Cladding Program.	
		B2020 Exterior Windows	Wood frame awning windows.	Fair	South windows are insulated over.	No Recommendation.	N/A	N/A	
		B2030 Exterior Doors	Wood door and frame.	Fair	Addition door has water staining at base. Back door is insulated over. Barn door has loose boards.	Repair doors.	3D	See Window and Door Program.

B30 Roofing	B3010 Roof Coverings	Cedar shake shingle roof with eavestroughs and downspouts and wood fascia.	Fair	Some organic growth.	Roof replacement.	1C	See Roof Replacement and Maintenance Programs.	
B3020 Roof Openings		Box vents and two metal chimneys.	Good	No comment on condition.	No Recommendation.	N/A	N/A		
C Interiors	C10 Interior Construction	C1010 Partitions	Exterior wall of original room. Wood frame.	Fair	No comment on condition.	No Recommendation.	N/A	N/A	
		C1020 Interior Doors	Wood door and trim.	Fair	No comment on condition.	No Recommendation.	N/A	N/A	
	C30 Interior Finishes	C3010 Wall Finishes	Wood plank.	Fair	Water staining in Addition South-West corner at top of wall.	Patch planks.	3D	See Cladding Program.	
		C3020 Floor Finishes	Plank floor in loft. N/A in addition.	Fair	No comment on condition.	No Recommendation.	N/A	N/A	
		C3030 Ceiling Finishes	Plywood in original room. Wood plank in addition.	Fair	Water staining near addition door. Ceiling is deflecting in original room.	Re-fasten ceiling to roof structure (maintenance). Patch repair plywood.	3D	See Cladding Program.

D Services	D50 Electrical	D5010 Electrical Service & Distribution	Overhead BC Hydro service to a load centre panel.	Fair	Service is in fair condition.	Maintain breakers (maintenance).	2D	N/A	
		D5020 Lighting and Branch Wiring	Interior lighting.	Fair	Fluorescent and screw base lamp holders.	Replace lighting with LED as existing fixtures fail (maintenance).	2D	N/A	
G Sitework	G20 Site Improvements	G2030 Pedestrian Paving	Extended slab patio.	Fair	Minor cracking.	Continue monitoring for changes.	N/A	N/A	
		G2040 Site Development	Lamppost and metal gate adjacent.	Fair	No comment on condition.	No Recommendation.	N/A	N/A	
		G2050 Landscaping	Vegetation on lattice.	Fair	No comment on condition.	No Recommendation.	N/A	N/A

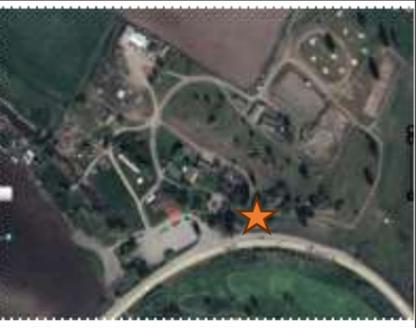
Carriage Shed

Other Names	Circa 1890. 1965 renovation. 1981 renovation: (add garage doors, close in some doorways and chimney).	A					\$ -		
Description	Single-storey wood frame building with concrete foundation wall and cedar shake shingle roof. Wood framed fibreglass doors. Two individual bathrooms. Red painted wood siding.	B					\$ -		
		C					\$ -		
		D		\$ 5,000			\$ 5,000		
		E					\$ -		
		F					\$ -		
		G					\$ -		
		Total		\$ -	\$ 5,000	\$ -			
Level 1	Level 2	Level 3	Assessment						
Major Group Elements	Group Elements	Individual Elements	Building Component	Condition	Comments	Recommended Action	Priority Ranking	Probable Cost

A Substructure	A10 Foundation	A1010 Standard Foundations	Concrete foundation wall. Floor joists on rocks or concrete piles.	Fair	Minor cracking. Undermined at South elevation.	Provide soil infill where undermined.	3C	See O'Keefe House A1010.	
	A20 Basement Construction	A2010 Basement Excavation	Vented crawlspace.	Fair	No vent covers.	Install vent covers (maintenance).	N/A	N/A	
B Shell	B10 Superstructure	B1010 Floor Construction	Wood joists.	Fair	No comment on condition.	No Recommendation.	N/A	N/A	
		B1020 Roof Construction	Wood joists.	Fair	No comment on condition.	No Recommendation.	N/A	N/A	
	B20 Exterior Enclosure	B2010 Exterior Walls	Mix of 1x6 vertical wood siding and cedar shake shingles. Wood frame.	Fair	Some loose of broken shingles and woodpecker holes.	Patch or replace damaged shingles.	3E	See Cladding Program.	
		B2030 Exterior Doors	Wood frame fibreglass doors.	Fair	Aged but functional.	No Recommendation.	N/A	N/A

B30 Roofing	B3010 Roof Coverings	Cedar shake shingle roof with eavestroughs and downspouts and wood fascia.	Fair	Some organic growth. Eavestroughs are dirty.	Clean eavestroughs.	1C	See Roof Maintenance Program.		
C Interiors	C10 Interior Construction	C1010 Partitions	Wood frame.	Good	No comment on condition.	No Recommendation.	N/A	N/A	
		C3010 Wall Finishes	Wood planks.	Fair	No comment on condition.	No Recommendation.	N/A	N/A	
	C30 Interior Finishes	C3020 Floor Finishes	2x6 tongue and groove.	Good	No comment on condition.	No Recommendation.	N/A	N/A	
		C3030 Ceiling Finishes	Drywall.	Fair	No comment on condition.	No Recommendation.	N/A	N/A	
D Services	D20 Plumbing	D2010 Plumbing Fixtures	Lavatories and water closets appear to be relatively new.	Good	The existing fixtures should provide good service for the near future.	Consideration should be made to provide hot water to both public washrooms for improved hand washing hygiene.	3D	\$ 2,500

D2020 Domestic Water Distribution	Original piping systems are not visible.	Fair	The systems are not likely to be very old as the washrooms seem to be a recent renovation to the building.	No Recommendation.	2E	N/A	
		D2030 Sanitary Waste	Sanitary waste systems utilize ABS piping systems where visible. Buried piping and piping within the walls were not reviewed.	Fair	The sanitary drainage piping should provide good service for the near future.	No Recommendation.	2E	N/A	
		D2090 Other Plumbing Systems	Domestic Water Heater	Fair	The electric domestic hot water heater is nearing the end of its service life.	The domestic water heater should be replaced relatively soon.	3D	\$ 2,500	
	D50 Electrical	D5010 Electrical Service & Distribution	Circuits sub fed from adjacent building.	Fair	Service is in fair condition.	No Recommendation.	N/A	N/A	
		D5020 Lighting and Branch Wiring	Interior Lighting	Fair	Fluorescent wraparound and incandescent.	Replace light with LED as fixtures fail or funding becomes available (maintenance).	2D	N/A

G Sitework	G20 Site Improvements	G2030 Pedestrian Paving	Wood platform outside of washrooms. Extended slab patio.	Fair	Wood platform is wet. Minor cracking in slab.	Replace wood platform at failure. Continue monitoring slab for changes.	N/A	N/A	
		G2040 Site Development	Metal fence with barbed wire.	Fair	Fence is in fair condition.	No Recommendation.	N/A	N/A

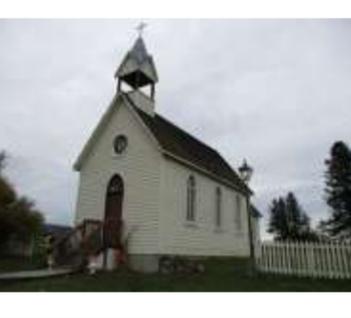
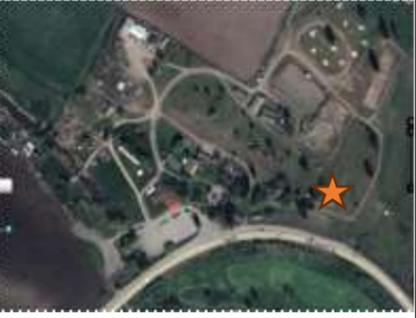
St. Anne's Church

Other Names	1889 constructed.	A					\$ -			
St. Ann's Church	1965 interior restored, repainted.	B					\$ -			
Description	1989 sacristy rehabilitation (linseed preservative oil).	C					\$ -			
Wood framed single-storey building with attic above sacristy. Vaulted ceiling in main room. Cedar shake roof with metal shingles on steeple. New white painted wood cladding. Wood doors and windows.	2015-2017 exterior restoration and foundation.	D			\$ 10,000	\$ 13,000	\$ 23,000			
	E					\$ -				
	F					\$ -				
	G					\$ -

Total		\$ -	\$ 10,000	\$ 13,000					
Level 1	Level 2	Level 3	Assessment							
Major Group Elements	Group Elements	Individual Elements	Building Component	Condition	Comments	Recommended Action	Priority Ranking	Probable Cost		
A Substructure	A10 Foundation	A1010 Standard Foundations	Cast-in-place concrete foundation.	Good	Foundation new in 2006.	No Recommendation.	N/A	N/A		
	B Shell	B10 Superstructure	B1010 Floor Construction	2x8 joists at 24" o/c on 6x6 beam.	Fair	No comment on condition.	No Recommendation.	N/A	N/A	
B1020 Roof Construction			Attic above back room. 1x10-12" strapping.	Fair	No comment on condition.	No Recommendation.	N/A	N/A		
B2010 Exterior Walls			Wood horizontal cladding. Wood balloon framing at 24" o/c.	Good	No comment on condition.	No Recommendation.	N/A	N/A		
B20 Exterior Enclosure		B2020 Exterior Windows	Exterior glazed single pane swing windows with wood trim. Some stained glass. Hung windows at back.	Poor	Paint chipping on sills. Glass is dirty.	Repair and paint trims.	2D	See Window and Door Program.

B2030 Exterior Doors	Original wood doors and trim.	Fair	Front door has astragal.	Adjust astragal to clear the door handle.	2B	See Window and Door Program.		
B30 Roofing	B3010 Roof Coverings	Cedar shake shingle roof with eavestroughs and downspouts and wood fascia.	Fair	No comment on condition.	No Recommendation.	N/A	N/A			
	B3020 Roof Openings	Metal chimney.	Fair	Chimney leaking.	Review and repair (maintenance).	N/A	N/A			
	C Interiors	C10 Interior Construction	C1010 Partitions	Wood frame.	Fair	No comment on condition.	No Recommendation.	N/A	N/A	
C1020 Interior Doors			Wood door and frame.	Fair	No comment on condition.	No Recommendation.	N/A	N/A		
C30 Interior Finishes		C3010 Wall Finishes	Generally 1"x2.5" tongue and groove. 1"x3.5" tongue and groove in sacristy.	Fair	No comment on condition.	No Recommendation.	N/A	N/A		
		C3020 Floor Finishes	Generally 1"x5" tongue and groove. 1"x5-9" tongue and groove in sacristy.	Fair	No comment on condition.	No Recommendation.	N/A	N/A

C3030 Ceiling Finishes	1x4 tongue and groove.	Fair	Some water staining in back room.	Assess chimney and repair flashing.	4E	See Roof Maintenance Program.

D Services	D30 HVAC	D3010 Energy Supply	The only building that is heated but not connected to Natural gas is the St Annes Church, that has a dedicated propane tank.	Good	Gas piping where visible appears to be in good condition.	No upgrades to the system are anticipated unless significant upgrades to the existing systems is initiated.	N/A	N/A
		D3020 Heat Generating Systems	Assumed there is a propane fired furnace in the ceiling space above the back entry to the church. Likely the unit is fairly old as the venting is an older style. Wood stove is not in use. Chimney has been reconfigured to serve the furnace mentioned above.	Poor	This gas fired appliances have been installed in a room that is not fire rated.	D3020.1 Update the propane furnace to a sealed combustion condensing furnace considering the cost of propane.	2D	\$ 12,500
						D3020.2 Fire rate the room that the furnaces are installed.	2B	\$ 10,000

D3040 Distribution Systems	Supply duct system.	Fair	The supply duct systems are in good shape considering the age of the system.	At most, an internal inspection of the duct and a duct cleaning every 5 years or so.	3E	\$ 500	
	D50 Electrical	D5010 Electrical Service & Distribution	Circuits sub fed from Blacksmith Shop.	Fair	Two circuits for lighting and receptacles.	No Recommendation.	N/A	N/A
		D5020 Lighting and Branch Wiring	Interior lighting and accent lighting surrounding.	Fair	Single incandescent up light, in ground accent lightings around building.	Some inground lights have been replaced with LED. Upgrade interior lighting to LED when fixture fails or if funding is available (maintenance).	2D	N/A
G Sitework	G20 Site Improvements	G2030 Pedestrian Paving	Wood steps to front door. Wood ramp to back door on concrete pedestals. Wood boardwalk from Log House to St. Anne's Church.	Fair	Wood handrail at ramp is rotting.	Replace handrail (maintenance).	N/A	N/A

G2040 Site Development	White picket fence surrounding. Mini stone retaining wall at south-east corner. Streetlamps along boardwalk.	Fair	Fence paint is chipping. Streetlamps in fair to poor condition.	Paint fence.	2E	See Fence Program.

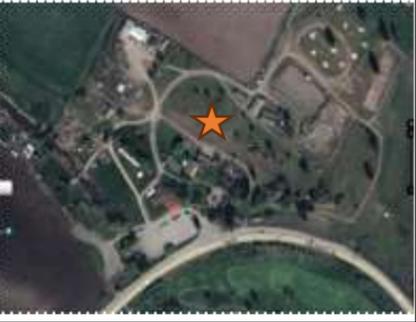
Smoke House

Other Names	1900 constructed circa. 2006 re-roofed "recently".			A				\$ -		
n/a				B				\$ -		
Description				C				\$ -		
Small wood framed structure, interior charred from smoke, pedestal foundation, and cedar shake roof.				D				\$ -		
				E				\$ -		
				F				\$ -		
				G				\$ -		
			Total	\$ -	\$ -	\$ -				
Level 1	Level 2	Level 3	Assessment							
Major Group Elements	Group Elements	Individual Elements	Building Component	Condition	Comments	Recommended Action	Priority Ranking	Probable Cost		
A Substructure	A10 Foundation	A1020 Special Foundations	Stone pedestal foundation.	Good	Foundation is in generally good condition.	No Recommendation.	N/A	N/A

B Shell	B10 Superstructure	B1010 Floor Construction	Wood joists.	Fair	No comment on condition.	No Recommendation.	N/A	N/A		
		B1020 Roof Construction	Wood joists.	Fair	No comment on condition.	No Recommendation.	N/A	N/A		
	B20 Exterior Enclosure	B2010 Exterior Walls	Vertical wood cladding. 2x4 wood frame walls with 2-ply 2x4 posts at corners.	Fair	Hole in cladding at North-East corner.	Patch cladding where required.	2D	See Cladding Program.		
		B2030 Exterior Doors	Wood door and trim with holes for ventilation.	Fair	No comment on condition.	No Recommendation.	N/A	N/A		
	B30 Roofing	B3010 Roof Coverings	Cedar shake shingle roof with wood fascia.	Fair	No comment on condition.	No Recommendation.	N/A	N/A		
C Interiors	C30 Interior Finishes	C3010 Wall Finishes	Wood plank.	Fair	Finish is charred from use.	No Recommendation.	N/A	N/A		
		C3020 Floor Finishes	Wood plank.	Fair	Finish is charred from use.	No Recommendation.	N/A	N/A

C3030 Ceiling Finishes	Wood plank.	Fair	Finish is charred from use.	No Recommendation.	N/A	N/A

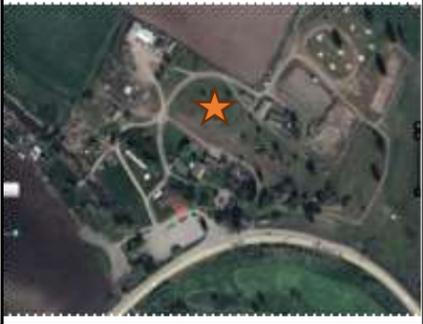
Pump House

Other Names	Construction date unknown.	A					\$ -					
n/a		B					\$ -					
Description		C					\$ -					
Water main for the site. Wood framed building with plywood interior sheathing and sheet metal roof. Board and batten siding. Concrete slab on grade foundation.		D			\$ 4,000		\$ 4,000					
		E					\$ -					
		F					\$ -					
		G					\$ -					
		Total		\$ -	\$ 4,000	\$ -	\$ 4,000					
Level 1	Level 2	Level 3	Assessment									
Major Group Elements	Group Elements	Individual Elements	Building Component	Condition	Comments	Recommended Action	Priority Ranking	Probable Cost

A Substructure	A10 Foundation	A1030 Slab on Grade	Standard concrete slab on grade.	Good	Foundation is in generally good condition.	No Recommendation.	N/A	N/A				
B Shell	B10 Superstructure	B1010 Floor Construction	See A1030.	Good	See A1030.	See A1030.	N/A	N/A				
		B1020 Roof Construction	Wood joists.	Fair	Potential repairs required due to roof leak. Potential stud deterioration from leak.	Review and repair with roof and cladding repairs.	N/A	See Roof Maintenance Program.				
	B20 Exterior Enclosure	B2010 Exterior Walls	Wood frame. Board and batten cladding.	Fair	Cladding is aged and touching grade.	Landscape to provide 4" clearance between cladding and vegetation. Repair or replace damaged cladding.	3E	See Landscaping and Cladding Programs.				
		B2030 Exterior Doors	Wood door and frame.	Fair	No comment on condition.	No Recommendation.	N/A	N/A				
		B30 Roofing	B3010 Roof Coverings	Sheet metal roof.	Good	No comment on condition.	No Recommendation.	N/A	N/A

C Interiors	C30 Interior Finishes	C3010 Wall Finishes	Plywood.	Poor	Staining at North-East corner.	Replace plywood and repair roof leaks.	4D	See Cladding Program.				
		C3020 Floor Finishes	See A1030.	Good	See A1030.	See A1030.	N/A	N/A				
		C3030 Ceiling Finishes	Plywood.	Poor	Staining at North-East corner.	See C3010.	N/A	See C3010.				
D Services	D20 Plumbing	D2020 Domestic Water Distribution	The piping systems use galvanized, copper, and plastic piping.		Galvanized piping is no longer approved on domestic water systems. The tanks and recent piping system appear to be functional.	The next time the system needs work, we recommended replacing the galvanized piping with approved domestic water systems.	3D	\$ 2,500				
	D50 Electrical	D5010 Electrical Service & Distribution	Electrical sub-fed from Implement Shed.	Fair	Older style ITE panel replacement breakers will be difficult to obtain.	Replace panel.	3D	\$ 1,500

D5020 Lighting and Branch Wiring	Lighting.	Fair	Fluorescent.	Replace with LED when fixture fails (maintenance).	2D	N/A				
		D5090 Other Electrical Systems	Generator input.	Fair	Manual transfer switch for connection of portable generator.	No Recommendation.	N/A	N/A

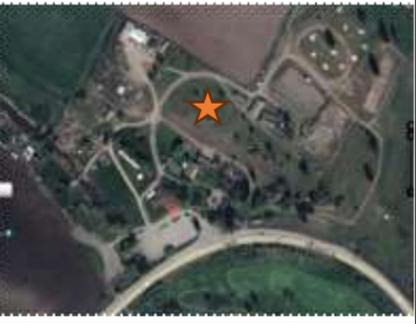
Windmill #2

n/a			B				\$ -			
Description			C				\$ -			
Galvanized metal frame wind mill installed on a wood platform.		D				\$ -				
		E				\$ -				
		F				\$ -				
		G				\$ -				
		Total	\$ -	\$ -	\$ -	\$ -				
Level 1	Level 2	Level 3	Assessment							
Major Group Elements	Group Elements	Individual Elements	Building Component	Condition	Comments	Recommended Action	Priority Ranking	Probable Cost		
A Substructure	A10 Foundation	A1020 Special Foundations	Wood platform sleeper.	Fair	Wood is in direct contact with soil.	Monitor and repair foundations as required.	N/A	N/A		
B Shell	B20 Exterior Enclosure	B2010 Exterior Walls	Galvanized steel frame with bolted connections.	Good	Connections show minor sings of corrosion.	No Recommendation.	N/A	N/A

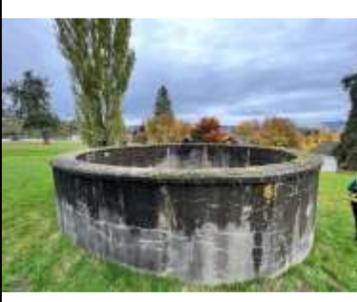
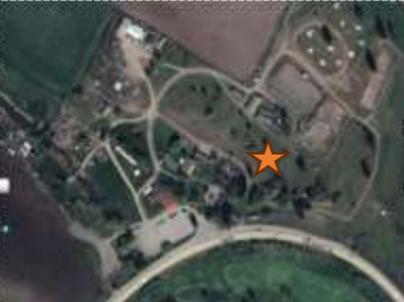
Water Cisterns

Other Names	1901 constructed.			A				\$ -	
n/a				B				\$ -	
Description	Two cisterns - West covered and East uncovered. Cistern cover is wood frame with cedar shake roof and rock pedestal foundation.			C				\$ -	
				D				\$ -	
				E				\$ -	
				F				\$ -	
				G				\$ -	
				Total		\$ -	\$ -	\$ -	
Level 1	Level 2	Level 3	Assessment						
Major Group Elements	Group Elements	Individual Elements	Building Component	Condition	Comments	Recommended Action	Priority Ranking	Probable Cost	
A Substructure	A10 Foundation	A1020 Special Foundations	Rock pedestal foundation at cover.	Good	Foundation is in generally good condition.	No Recommendation.	N/A	N/A

A20 Basement Construction	A2020 Basement Walls	Concrete cistern.	Fair	At East cistern: crack through wall near west side, pour joint at half height is cracked. Concrete cap is in fair condition.	Remove vegetation and clean (maintenance).	N/A	N/A	
B Shell	B10 Superstructure	B1020 Roof Construction	Collar tied wood trusses at cover.	Fair	Minor staining	Roof replacement.	2D	See Roof Replacement and Maintenance Programs.	
	B20 Exterior Enclosure	B2010 Exterior Walls	Approximately 2x4 wood frame with double layer of horizontal wood cladding on cover.	Fair	Cladding near grade has minor deterioration and is buried at north elevation.	Repair and paint cladding.	3E	See Cladding Program.	
		B2020 Exterior Windows	Wood framed opening with wood shutter.	Fair	Shutters are aged.	Repair shutters.	3E	See Window and Door Program.	
	B30 Roofing	B3010 Roof Coverings	Cedar shake shingle roof with wood fascia.	Fair	Sheathing is water damaged and splitting in some locations. Some organic growth.	See B1020.	N/A	See B1020.

C Interiors	C30 Interior Finishes	C3010 Wall Finishes	Parging layer.	Fair	Shrinkage cracking in both cisterns. East cistern has spalling, efflorescence, delaminations, and vegetation growth. No mortar joint deterioration.	See A2020.	N/A	See A2020.	
G Sitework	G20 Site Improvements	G2050 Landscaping	Trees near West cistern.		No comment on condition.	No Recommendation.	N/A	N/A

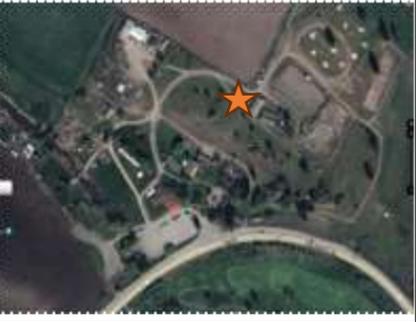
SPALLUMCHEEN PIONEER POWER CLUB DISPLAY #1

Other Names	Antique Farming Equipment Display	A					\$ -					
Description	Pressure-treated post and beam on concrete slab on grade. Sheet metal roof on engineered trusses. Houses antique farming equipment.	B					\$ -					
				C				\$ -				
				D		\$ 2,000		\$ 2,000				
				E				\$ -				
				F				\$ -				
				G				\$ -				
				Total	\$ -	\$ 2,000	\$ -	\$ 2,000				
Level 1	Level 2	Level 3	Assessment						Priority Ranking	Probable Cost		
Major Group Elements	Group Elements	Individual Elements	Building Component	Condition	Comments	Recommended Action	Priority Ranking	Probable Cost

A Substructure	A10 Foundation	A1010 Standard Foundations	Pressure-treated embedded posts.	Fair	Posts are in fair condition.	No Recommendation.	N/A	N/A				
B Shell	B10 Superstructure	B1010 Floor Construction	Concrete slab on grade.	Good	No comment on condition.	No Recommendation.	N/A	N/A				
		B1020 Roof Construction	Engineered trusses at 4' o/c.	Fair	No comment on condition.	No Recommendation.	N/A	N/A				
	B30 Roofing	B3010 Roof Coverings	Sheet metal roof with wood fascia. Sheet metal cladding on gable ends.	Good	No comment on condition.	No Recommendation.	N/A	N/A				
C Interiors	C10 Interior Construction	C1030 Fittings	Steel fence surrounding.	Fair	Surface corrosion on steel fence.	Clean fence (maintenance)	N/A	N/A				
D Services	D40 Fire Protection	D4030 Fire Protection Specialties	Fire extinguisher.	Fair	No comment on condition.	No Recommendation.	N/A	N/A				
	D50 Electrical	D5010 Electrical Service & Distribution	Circuits fed from panel in SPPC #2.	Poor	Circuits are in poor condition.	Non-weatherproof disconnect switch is exposed to weather and is rusting. Replace.	3D	\$ 2,000
