THE CORPORATION OF THE CITY OF VERNON REPORT TO COUNCIL

SUBJECT: HISTORIC O'KEEFE RANCH FACILITY CONDITION ASSESSMENT

Facility Condition Assessment

At the City of Vernon's request Read Jones Christoffersen Ltd. (RJC) has completed a Facility Condition Assessment (FCA) at the Historic O'Keefe Ranch located at 9380 BC-97 near Vernon, BC per our proposal dated September 14, 2023. The FCA forms part of Phase 1 of the overall services. Phase 1 also includes preparation of Statements of Significance (SoS).

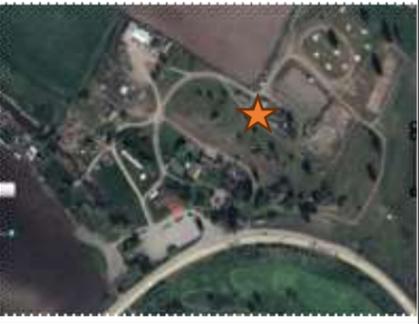
SPALLUMCHEEN PIONEER POWER CLUB DISPLAY #2

Other Names	Construction date unknown.	A					\$ -			
n/a		B			\$ 6,000		\$ 6,000			
Description	Pressure-treated pole barn. Cedar shake roof on engineered trusses. Houses tractor collection.	C					\$ -			
		D					\$ -			
		E					\$ -			
		F					\$ -			
		G					\$ -			
		Total			\$ -	\$ 6,000	\$ -	\$ 6,000		
Level 1	Level 2	Level 3	Assessment							
Major Group Elements	Group Elements	Individual Elements	Building Component	Condition	Comments	Recommended Action	Priority Ranking	Probable Cost

A Substructure	A10 Foundation	A1010 Standard Foundations	Pressure-treated embedded posts.	Fair	Water staining at base.	No Recommendation.	N/A	N/A		
		B1010 Floor Construction	Soil.		No comment on condition.	No Recommendation.	N/A	N/A		
	B Shell	B10 Superstructure	B1020 Roof Construction	Engineered trusses with steel tie downs. Pole barn construction with poles at 15' o/c.	Fair	Notched poles in bearing. Some cracking in beams and some poles checking.	Add new strap anchors. Continue monitoring for changes. See A1010 at buildings 28 & 29, B1020 at building 30, G2040 at building 36.	2B	\$ 6,000	
B30 Roofing			B3010 Roof Coverings	Cedar shake shingle roof with wood fascia and horizontal wood cladding at gable ends.	Poor	Shingles in fair to poor condition with some organic growth. Sheathing stained.	Roof replacement.	3C	See Roof Replacement and Maintenance Programs.	
D Services	D50 Electrical	D5010 Electrical Service & Distribution	100A single phase panel.	Good	Panel is located in weather protective wooden cabinet	No Recommendation.	N/A	N/A

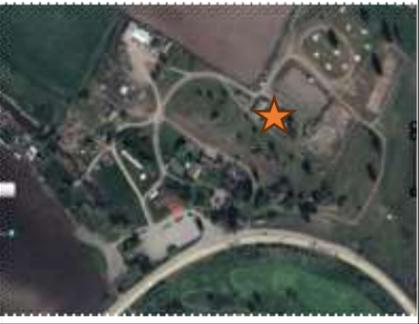
Implement Shed #1

Other Names	1981 constructed.	A				\$ 6,000	\$ 6,000				
Description	Wood post and beam barn with concrete footings and cedar shake roof. Open on the South side and livestock lean-to on North side. Board and batten siding on enclosed elevations.	B				\$ -	\$ -				
Level 1	Level 2	Level 3		Assessment							
Major Group Elements	Group Elements	Individual Elements		Building Component	Condition	Comments	Recommended Action	Priority Ranking			Probable Cost

A Substructure	A10 Foundation	A1010 Standard Foundations		Sono tube concrete footings with steel saddle connection to columns.	Good	Surface corrosion on steel connections.	Clean steel connection. See A1010 at building 29, B1020 at buildings 27 & 30, G2040 at building 36.	2D			\$ 6,000
B Shell	B10 Superstructure	B1010 Floor Construction		Soil.		No comment on condition.	No Recommendation.	N/A			N/A
		B1020 Roof Construction		Engineered trusses.	Good	No comment on condition.	No Recommendation.	N/A			N/A
	B20 Exterior Enclosure	B2010 Exterior Walls		Post and beam construction. Board and batten cladding.	Fair	Water staining around mid-height.	Landscape to provide 4" clearance between cladding and vegetation.	3E			See Landscaping Program.
	B30 Roofing	B3010 Roof Coverings	Cedar shake shingle roof with wood fascia.	Poor	Shingles curling and organic growth on North side. Fascia is in fair to poor condition.	Roof replacement.	3C	See Roof Replacement and Maintenance Programs.

D Services	D40 Fire Protection	D4030 Fire Protection Specialties	Fire extinguisher.	Fair	No comment on condition.	N/A	N/A	N/A			
	D50 Electrical	D5010 Electrical Service & Distribution	Local centre sub fed from SPPC #2.	Fair	Event receptacle load centre fed with cab-tire cable/cord cap OK on temporary basis.	No Recommendation.	N/A	N/A			
		D5020 Lighting and Branch Wiring	Lighting.		Switches but no lighting observed.	No Recommendation.	N/A	N/A			
G Sitework	G20 Site Improvements	G2040 Site Development	Post and beam shelter at back with concrete footing with steel saddle connection and sheet metal roof.	Fair	Some posts buried	Landscape to expose buried posts.	3D	See A1010.

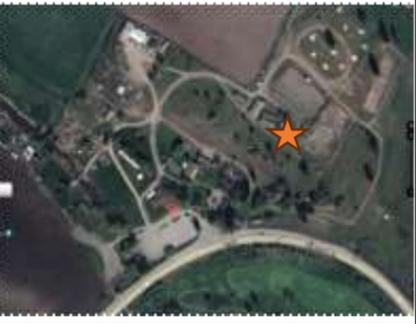
Implement Shed #2

Other Names	1950 constructed circa. Mid 1950s addition.	A				\$ 6,000	\$ 6,000			
Description	Wood post and beam barn with concrete foundation and cedar shake roof. Open on the South side and livestock holding lean-to on the North. Board and batten cladding on enclosed sides.	B				\$ -	\$ -			
		C				\$ -	\$ -			
		D				\$ -	\$ -			
		E				\$ -	\$ -			
		F				\$ -	\$ -			
		G				\$ -	\$ -			
		Total			\$ -	\$ -	\$ 6,000	\$ 6,000

Level 1	Level 2	Level 3	Assessment					
Major Group Elements	Group Elements	Individual Elements	Building Component	Condition	Comments	Recommended Action	Priority Ranking	Probable Cost
A Substructure	A10 Foundation	A1020 Special Foundations	18 concrete blocks with mix of posts bearing on concrete in some locations and steel saddle connection.	Good	Surface corrosion on steel connections.	Clean steel connection. See A1010 at building 28, B1020 at buildings 27 & 30, G2040 at building 36.	2D	\$ 6,000
B Shell	B10 Superstructure	B1010 Floor Construction	Soil.		No comment on condition.	No Recommendation.	N/A	N/A
		B1020 Roof Construction	Engineered trusses and 1x6 strapping.	Fair	No comment on condition.	No Recommendation.	N/A	N/A
	B20 Exterior Enclosure	B2010 Exterior Walls	8x8 post and beam construction with mix of board and batten and vertical wood plank cladding.	Fair	Cladding is aged.	No Recommendation.	N/A	N/A

B30 Roofing	B3010 Roof Coverings	Cedar shake shingle roof with wood fascia.	Poor	Substantial organic growth on North elevation. Sheathing stained. Fascia in very poor condition.	Roof replacement.	4C
G Sitework	G20 Site Improvements	G2040 Site Development	Post and beam lean-to at back for animals with concrete footings and steel saddle connection. Plywood cladding and sheet metal roof.	Poor	Plywood is aged.	No Recommendation under current use.	N/A	N/A
		G2050 Landscaping	Plantings at back corner.		Vegetation touches grade.	Landscape to provide clearance.	2E	See Landscaping Program.

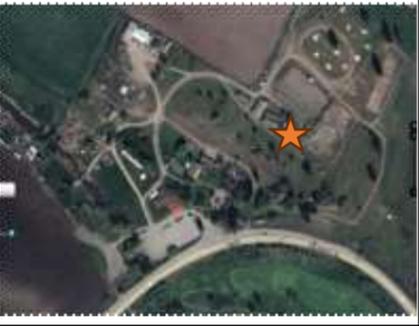
Tack Shed

Other Names	n/a			A				\$ -		
Description				B		\$ 6,000		\$ 6,000		
				C				\$ -		
				D				\$ -		
				E				\$ -		
				F				\$ -		
				G				\$ -		
			Total	\$ -	\$ 6,000	\$ -	\$ 6,000

Level 1	Level 2	Level 3	Assessment					
Major Group Elements	Group Elements	Individual Elements	Building Component	Condition	Comments	Recommended Action	Priority Ranking	Probable Cost
A Substructure	A10 Foundation	A1020 Special Foundations	Retrofit concrete piles with collar tie connection between post and pile and decorative rope.	Good	The connection is unconventional but appears to be sufficient.	No Recommendation.	N/A	N/A
B Shell	B10 Superstructure	B1010 Floor Construction	Slab on grade in tack room, else soil.	Good	No comment on condition.	No Recommendation.	N/A	N/A
		B1020 Roof Construction	Pole barn construction with notched pole in bearing acting as "beam" and some straps toe-nailed in at ends. Engineered wood trusses at 4'6" o/c in barn and wood rafters in tack room.	Fair	Normal weathering of poles.	Add new strap anchors. See A1010 at buildings 28 & , B1020 at building 27, G2040 at building 36.	2B	\$ 6,000

B20 Exterior Enclosure	B2010 Exterior Walls	Sheet metal cladding on tack room.	Good	No comment on condition.	No Recommendation.	N/A	N/A
		B2030 Exterior Doors	Wood frame OSB doors.	Good	No comment on condition.	No Recommendation.	N/A	N/A
	B30 Roofing	B3010 Roof Coverings	Sheet metal roof. Horizontal wood plank cladding on gable ends.	Fair	Debris on roof.	Clear roof.	1D	See Roof Maintenance Program.
		B3020 Roof Openings	Wood frame skylight in tack room.	Fair	No comment on condition.	No Recommendation.	N/A	N/A
C Interiors	C10 Interior Construction	C1030 Fittings	2-rail wood fence around perimeter.	Good	No comment on condition.	No Recommendation.	N/A	N/A
	C30 Interior Finishes	C3010 Wall Finishes	Painted plywood.	Good	No comment on condition.	No Recommendation.	N/A	N/A
		C3020 Floor Finishes	Painted plywood.	Good	No comment on condition.	No Recommendation.	N/A	N/A
G Sitework	G20 Site Improvements	G2050 Landscaping	Coniferous tree adjacent.		No comment on condition.	No Recommendation.	N/A	N/A

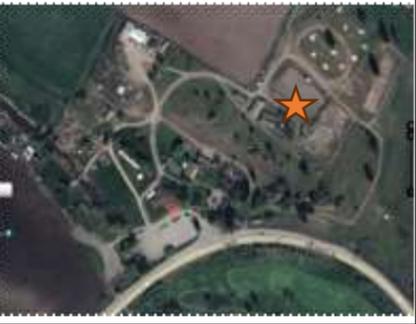
Corral

Other Names	Construction date unknown.	A					\$ -					
n/a		B					\$ -					
Description		C					\$ -					
5-rail pressure-treated wood fence, announcer, and decommissioned grandstand.		D					\$ -					
		E					\$ -					
		F					\$ -					
		G			\$ 10,000		\$ 10,000					
		Total		\$ -	\$ -	\$ -	\$ 10,000					
Level 1	Level 2	Level 3	Assessment									
Major Group Elements	Group Elements	Individual Elements	Building Component	Condition	Comments	Recommended Action	Priority Ranking	Probable Cost				
G Sitework	G20 Site Improvements	G2040.1 Site Development	Five rail fenced corral	Good	Rails are in good condition.	Maintain the rails under the fencing program	N/A	See Fence Program.

G2040.2 Site Development	Grandstand platform	Poor	Platform structure has signs of rotting. Seating has been removed.	Decommission or repair Platform and seating.	3B	\$ 10,000				
		G2040.3 Site Development	Announcer boot with PA System	Good	Announcer booth is in good condition. PA system is exposed to the elements.	Maintain and replace PA equipment (maintenance).	N/A	N/A

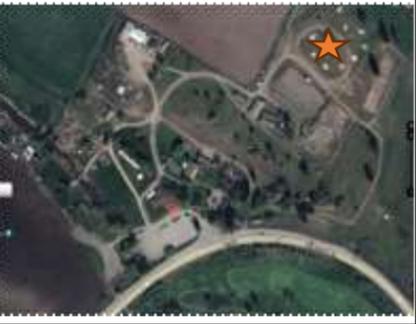
Glamping

n/a				B				\$ -		
Description				C				\$ -		
Newly installed glamping area. Includes nine glamping tents on wood platforms. Four compost toilettes are located in the center of the area. The area is enclosed by a post and rail fence.				D				\$ -		
		E					\$ -			
		F					\$ -			
		G					\$ -			
		Total		\$ -	\$ -	\$ -	\$ -			
Level 1	Level 2	Level 3		Assessment						
Major Group Elements	Group Elements	Individual Elements	Building Component	Condition	Comments	Recommended Action	Priority Ranking	Probable Cost		
A Substructure	A10 Foundation	A1010 Standard Foundations	Pre-cast concrete pedestals.	Good	No comment on condition.	No Recommendation.	N/A	N/A		
B Shell	B10 Superstructure	B1010 Floor Construction	Pressure treated wood platforms.	Good	No comment on condition.	No Recommendation.	N/A	N/A

B20 Exterior Enclosure	B2010 Exterior Walls	Tents were not reviewed.		No comment on condition.	No Recommendation.	N/A	N/A		
D Services	D20 Plumbing	D2010 Plumbing Fixtures	The water closets are a purpose-built composting type unit.	Fair	The system appears to be functional. Composting toilets are generally not considered a "high volume" system.	As the glamping site becomes more popular, the operator may need to add more toilet systems to keep up with demand.	N/A	N/A		
G Sitework	G20 Site Improvements	G2040 Site Development	Wood Gazebo and rail fence.	Good	No comment on condition.	No Recommendation.	N/A	N/A

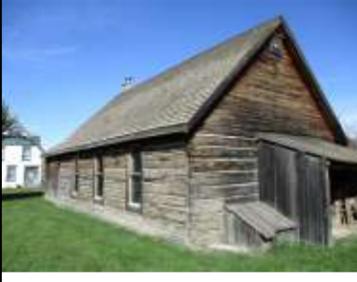
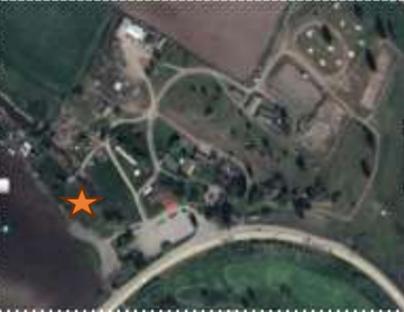
Balmoral School House

Other Names	1912 constructed. 1989 relocated.	A					\$ -			
n/a		B					\$ -			
Description		C					\$ -			
Single-storey log cabin with wood framed addition on front (West). Sloped cedar shake roof and concrete foundation wall. Wood doors and windows.		D					\$ -			
		E					\$ -			
		F					\$ -			
		G					\$ -			
		Total		\$ -	\$ -	\$ -				
Level 1	Level 2	Level 3	Assessment							
Major Group Elements	Group Elements	Individual Elements	Building Component	Condition	Comments	Recommended Action	Priority Ranking	Probable Cost		
A Substructure	A10 Foundation	A1010 Standard Foundations	Concrete foundation wall at main room.	Good	Foundation is in generally good condition.	No Recommendation.	N/A	N/A

A1020 Special Foundations	Permanent wood foundation at addition.	Good	Foundation is in generally good condition.	No Recommendation.	N/A	N/A		
	A20 Basement Construction	A2010 Basement Excavation	Crawlspace.		No comment on condition.	No Recommendation.	N/A	N/A		
B Shell	B10 Superstructure	B1010 Floor Construction	See A1010.	Good	See A1010.	No Recommendation.	N/A	N/A		
		B1020 Roof Construction	2x4 roof trusses.		Roof structure is in fair condition.	No Recommendation.	N/A	N/A		
	B20 Exterior Enclosure	B2010 Exterior Walls	V-notched split log and chinking in main room and 2x4 wood frame in addition. Horizontal drop wood siding at addition with wood corner cap.	Poor	Siding touches grade and is dirty. Some previous repairs and new rot at the main room. New chinking with insulation. Loose boards at addition.	Repair logs and chinking at rotted locations.	5D	See Cladding Program.		
		B2020 Exterior Windows	Wood frame hung and fixed windows.	Fair	Poor seals.	Repair seals.	3D	See Window and Door Program.

B2030 Exterior Doors	Wood door and frame.	Fair	No comment on condition.	No Recommendation.	N/A	N/A		
	B30 Roofing	B3010 Roof Coverings	Cedar shake shingle roof with wood fascia.	Poor	Organic growth on roof and fascia. Some previous metal patch repairs.	Roof replacement.	1C	See Roof Replacement and Maintenance Programs.		
B3020 Roof Openings		OSB and metal chimney.	Fair	No comment on condition.	No Recommendation.	N/A	N/A			
C Interiors	C10 Interior Construction	C1010 Partitions	Former exterior wall.	Fair	No comment on condition.	No Recommendation.	N/A	N/A		
	C30 Interior Finishes	C3010 Wall Finishes	1x6 wood plank.	Fair	No comment on condition.	No Recommendation.	N/A	N/A		
		C3020 Floor Finishes	Wood plank.	Fair	No comment on condition.	No Recommendation.	N/A	N/A		
		C3030 Ceiling Finishes	1x6 tongue and groove with center bead.	Fair	No comment on condition.	No Recommendation.	N/A	N/A

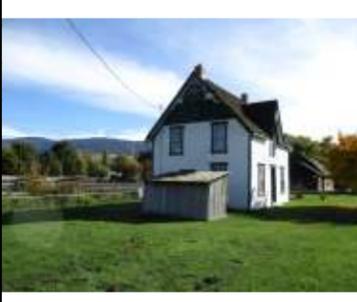
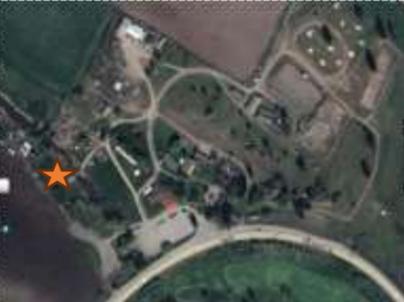
Schubert House

B Shell	B10 Superstructure	B1020 Roof Construction	Wood frame 2x6 at 16" o/c with skip sheathing.	Fair	No comment on condition.	No Recommendation.	N/A	N/A		
		B20 Exterior Enclosure	B2010 Exterior Walls	Split log construction. Horizontal drop cladding with strapping at 24" o/c and wood corner caps.	Fair	Paint is chipping and boards broken at base of wall. Some contact between siding and grade.	Landscape to provide 4" clearance between cladding and vegetation. Repair and paint cladding.	3D	See Landscaping and Cladding Programs.	
	B20 Exterior Enclosure	B2020 Exterior Windows	Wood frame single glazed hung windows with linseed oil glazing putty.	Poor	Uppers drooping and paint on sills chipping.	Repair and paint.	4D	See Window and Door Program.		
		B2030 Exterior Doors	Wood door and trim.	Fair	No comment on condition.	No Recommendation.	N/A	N/A		
	B30 Roofing	B3010 Roof Coverings	Cedar shake shingle roof with wood fascia. Decorative truss ends. Some insulation.	Fair	Truss tips missing in two locations. Paint on fascia is chipping. Shingles in fair condition.	Repair and paint fascia and replace truss tips.	3E	See Roof Replacement and Maintenance Programs.

B3020 Roof Openings	Two brick chimneys and box vents.	Fair	Mortar is starting to deteriorate and crack.	Roof replacement.	3C	See Roof Replacement and Maintenance Programs.		
C Interiors	C10 Interior Construction	C1010 Partitions	Woof frame.	Fair	No comment on condition.	Repoint mortar. <i>See B3020 at building 11.</i>	2C	\$ 5,000		
		C1020 Interior Doors	Wood doors and trim.	Poor	Trim in kitchen is damaged.	Repair trim (maintenance).	N/A	N/A		
	C20 Stairs	C2010 Stair Construction	Wood stair and rail.	Good	No comment on condition.	No Recommendation.	N/A	N/A		
	C30 Interior Finishes	C3010 Wall Finishes	Plaster and lath.	Poor	Some cracking and a hole in wall at north corner.	Repair or replace cladding and provide heating during winter. <i>See C3010 at building 4A.</i>	3E	\$ 14,000		
		C3020 Floor Finishes	Hardwood.	Fair	No comment on condition.	No Recommendation.	N/A	N/A		
		C3030 Ceiling Finishes	Generally lath and plaster except upstairs ceiling which is drywall	Poor	Cracking is extensive upstairs with a large section missing in the kitchen.	See C3010.	3E	See C3010.

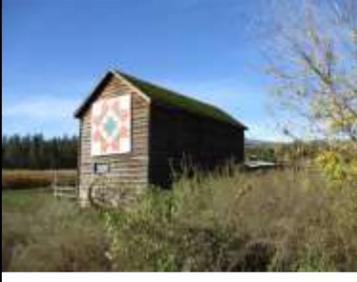
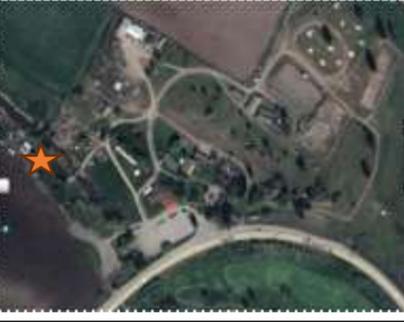
Schubert Barn

Other Names	1920 constructed circa. 1989 relocated.	A					\$ -			
n/a		B			\$ 8,000		\$ 8,000			
Description	Single-storey wood framed building. Wood door and windows. Leaning towards Deep Creek.	C					\$ -			
				D				\$ -		
				E				\$ -		
				F				\$ -		
				G				\$ -		
			Total	\$ -	\$ 8,000	\$ -	\$ 8,000			
Level 1	Level 2	Level 3	Assessment							
Major Group Elements	Group Elements	Individual Elements	Building Component	Condition	Comments	Recommended Action	Priority Ranking	Probable Cost

A Substructure	A10 Foundation	A1010 Standard Foundations	Concrete foundation wall with vapour barrier and crawlspace.	Fair	Vapour barrier extends 4' above grade.	No Recommendation.	N/A	N/A		
		A1030 Slab on Grade	Concrete slab foundation.	Fair	No comment on condition.	No Recommendation.	N/A	N/A		
B Shell	B10 Superstructure	B1010 Floor Construction	Wood frame.	Fair	No access to interior.	No Recommendation.	N/A	N/A		
		B1020 Roof Construction	Wood frame.	Poor	Leaning North-East towards Deep Creek.	Structural Assessment. See B1010 at building 11, B1020 at building 4A.	4C	\$ 8,000		
	B20 Exterior Enclosure	B2010 Exterior Walls	2x6 studs at 24" o/c. 1x9 drop siding, mostly horizontal and some vertical with wood corner caps.	Fair	Some broken siding boards and missing siding cap at some corners.	Repair cladding.	3D	See Program.		
		B2020 Exterior Windows	Wood framed windows with plexiglass panels.	Fair	Sills deteriorated at edges.	Repair trims.	1E	See Program.

B2030 Exterior Doors	Wood door and frame.	Fair	Stained at base.	Patch repair door.	1E	See Program.		
B30 Roofing	B3010 Roof Coverings	Cedar shake shingle roof with wood fascia.	Poor	Some missing shingles and organic growth. Some fascia missing.	Roof replacement.	3C	See Program.			
D Services	D50 Electrical	D5010 Electrical Service & Distribution	Circuit fed from house.	Fair	No comment on condition.	No Recommendation.	N/A	N/A		
G Sitework	G20 Site Improvements	G2040 Site Development	2-rail wood fence	Good	No comment on condition.	No Recommendation.	N/A	N/A		
		G2050 Landscaping	Vegetation on three sides and garden bed at front.	Fair	Vegetation touches grade.	No Recommendation.	N/A	N/A

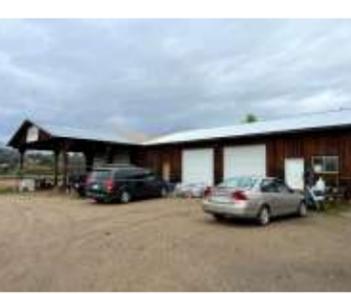
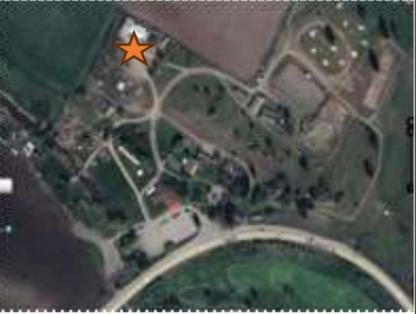
Spallumcheen Pioneer Power Club Clubhouse

B2030 Exterior Doors	5 garage doors (two with electric openers). Mix of wood and fiberglass doors, all wood frame.	Fair	Some garage doors not fully sealed and weather stripping weathered. Minor damage to garage doors.	No Recommendation.	N/A	N/A		
B30 Roofing	B3010 Roof Coverings	Sheet metal roof with wood fascia.	Fair	From various eras, previous patch on maintenance side. Vegetation on fascia.	No Recommendation.	N/A	N/A			
C Interiors	C10 Interior Construction	C1010 Partitions	Wood frame.	Good	No comment on condition.	No Recommendation.	N/A	N/A		
		C1020 Interior Doors	Wood door and frame.	Fair	No comment on condition.	No Recommendation.	N/A	N/A		
		C3010 Wall Finishes	Mix of painted plywood and drywall.	Fair	No comment on condition.	No Recommendation.	N/A	N/A		
	C30 Interior Finishes	C3030 Ceiling Finishes	Drywall.	Good	Failing at joints in SPPC garage.	Retape joints and repaint (maintenance).	N/A	N/A

D Services	D20 Plumbing	D2010 Plumbing Fixtures	Lavatories and water closets.	Fair	Lavatories and water closets are in fair condition but are still serviceable. The existing fixtures should provide good service for the near future.	No Recommendation.	N/A	N/A		
		D2020 Domestic Water Distribution	Original piping systems are copper.	Fair	The insulation is in poor condition or missing in certain locations. The domestic water piping should provide good service for the near future.	D2020.1 The operators should look for pinhole leaks from time to time.	3C	\$ 100		
						D2020.2 Consideration should be made for upgrades to the existing insulation to save energy.	1E	\$ 500		
D2030 Sanitary Waste	Sanitary waste systems are not visible.	Fair	Based on the age of the building, sanitary drainage piping should provide good service for the near future.	The system is at an age where blockages could occur, so should be inspected and cleaned from time to time. Repairs if needed could be completed for the location at hand. There is no need for wholesale piping upgrades in the near future.	3D	\$ 300

D Services	D20 Plumbing	D2090 Other Plumbing Systems	Domestic Water Heater	Poor	The Domestic hot water heater is nearing the end of its service life and is need of replacement. This gas fired appliances has not been installed in a room that is fire rated. The Water heater has not been provided with a drain pan.	D2090.1 The domestic water heater should be replaced soon.	4C	\$	5,500
					D2090.2 Consideration should be made to provide the water heater with a drain pan to catch and direct the water to a drainage system, in the event of a leak in the tank.	4C	\$	500	
					D2090.3 Consideration should be made to build a fire rated room that would house the domestic water heater.	2B	\$	10,000	
	D30 HVAC	D3020 Heat Generating Systems	Furnace	Poor	Gas piping does not appear to have the appropriate protective coatings.	The owner will want to engage a technician to ensure the systems are configured to code.	2C	\$	500

D5090 Other Electrical Systems	Emergency lighting.	Fair	Minimal emergency lighting installed.	Test emergency lighting regularly.	2D		N/A
G Sitework	G20 Site Improvements	G2040 Site Development	Lean-tos around building of post and beam and pole barn construction with buried post footings and sheet metal roofs. Front shelter of pressure treated post and beam construction with engineered trusses at 4' o/c. Posts tied to main building.	Fair	One rotted pole at lean-tos. North lean-to roof failed at south corner.	Support and provide new pedestal at rotted poles. Patch roof. See A1010 at buildings 28 & 29, B1020 at buildings 27 & 30.	4D	\$	6,000
		G2050 Landscaping	Vegetation on 3 sides and garden bed at front.	Fair	No comment on condition.	Landscape to provide clearance between cladding and vegetation.	N/A		See Program.

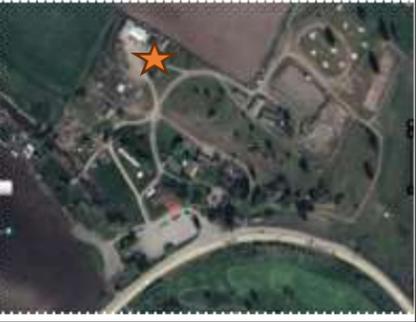
Storage Shed

B1020 Roof Construction	Pole barn with notched poles in bearing for beams and engineered trusses at 2' o/c.	Fair	Condition commensurate of its age.	No Recommendation.	N/A	N/A		
	B30 Roofing	B3010 Roof Coverings	Cedar shake shingle roof with wood fascia. Plywood sheathing on gable ends.	Poor	Staining underside of soffit. Sheathing missing on South elevation. Shingles missing loose and curled. Fascia missing in some locations.	Roof replacement.	5D	See Roof Replacement and Maintenance Programs.		
C Interiors	C10 Interior Construction	C1030 Fittings	Wood racks for storage.	Fair	No comment on condition.	No recommendation.	N/A	N/A		
G Sitework	G20 Site Improvements	G2050 Landscaping	Vegetation surrounding.	Fair	No comment on condition.	No Recommendation.	N/A	N/A

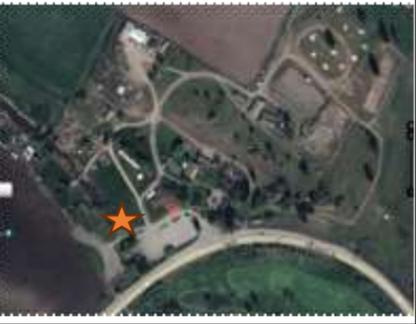
Decommissioned Vehicle Bridge

n/a				B	\$ 125,000						\$ 125,000
Description				C							\$ -
Single span timber bridge. Log stringers bear on log sills and gabion abutments.				D							\$ -
		E						\$ -			
		F						\$ -			
		G						\$ -			
		Total		\$ 125,000	\$ -	\$ -					
Level 1	Level 2	Level 3		Assessment							
Major Group Elements	Group Elements	Individual Elements	Building Component	Condition	Comments	Recommended Action	Priority Ranking	Probable Cost			
A Substructure	A10 Foundation	A1010 Standard Foundations	Stone Gabion abutments.	Fair	No comment on condition.	No Recommendation.	N/A	N/A			
B Shell	B10 Superstructure	B1010 Floor Construction	Log stringers. And wood deck.	Poor	Deflected at midspan. Rotted beams and deck.	Decommission and dispose of bridge.	4B	\$ 125,000

F Special Construction & Demolition	F10 Special Construction	F1010 Special Structures	Guard logs	Poor	Signs of impact damage and not marked.	See B1010.		See B1010.

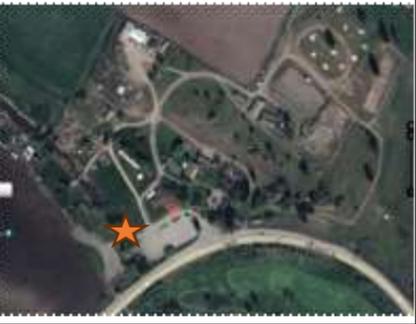
Log Foot Bridge

n/a				B				\$ -		
Description				C				\$ -		
Single span timber bridge. Log stringers bear on log sills and no visible abutments.				D				\$ -		
		E					\$ -			
		F					\$ -			
		G					\$ -			
		Total		\$ -	\$ -	\$ -	\$ -			
Level 1	Level 2	Level 3		Assessment						
Major Group Elements	Group Elements	Individual Elements	Building Component	Condition	Comments	Recommended Action	Priority Ranking	Probable Cost		
A Substructure	A10 Foundation	A1010 Standard Foundations	Log Sills	Fair	No comment on condition.	No Recommendation.	N/A	N/A		
B Shell	B10 Superstructure	B1010 Floor Construction	Log stringers. And wood deck.	Poor	Deflected at midspan. Rotted beams and deck.	Decommission Bridge	N/A	N/A

F Special Constnution & Demolition	F10 Special Construction	F1010 Special Structures	Guard logs	Poor	Signs of impact damage and not marked.	Decommission Bridge	N/A	N/A

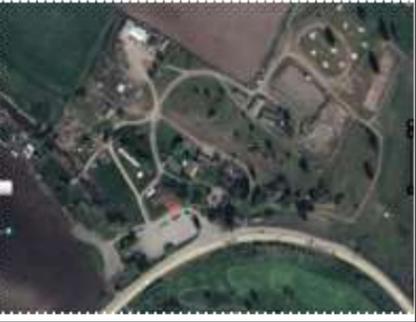
Other Names		Unknown		A				\$ -		
Animal Feed Buildings				B				\$ -		
Description				C				\$ -		
Small Buildings consist of feed buildings, wood storage wayfinding buildings and small shed coverings.				D				\$ -		
				E				\$ -		
				F				\$ -		
				G				\$ -		
				Total	\$ -	\$ -	\$ -			
Level 1	Level 2	Level 3	Assessment							
Major Group Elements	Group Elements	Individual Elements	Building Component	Condition	Comments	Recommended Action	Priority Ranking	Probable Cost		
A Substructure	A10 Foundation	A1010 Standard Foundations	Wood foundations	Good	Foundation types vary by building but are in generally good condition.	Monitor and repair foundations as required.	3E	See Cladding Program.

B Shell	B30 Roofing	B3010 Roof Coverings	Varied Roofs	Good	Roof types vary by building but are in generally good condition.	Monitor and repair roofs as required.	3E	See Roof Maintenance Program.		
G Sitework	G20 Site Improvements	G2050 Landscaping	Some buildings surrounded by vegetation.	Fair	Where vegetation touches wood building elements they are at risk of rot.	Landscape to provide 4" clearance between wood members and vegetation.	N/A	See Landscaping Program.

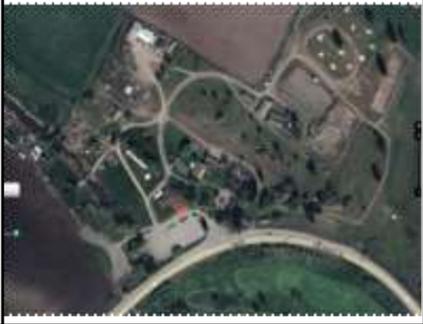
Parking Lot and Roads

Other Names	n/a		A				\$ -	
Description	Asphalt parking lot in front of the Visitor Center and O'Keefe Mansion. Dirt Roads are found through out the site.		B				\$ -	
			C				\$ -	
			D				\$ -	
			E				\$ -	
			F				\$ -	
			G				\$ -	
		Total	\$ -	\$ -	\$ -			
Level 1	Level 2	Level 3	Assessment					
Major Group Elements	Group Elements	Individual Elements	Building Component	Condition	Comments	Recommended Action	Priority Ranking	Probable Cost
G Sitework	G20 Site Improvements	G2010 Roads	Dirt Roads	Good	No comment on condition.	No Recommendation.	N/A	N/A
		G2020 Parking Lots	Asphalt Parking Lot in front of the Visitor Center	Fair	Lateral and alligator cracking found throughout. Pot holes developing. Parking line paint has worn off.	Repair potholes and slope surface to drainage.		See Road Maintenance Program.

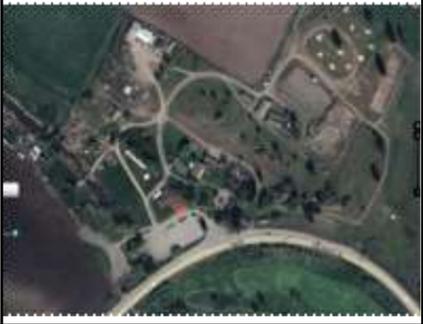
Fences

Other Names	n/a		A				\$ -	
Description	Wood rail, barbed wire, smooth wire, chicken wire, picket and metal rail fences can be found through out the complex.		B				\$ -	
			C				\$ -	
			D				\$ -	
			E				\$ -	
			F				\$ -	
			G				\$ -	
		Total	\$ -	\$ -	\$ -			
Level 1	Level 2	Level 3	Assessment					
Major Group Elements	Group Elements	Individual Elements	Building Component	Condition	Comments	Recommended Action	Priority Ranking	Probable Cost
G Sitework	G20 Site Improvements	G2040 Site Development	Fencing	Fair	The fencing is an a functioning state but requires a continued maintenance program to continue to operate.	Fence Maintenance Program	5D	See Fence Maintenance Program.

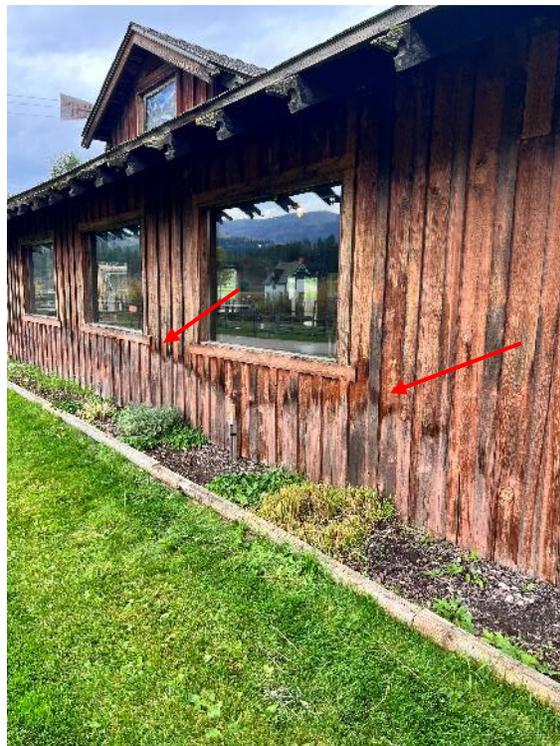
Photo 3

1: Visitor Center:
Typical water staining on cladding near garden beds.

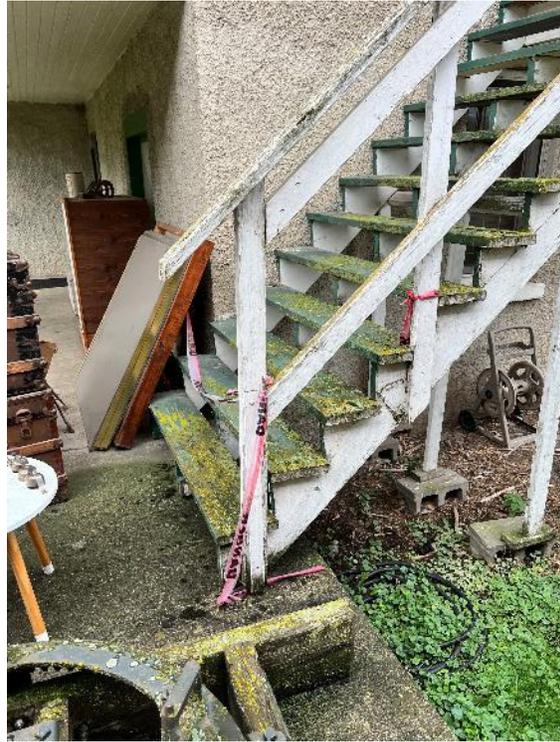
Photo 6

2: Greenhow Museum:
Decommissioned back emergency exit stair.

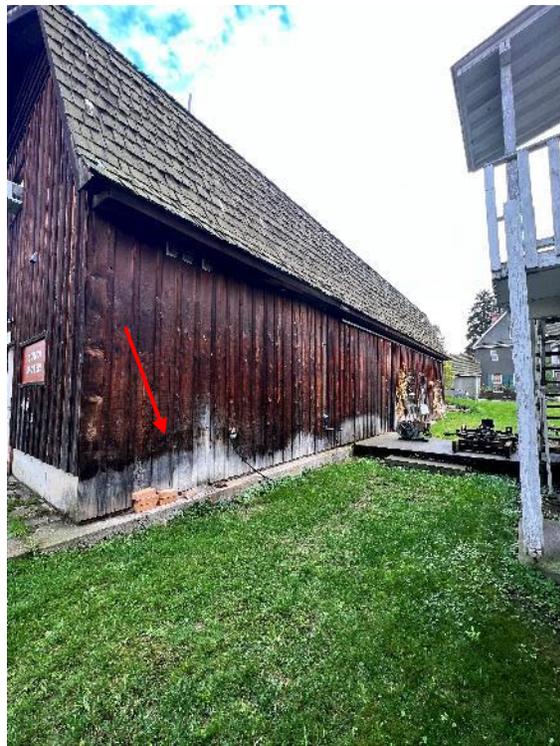
Photo 13

3: Stagecoach Depot:
Typical water-stained cladding at base of wall.

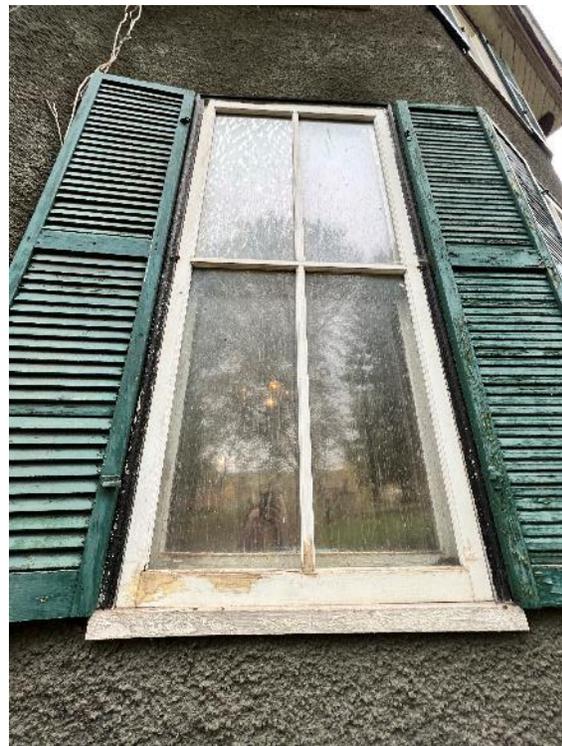
Photo 19

4A: O'Keefe House:
Typical condition of windows and shutters.

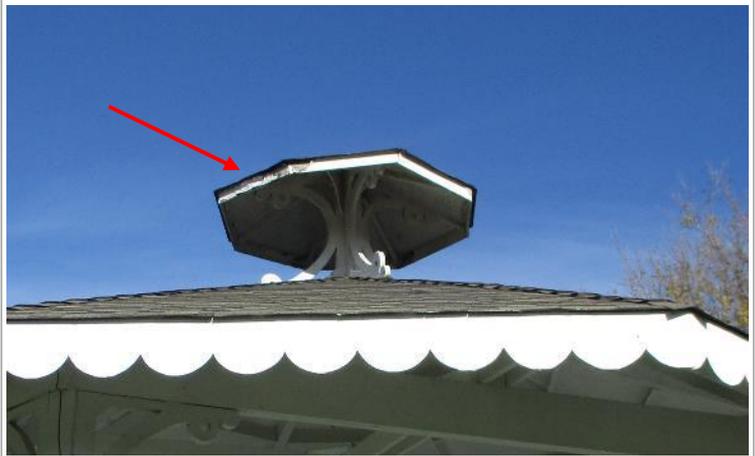
Photo 27

6: Gazebo:
Deteriorated fascia at cupola.

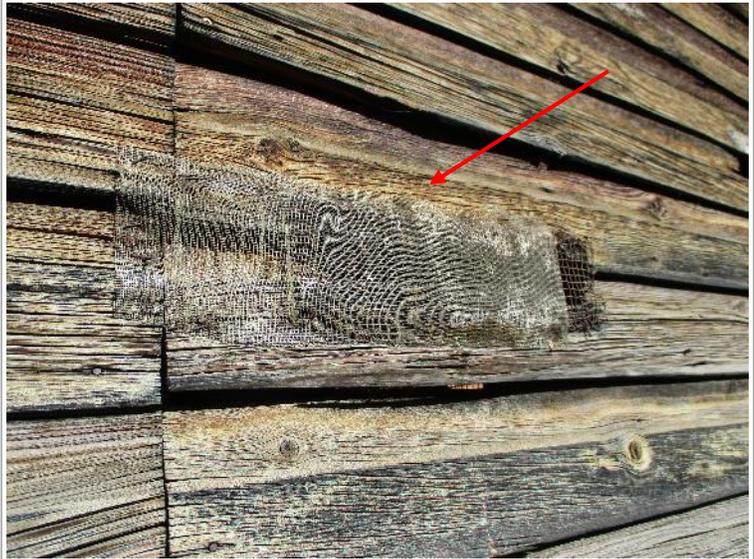
Photo 32

8: Cowboy Bunkhouse:
Mesh cladding patch.

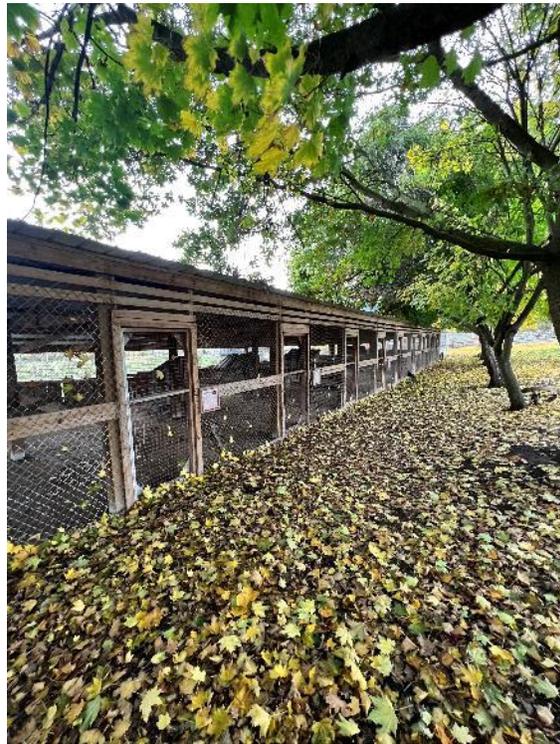
Photo 33

9: Bird Pens:
General view of North elevation.

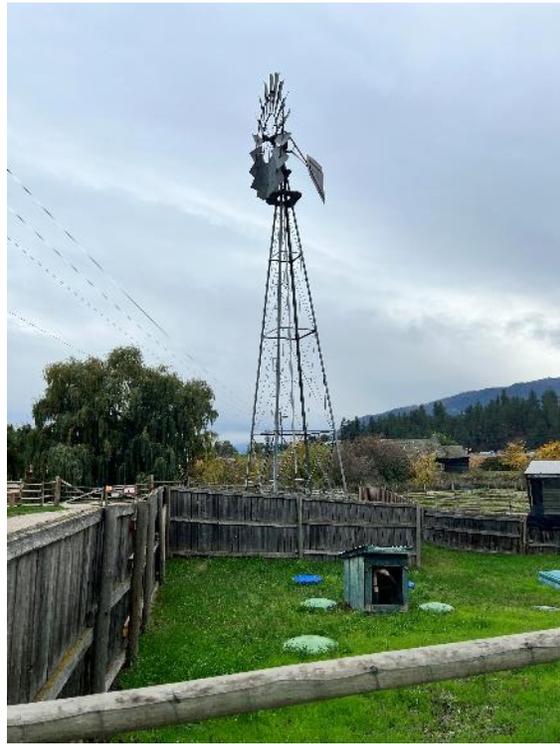
Photo 34

10: Windmill #1:
General view.

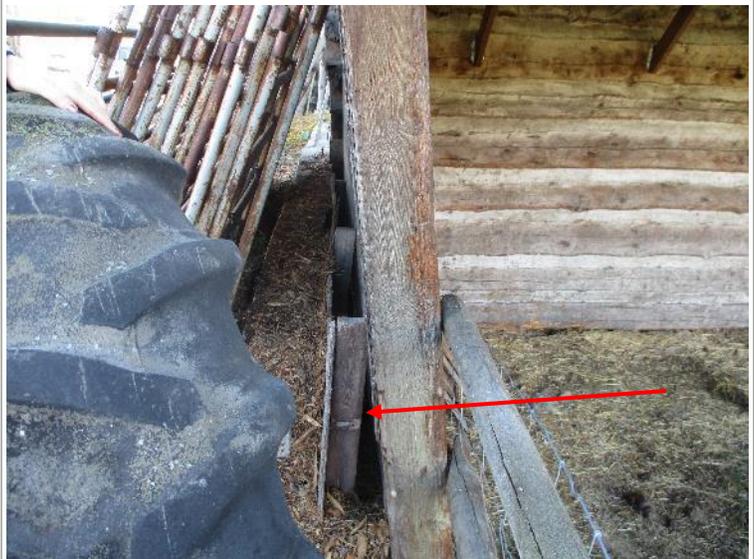
Photo 37

11: Log Barn:
Heaved out wood retaining wall.

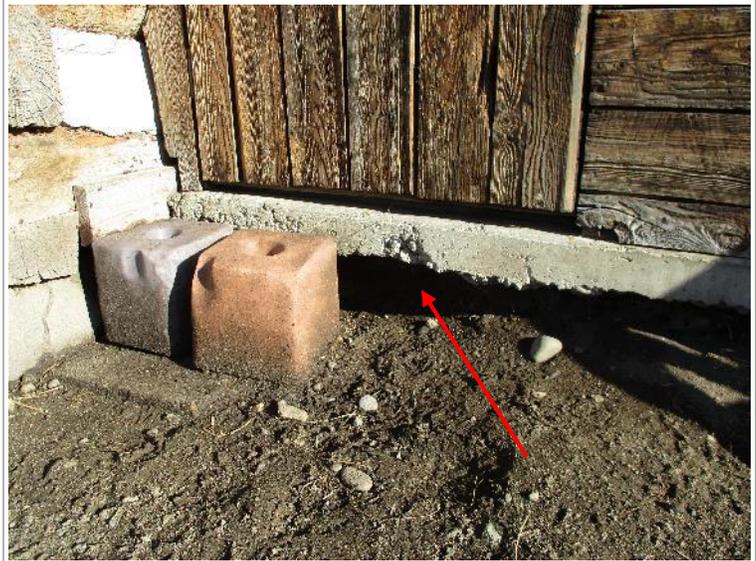
Photo 38

11: Log Barn:
Concrete slab at East lean-to.

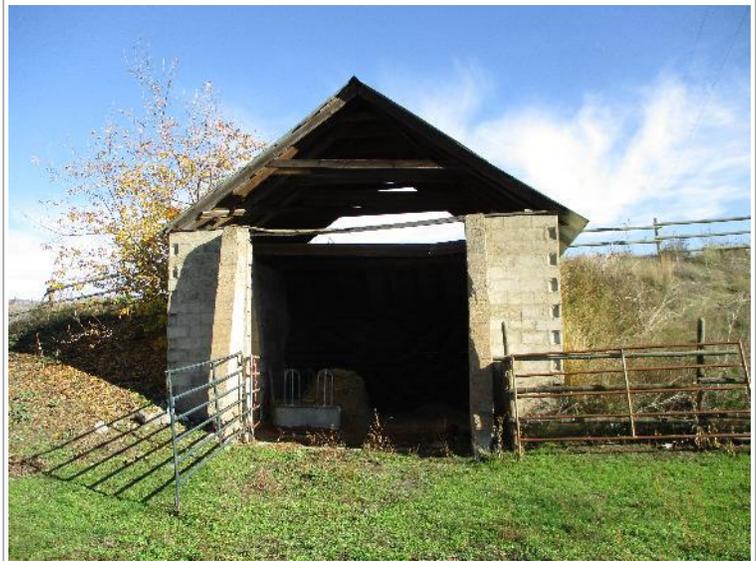
Photo 39

12: Hay Shed:
General view of South elevation.

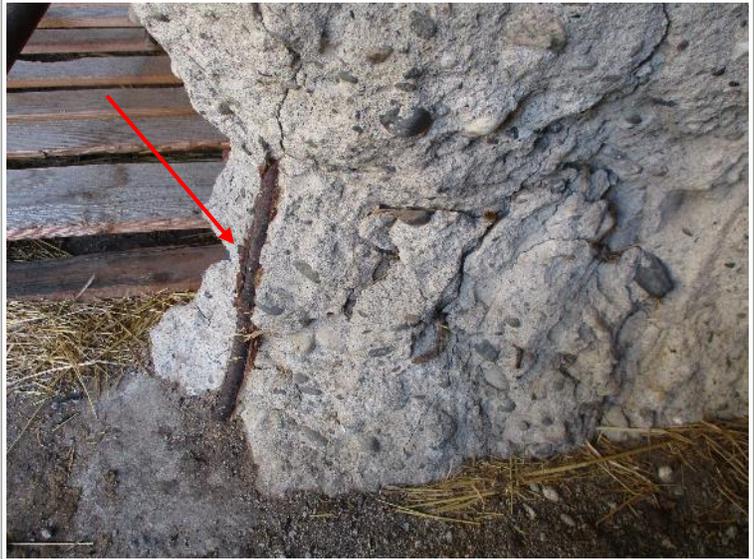
Photo 40

12: Hay Shed:
Eroded concrete and exposed rebar.

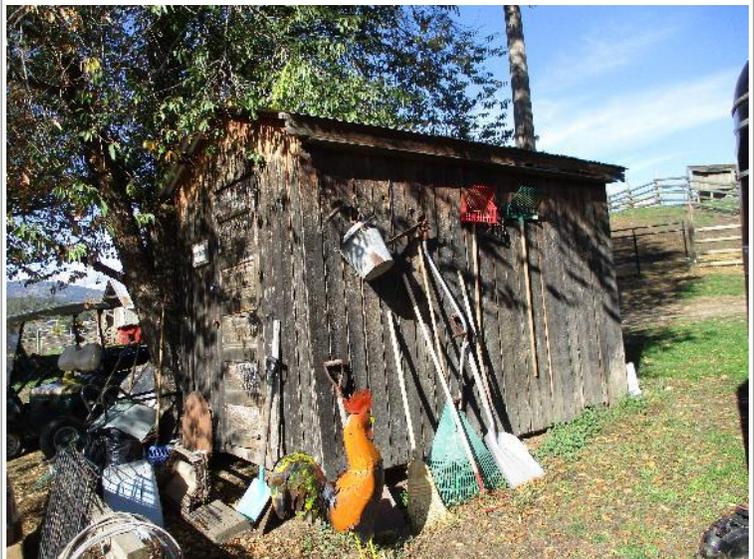
Photo 41

13: Ye Ol' Feed Shed:
General view of South corner.

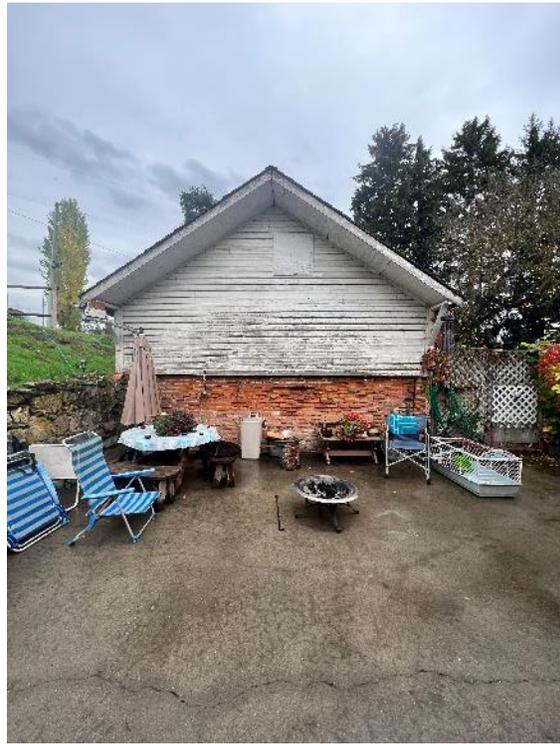
Photo 42

14: Meat & Dairy:
General view of West elevation.

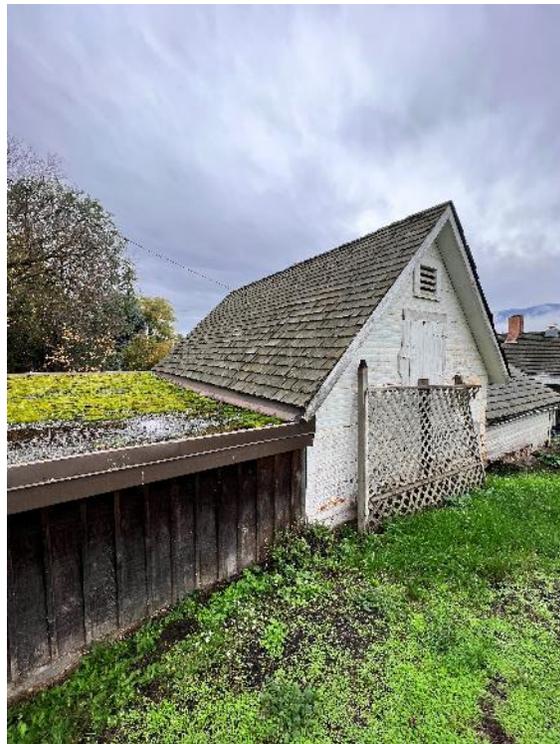
Photo 43

14: Meat & Dairy:
General view of North elevation.

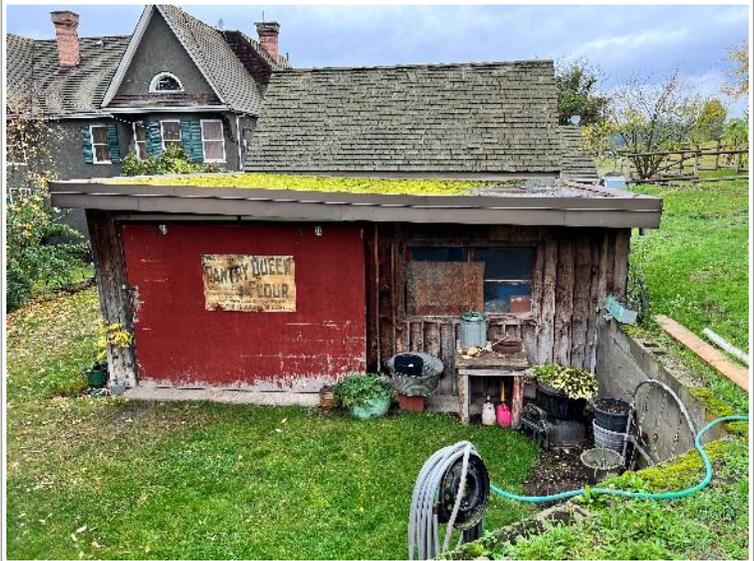
Photo 44

14: Meat & Dairy:
General view of East elevation.

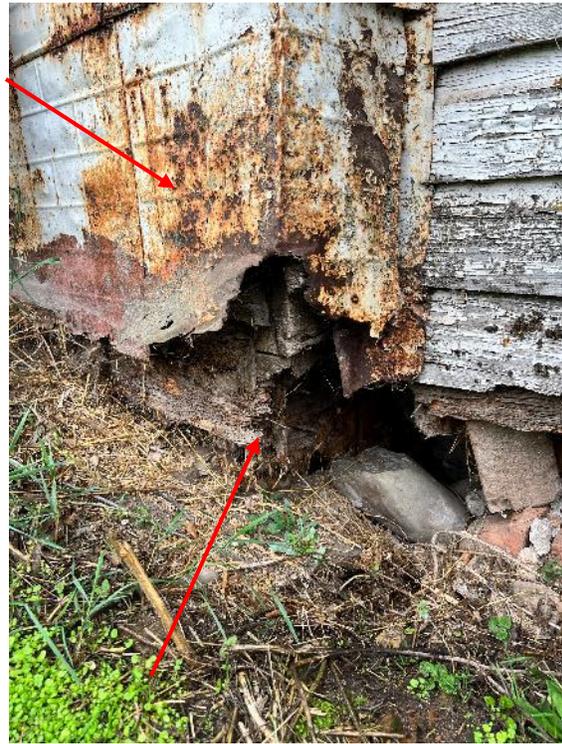
Photo 46

14: Meat & Dairy:
Corroded cladding and rotten structure at
North elevation.

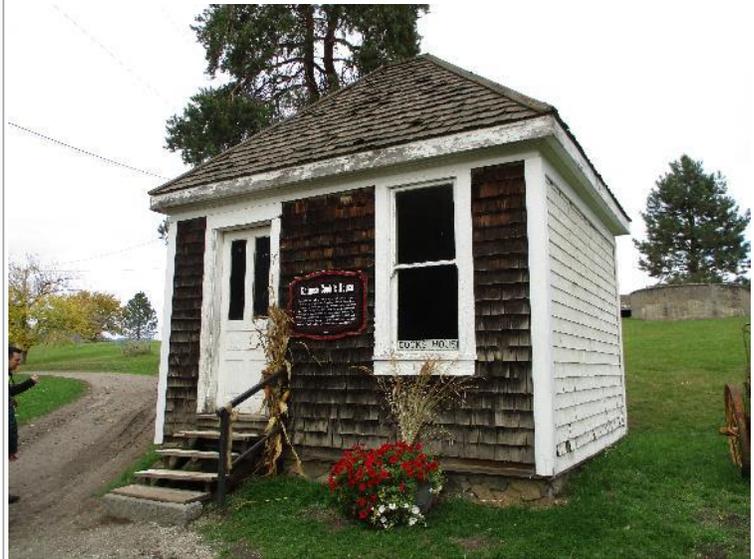
Photo 47

15: Chinese Cook's House:
General view of South elevation.

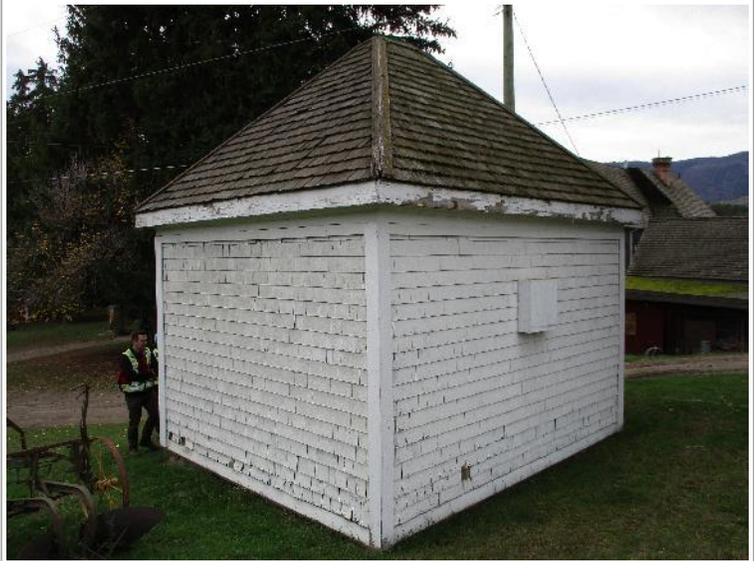
Photo 48

15: Chinese Cook's House:
General view of North-West corner.

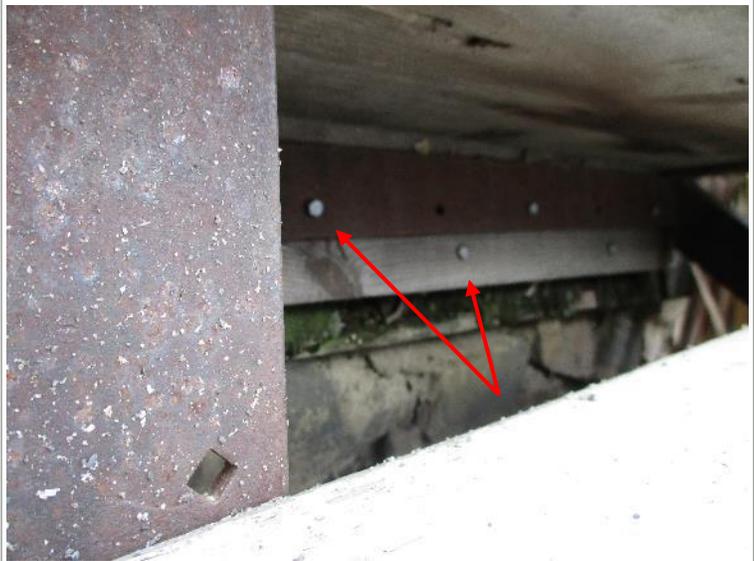
Photo 49

15: Chinese Cook's House:
Stair is nailed to cladding at top.

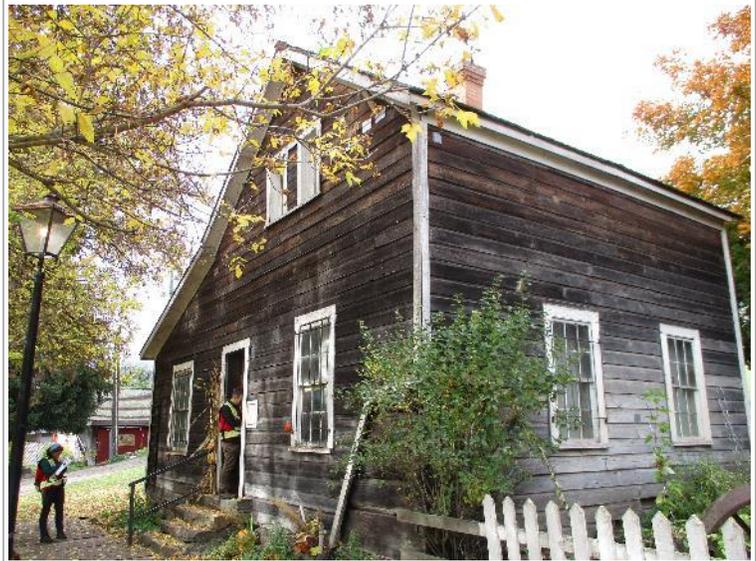
Photo 50

16: Log House:
General view of South-East corner.

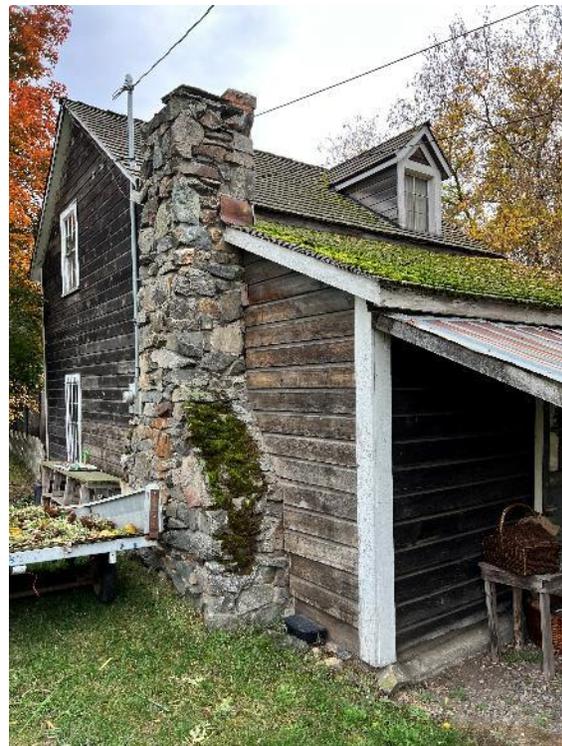
Photo 51

16: Log House:
General View of North elevation and roofs.

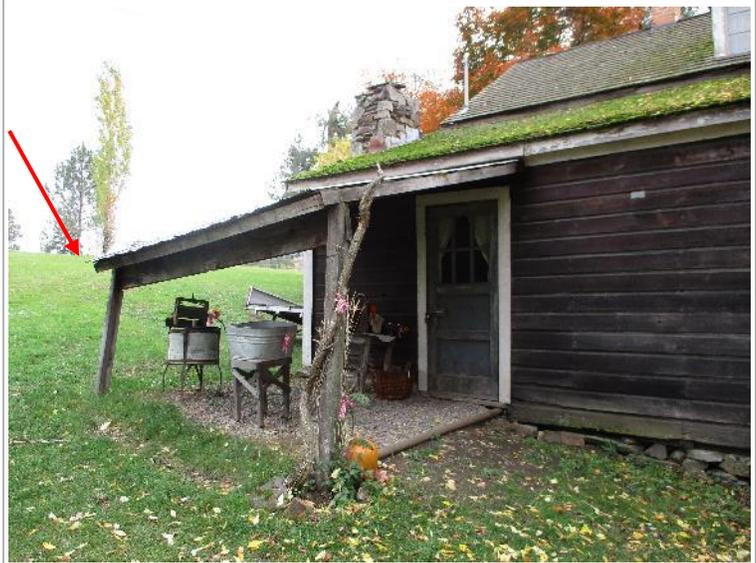
Photo 52

16: Log House:
Low edge of sheet metal lean-to roof.

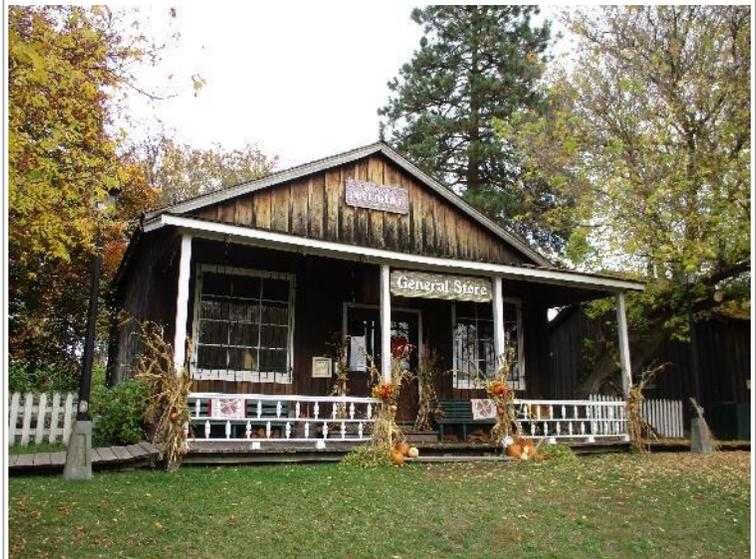
Photo 53

17: General Store:
General view of South elevation.

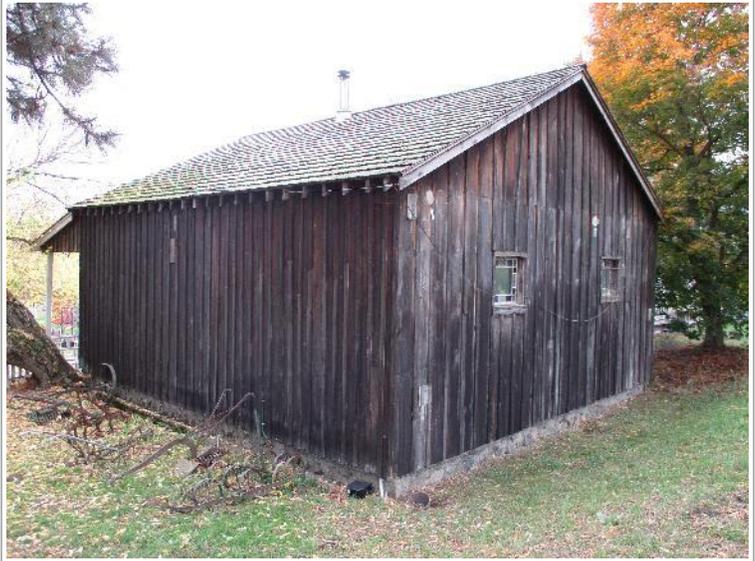
Photo 54

17: General Store:
General view of North-East corner.

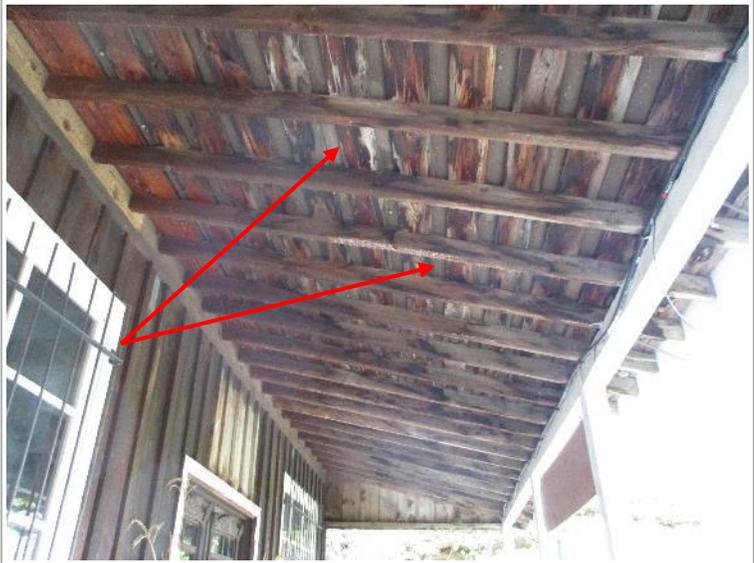
Photo 56

17: General Store:
Water-stained soffit.

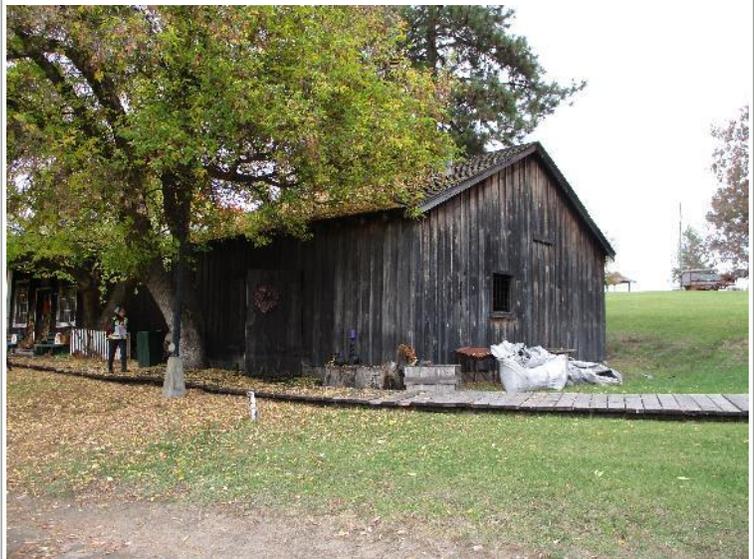
Photo 57

18: Blacksmith Shop:
General view of South-East corner.

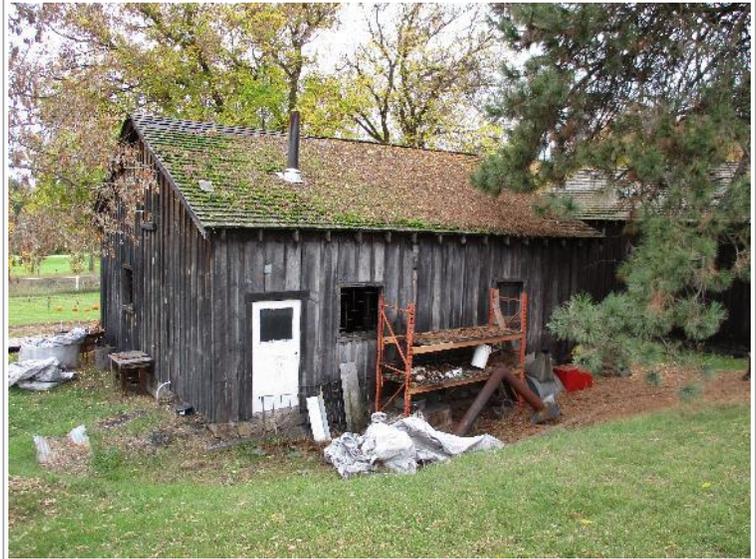
Photo 58

18: Blacksmith Shop:
General view of North elevation and roof.
