THE CORPORATION OF THE CITY OF VERNON REPORT TO COUNCIL

SUBJECT: HISTORIC O'KEEFE RANCH FACILITY CONDITION ASSESSMENT

Facility Condition Assessment

At the City of Vernon's request Read Jones Christoffersen Ltd. (RJC) has completed a Facility Condition Assessment (FCA) at the Historic O'Keefe Ranch located at 9380 BC-97 near Vernon, BC per our proposal dated September 14, 2023. The FCA forms part of Phase 1 of the overall services. Phase 1 also includes preparation of Statements of Significance (SoS).

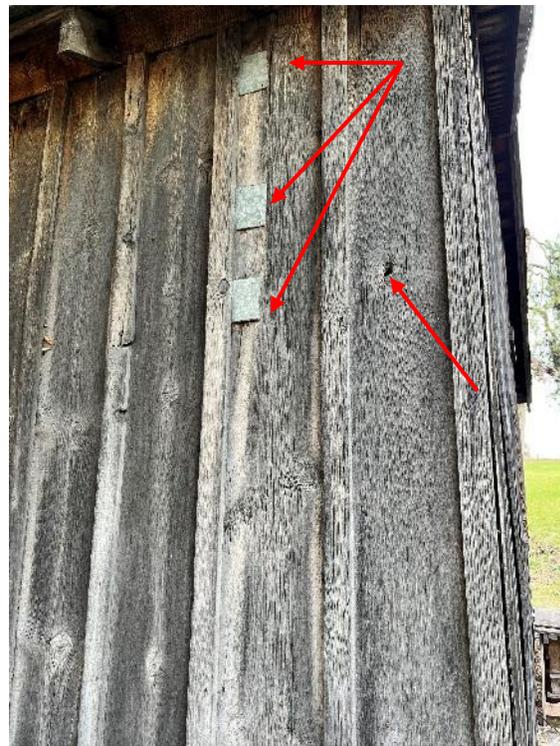
Photo 59

18: Blacksmith Shop:
Woodpecker hole and previous metal patches.

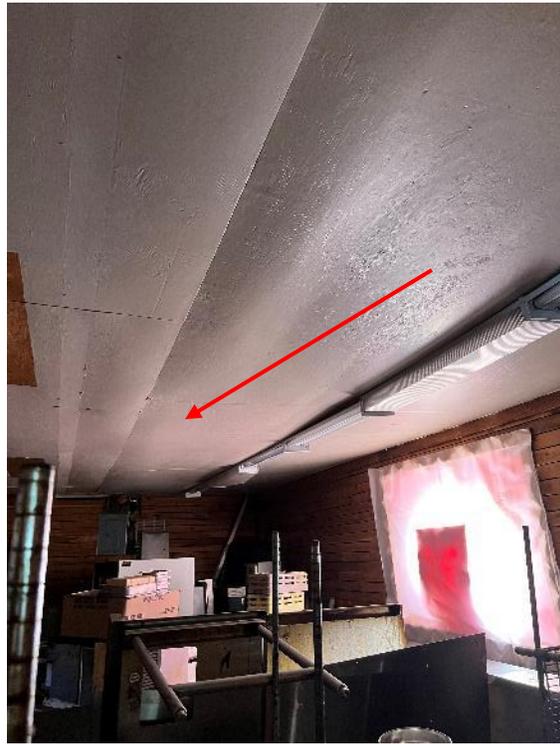
Photo 62

19: Red Shed:
Deflected ceiling in East room.

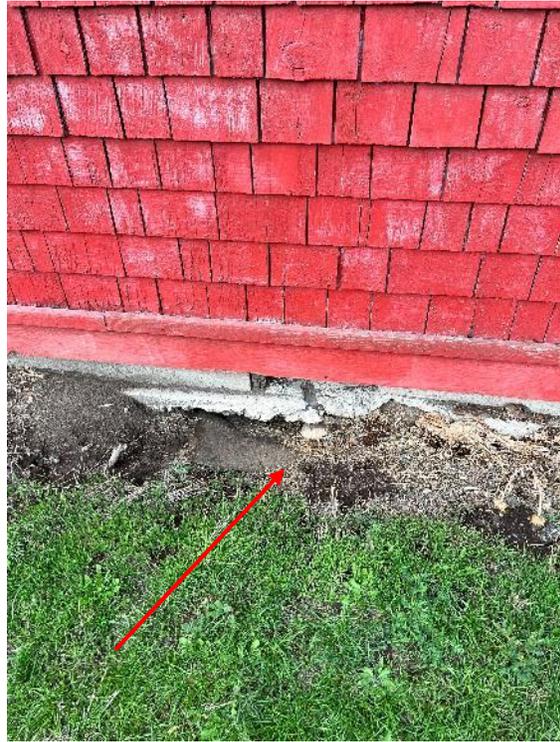
Photo 64

20: Carriage Shed:
Undermined foundation at South elevation.

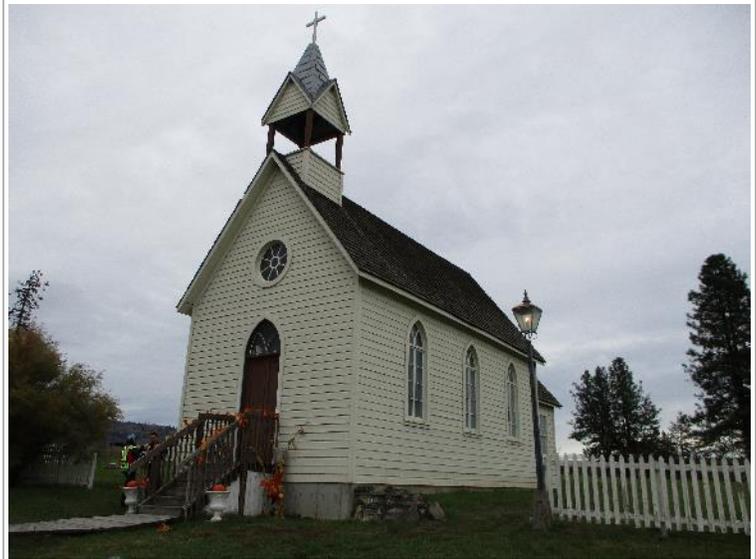
Photo 65

21: St. Anne's Church:
General view of South and East elevations.

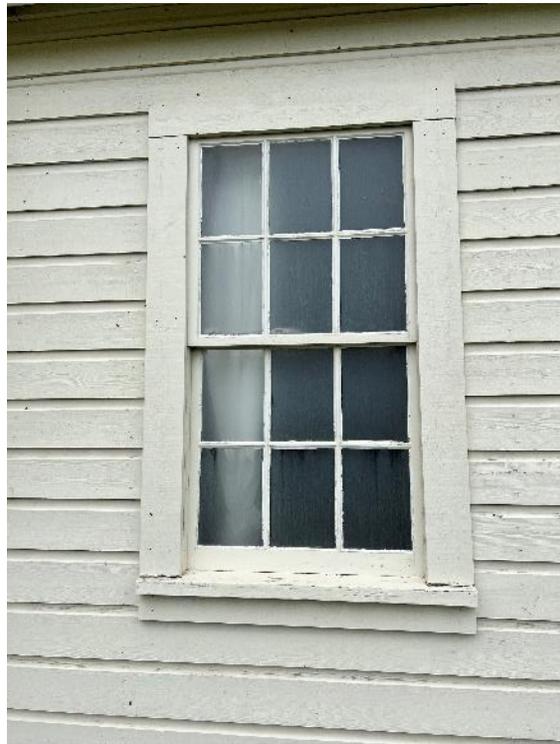
Photo 67

21: St. Anne's Church:
Typical condition of windows.

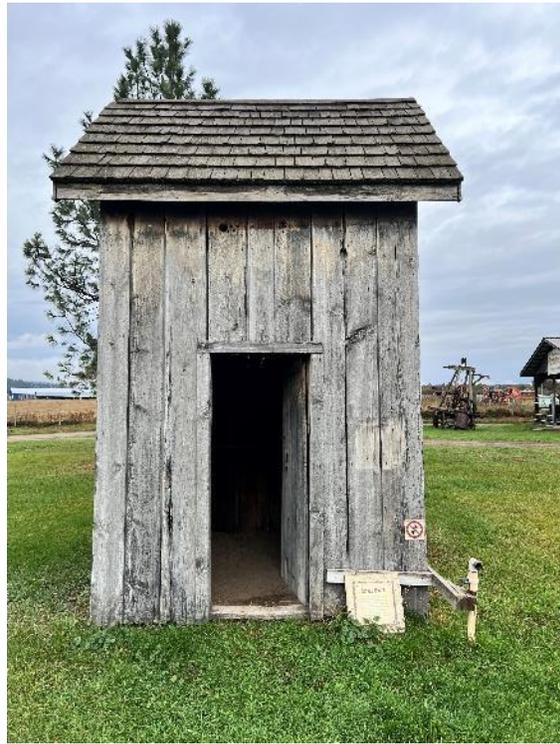
Photo 68

22: Smoke House:
General view of South elevation.

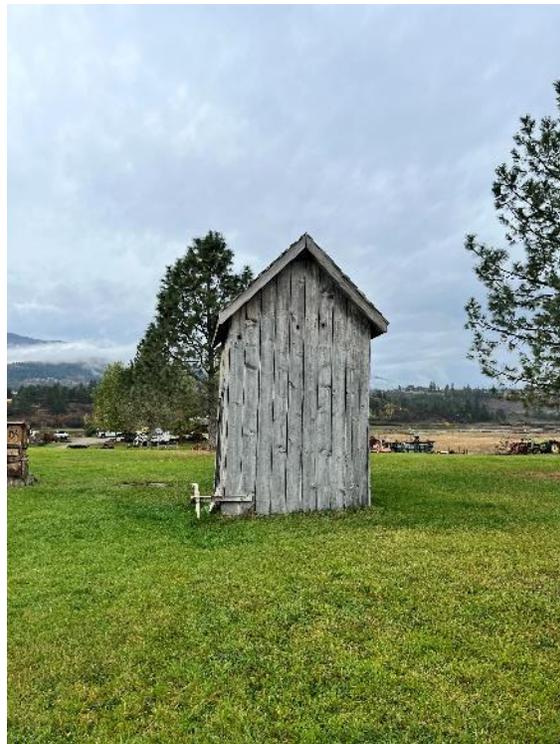
Photo 69

22: Smoke House:
General view of North elevation.

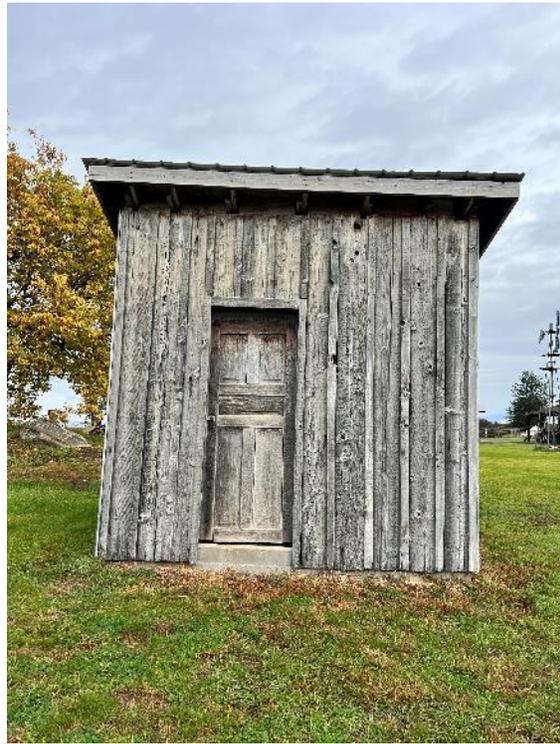
Photo 70

23: Pump House:
General view of South elevation.

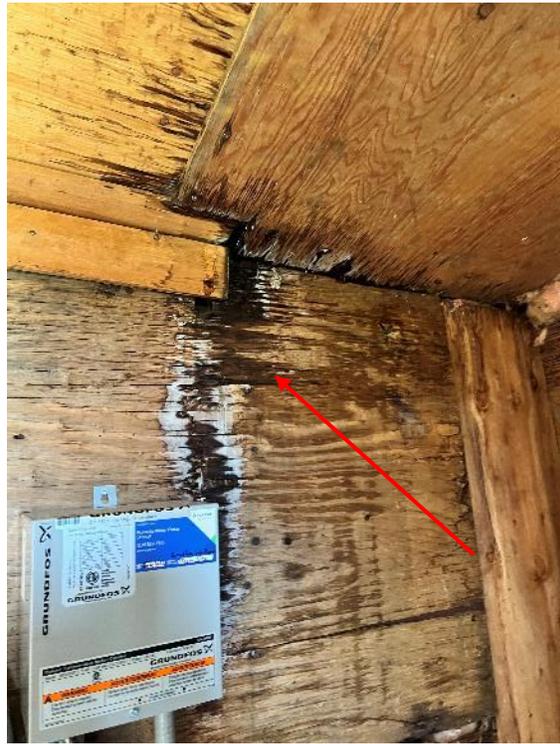
Photo 72

23: Pump House:
Interior water staining.

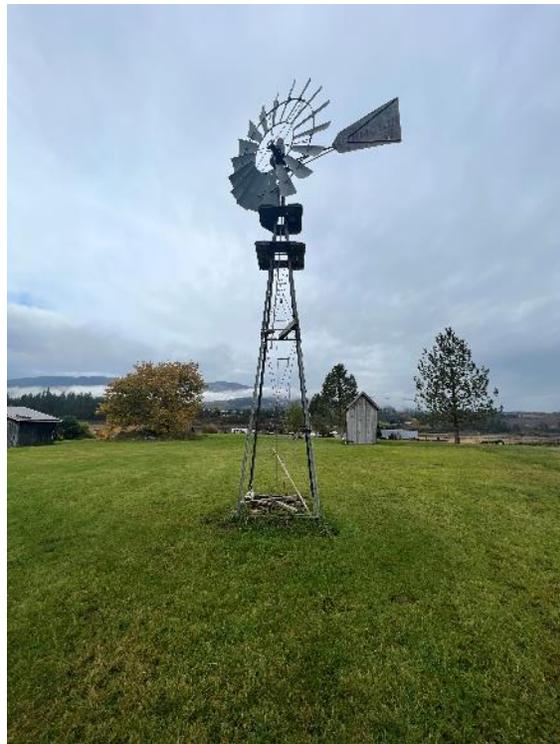
Photo 73

24: Windmill #2:
General View.

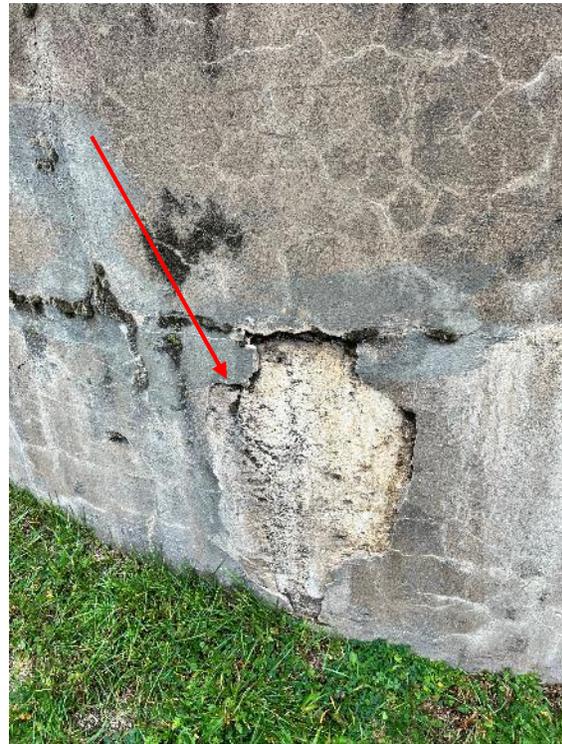
Photo 75

25: Water Cisterns:
Spalled parging at East uncovered cistern.

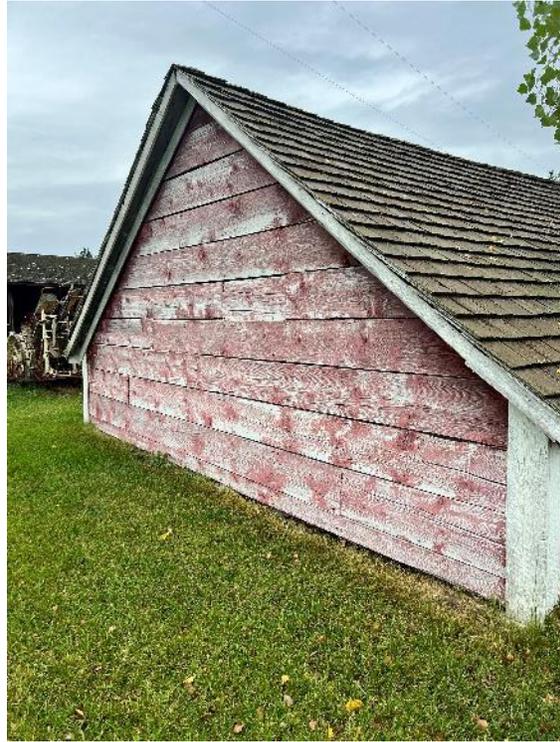
Photo 76

25: Water Cisterns:
General view of West covered cistern South
elevation of cover.

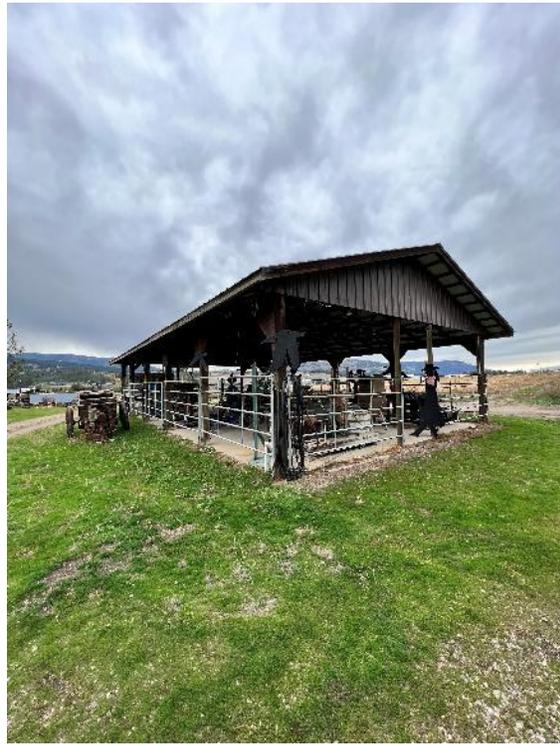
Photo 78

26: Spallumcheen Pioneer Power Club
Display #1:
General view from South-East corner.

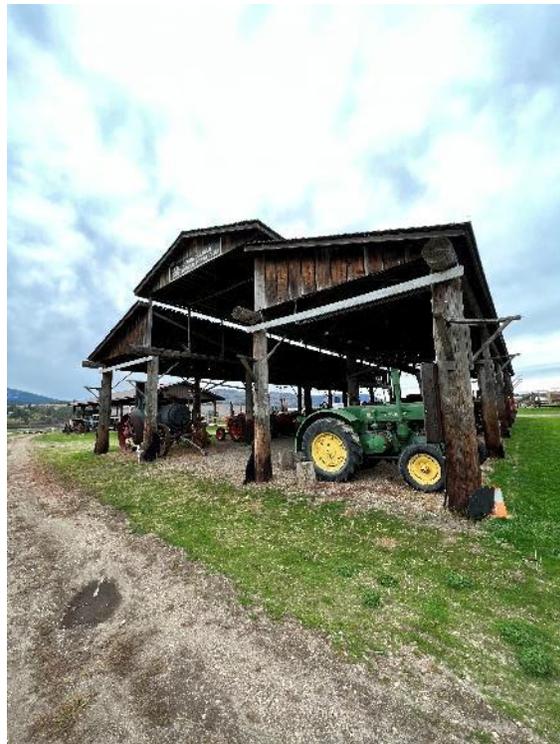
Photo 79

27: Spallumcheen Pioneer Power Club
Display #2:
General view from South elevation.

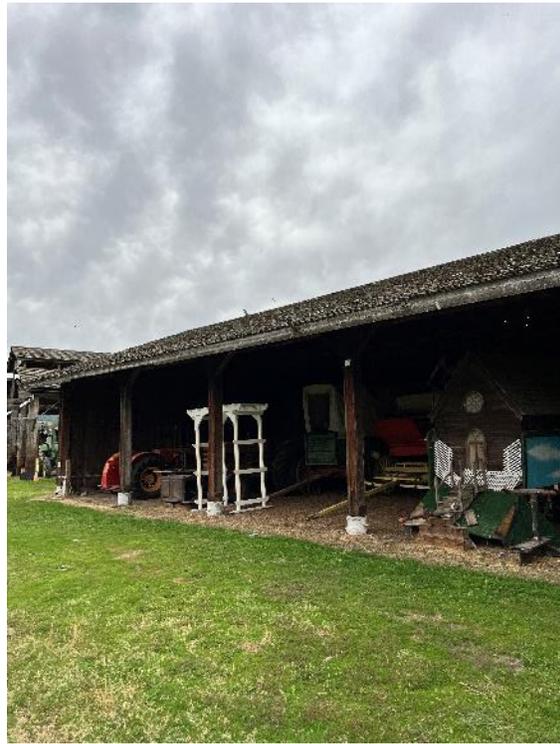
Photo 81

28: Implement Shed #1:
General view of South elevation.

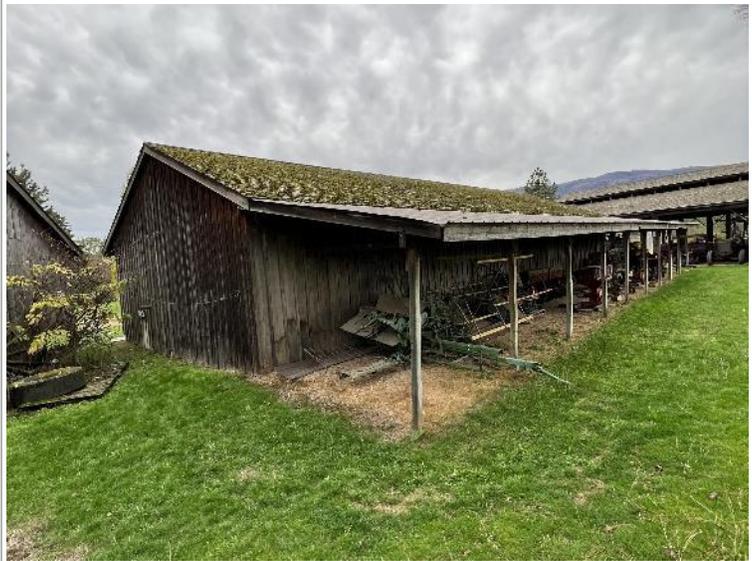
Photo 82

28: Implement Shed #1:
General view of North elevation.

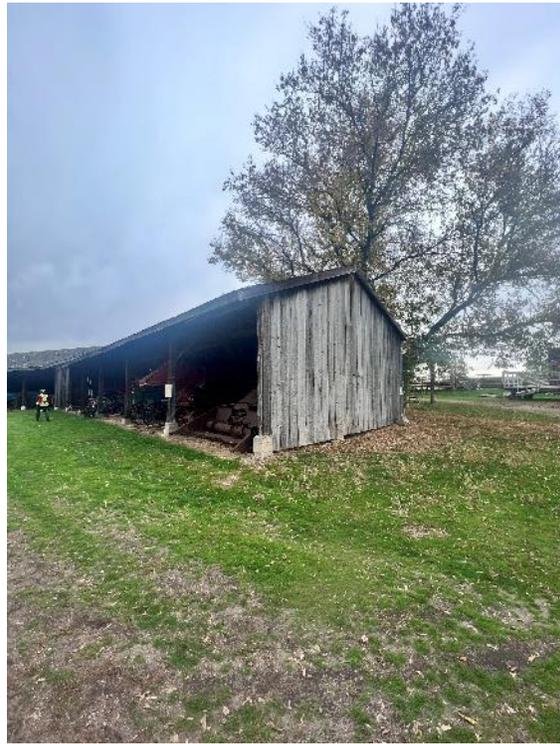
Photo 83

29: Implement Shed #2:
General view of South and East elevations.

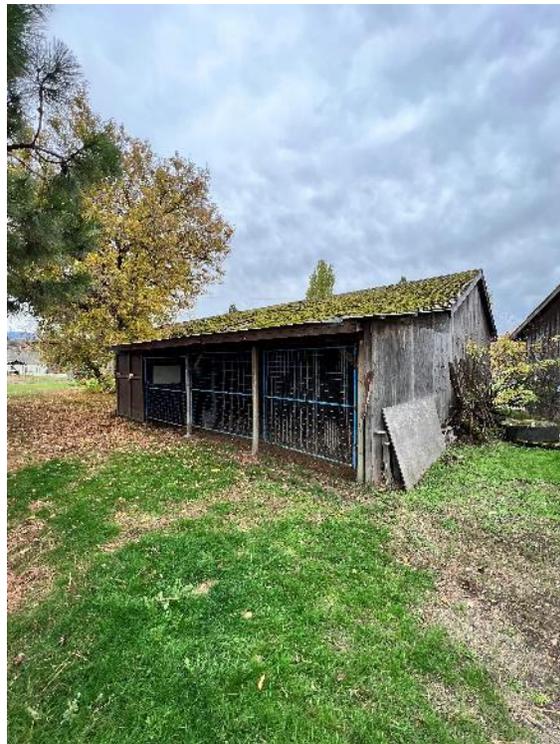
Photo 84

29: Implement Shed #2:
General view of North elevation.

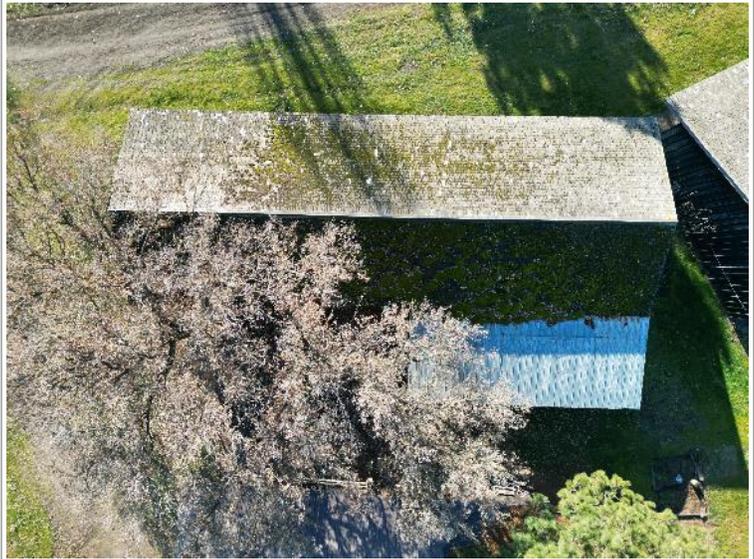
Photo 85

29: Implement Shed #2:
General view of roof.

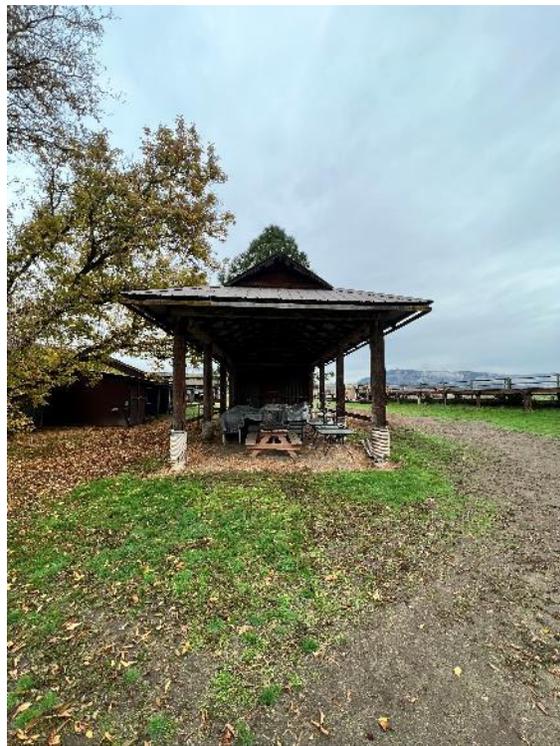
Photo 86

30: Tack Shed:
General view of East elevation.

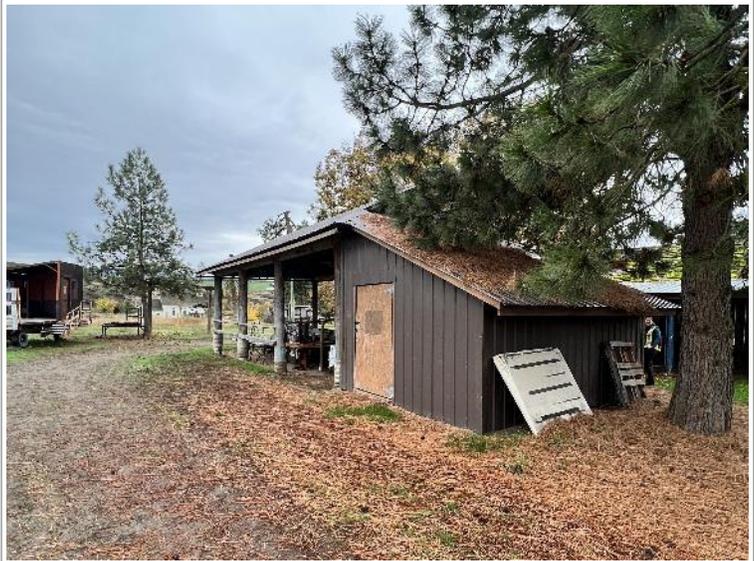
Photo 87

30: Tack Shed:
General view of North elevation.

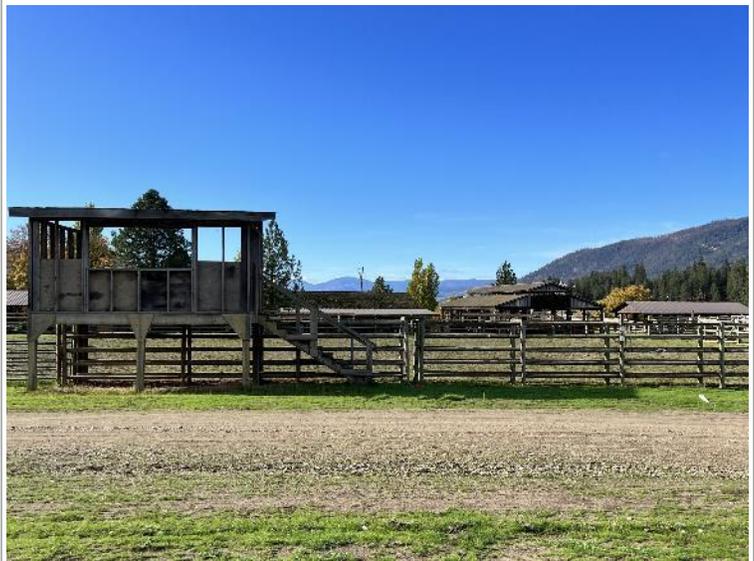
Photo 88

31: Corral:
General view from North.

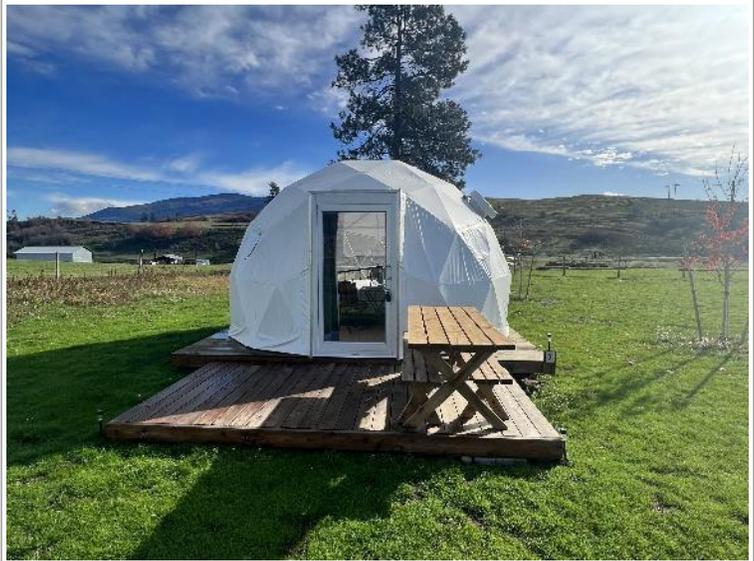
Photo 89

32: Glamping:
Typical glamping site.

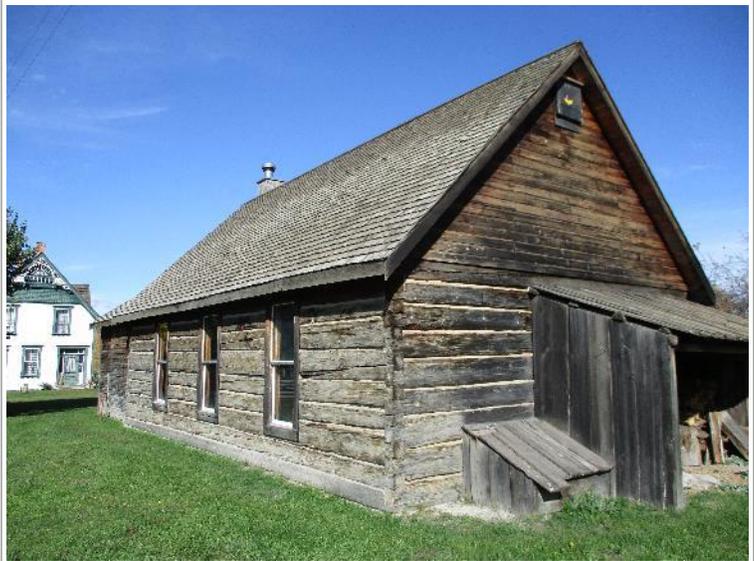
Photo 90

33: Balmoral School House:
General view from South-East corner.

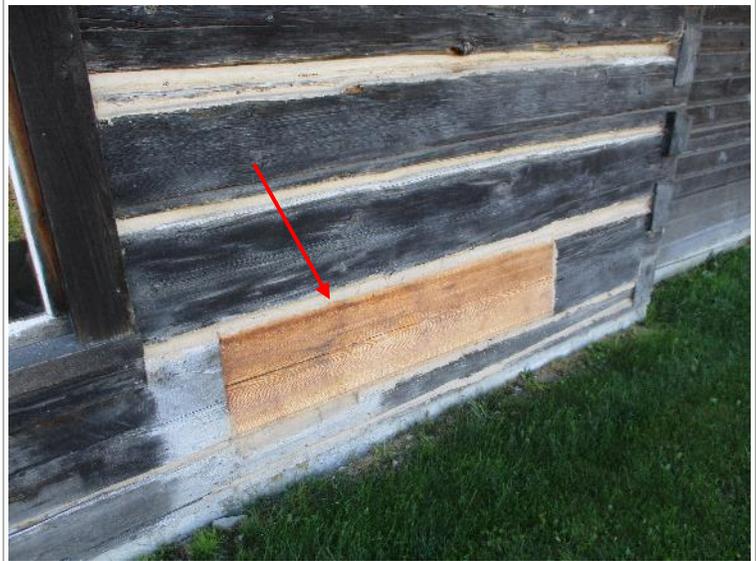
Photo 92

33: Balmoral School House:
Previous patch repair at south elevation.

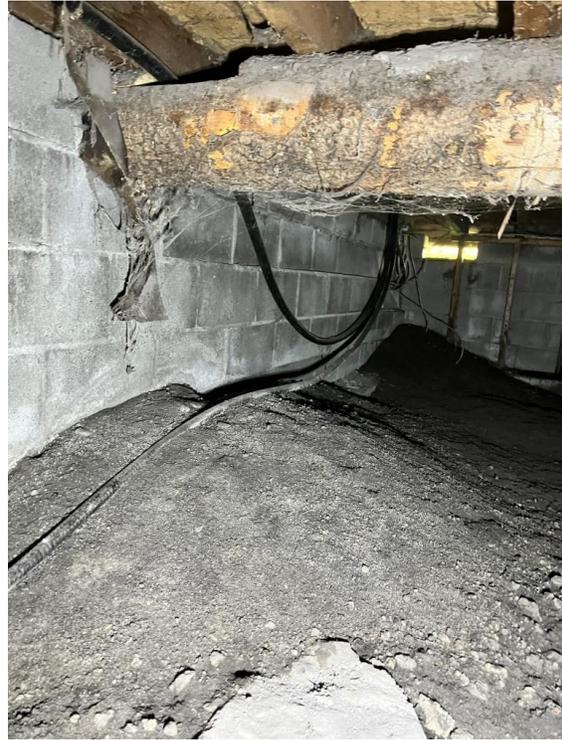
Photo 97

34: Schubert House:
Foundation wall

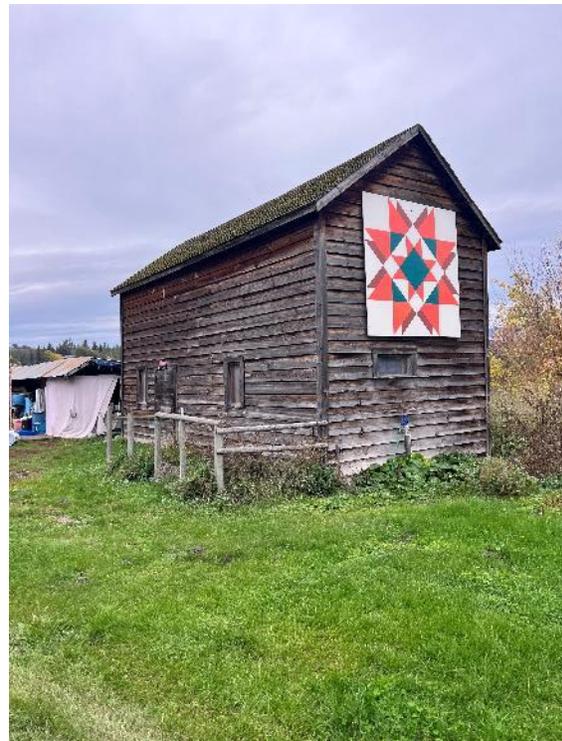
Photo 98

35: Schubert Barn:
General view of South and East elevations.

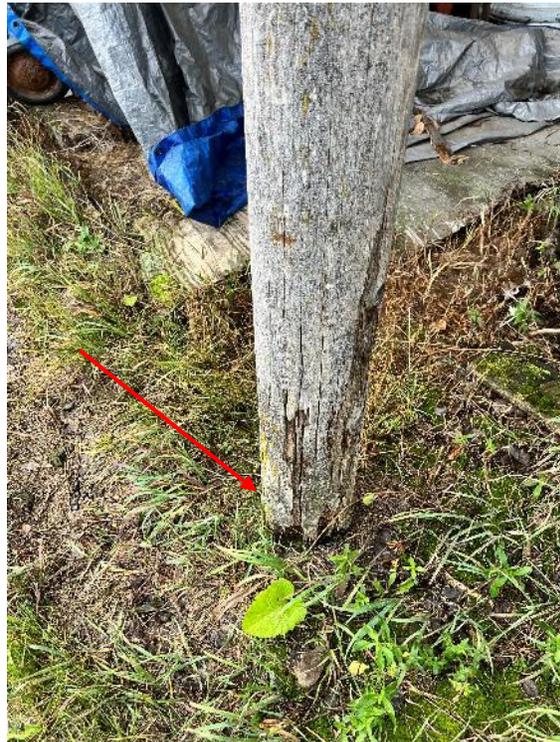
Photo 101

36: Spallumcheen Pioneer Power Club
Clubhouse:
Rotted buried post at North lean-to.

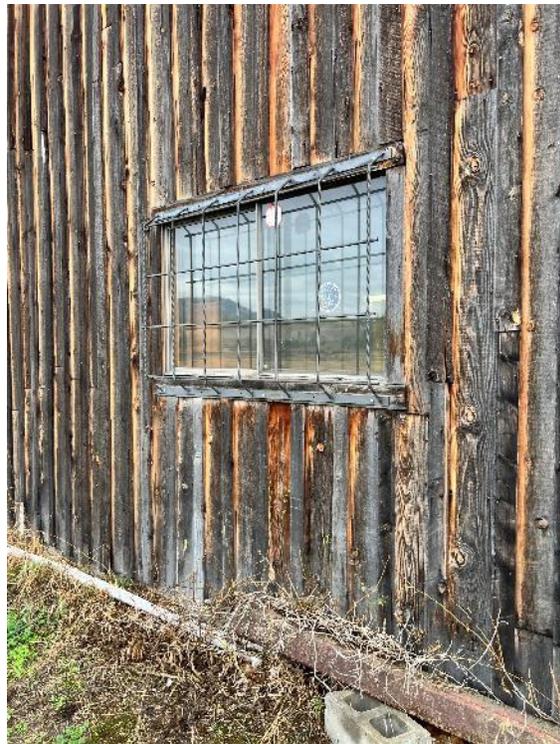
Photo 102

36: Spallumcheen Pioneer Power Club
Clubhouse:
Typical condition of cladding and windows.

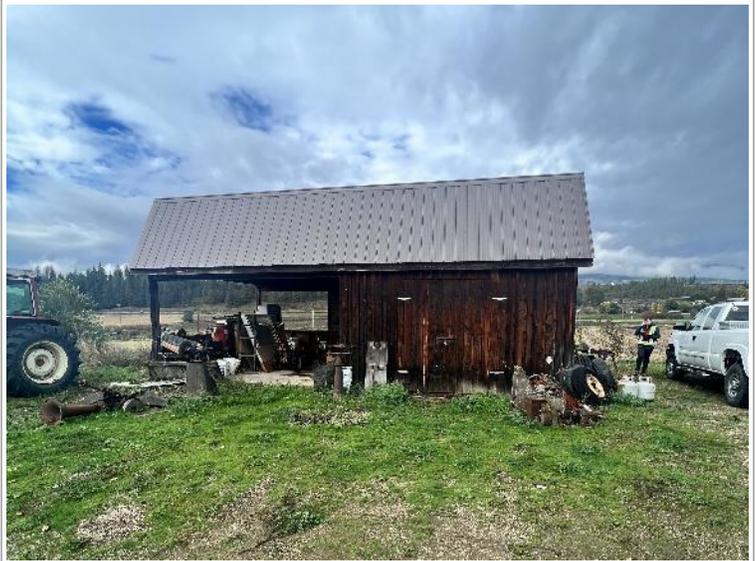
Photo 103

37: Storage Building:
General view of East elevation.

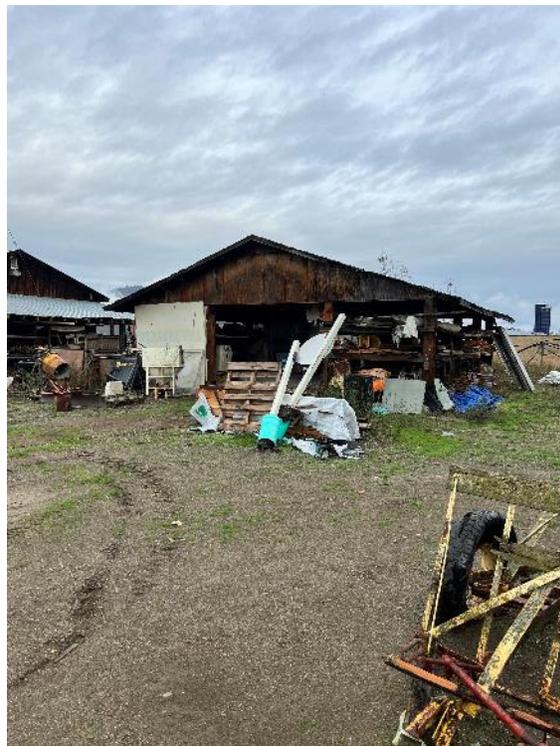
Photo 104

38: Storage Shed:
General view of South elevation.

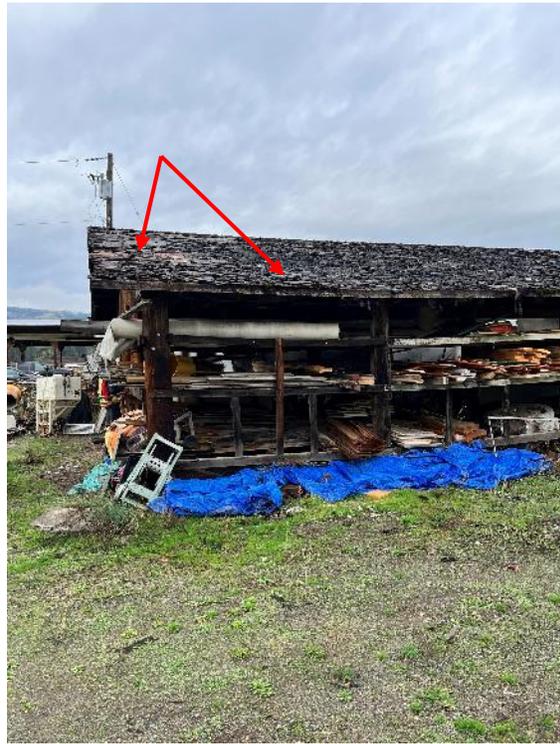
Photo 105

38: Storage Shed:
Missing shingles and sheathing at South end
of roof.

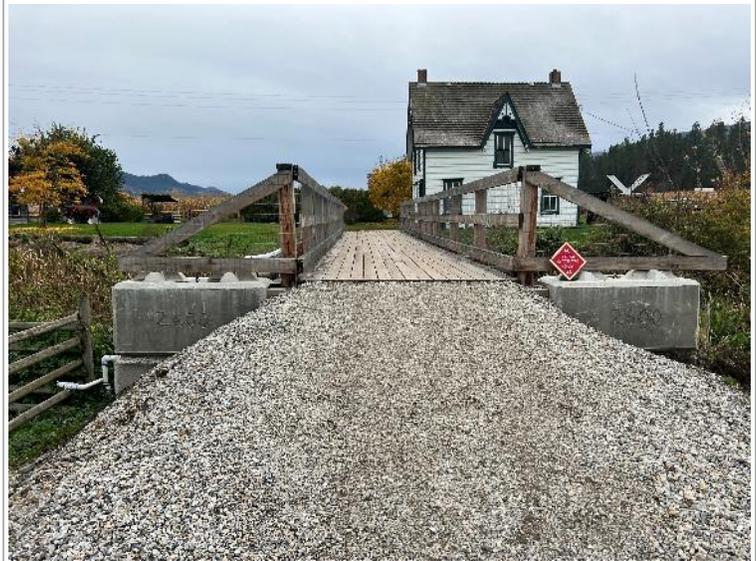
Photo 106

A: Foot Bridge:
General view from North

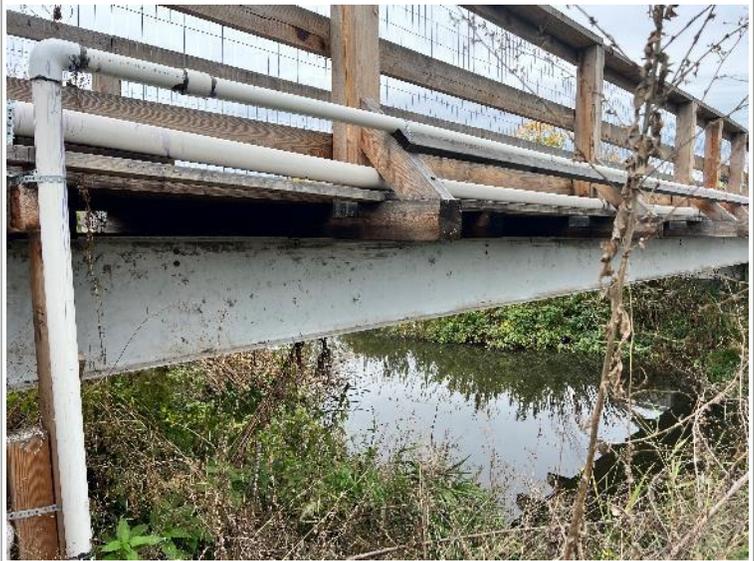
Photo 107

A: Foot Bridge:
Supporting beam and structure.

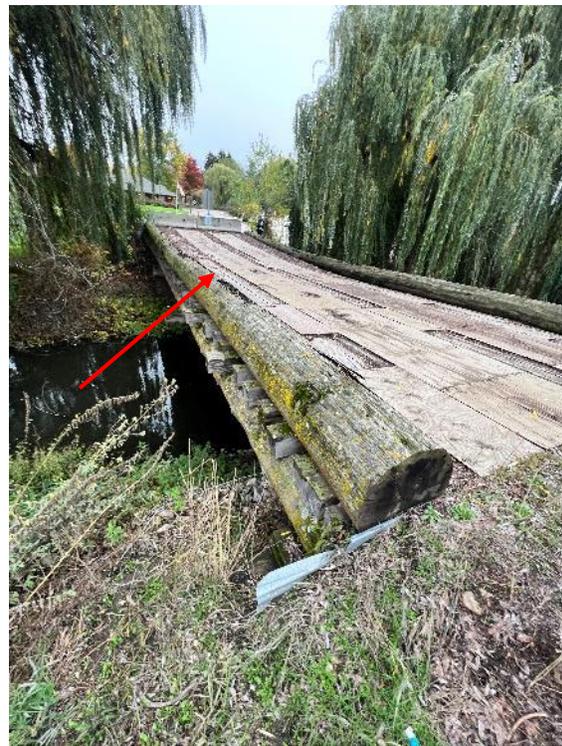
Photo 108

B: Decommissioned Bridge
General view showing deflection at midspan.

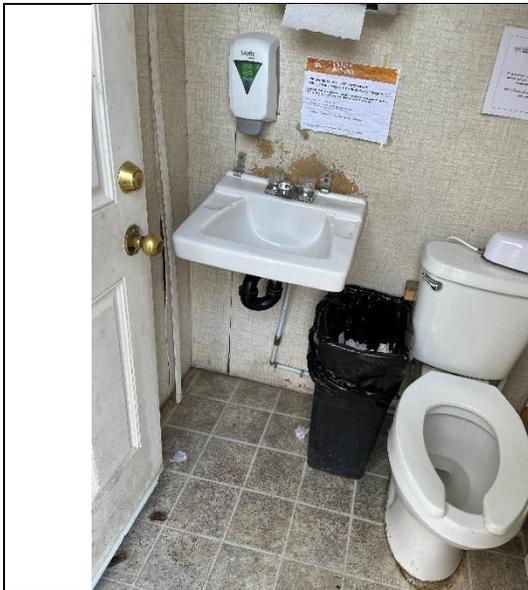
D2010 - Plumbing Fixtures

- Lavatories and water closets are in good condition and seem to have been recently upgraded.
- The lavatory is only served with cold water. Hot water has not been provided.

- The existing fixtures should provide good service for the near future. Risk Rank 2E.
- Consideration should be made to provide hot water to both public washrooms for improved hand washing hygiene. Risk Rank 3D.

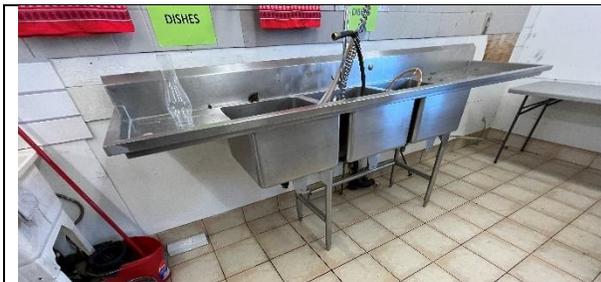
- Kitchen equipment is in good shape but has been abandoned in place, as the restaurant is no longer in use.

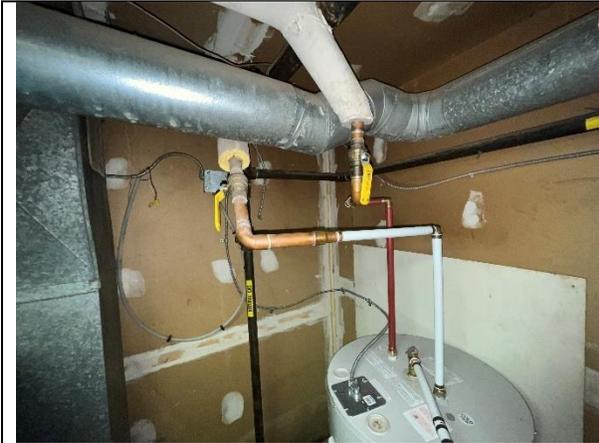
D2020 - Domestic Water Distribution

- Original piping systems are copper systems. Recent upgrades have used approved plastic piping systems.
- The insulation is in poor condition or missing in certain locations.
- Some elbows witnessed look suspiciously to be made with asbestos.

- The domestic water piping should provide good service for the near future. Nonetheless, the operators should look for pinhole leaks from time to time. Risk Rank 3C.
- Consideration should be made for upgrades to the existing insulation to save energy. Risk Rank 1E.
- The piping system should be assessed by a hazardous materials professional to determine if there is asbestos on these systems. Risk Rank 3B

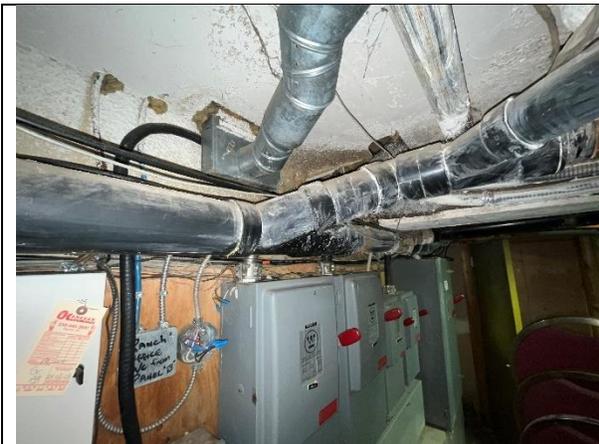
D2030 – Sanitary Waste

- Sanitary waste systems utilize ABS piping systems where visible. Buried piping and piping within the walls were not reviewed.

- The sanitary drainage piping should provide good service for the near future. However, the system is at an age where blockages could occur, so should be inspected and cleaned from time to time. Repairs if needed could be completed for the location at hand. There is no need for wholesale piping upgrades in the near future. Risk Rank 3D.

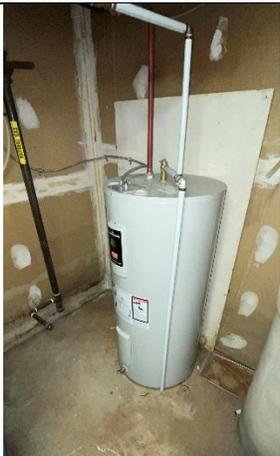
D2090 - Domestic Water Heater

<p>Observations:</p> <ul style="list-style-type: none"> Domestic hot water has been recently upgraded with a 3 kW electric domestic water heater. <p>Recommendations:</p> <ul style="list-style-type: none"> The domestic water heater should provide good service for the near future. Consideration should be made to provide the water heater with a drain pan to catch and direct the water to a drainage system, in the event of a leak in the tank. Risk Rank 2C.
---	--

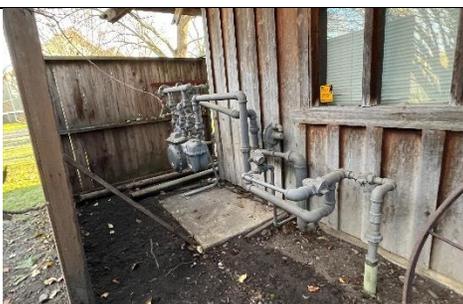
D3010 – Energy Supply

<p>Observations:</p> <ul style="list-style-type: none"> The bulk of the facilities that are heated are served through the natural gas meter and pressure regulation systems. These systems are owned and operated by the utility supplier. The only building that is heated but not connected to natural gas is the St. Annes Church, that has a dedicated propane tank. Gas piping where visible appears to be in good condition. <p>Recommendations:</p> <ul style="list-style-type: none"> No upgrades to the system are anticipated unless significant upgrades to the existing systems is initiated.
--	--

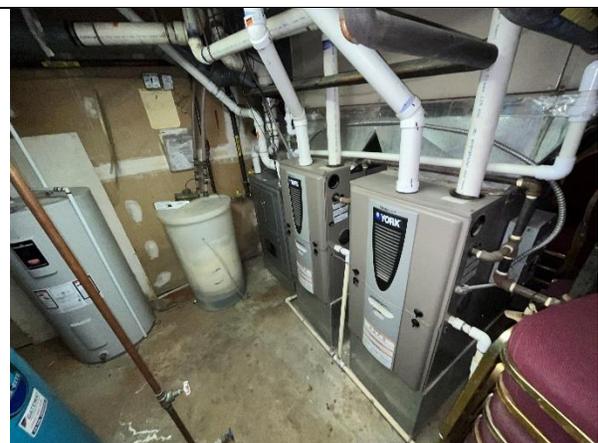
D3020 – Heat Generation Systems

<p>Observations:</p> <ul style="list-style-type: none"> Three furnaces have been recently upgraded with sealed combustion energy efficient units. These gas fired appliances have been installed in a room that is not fire rated. <p>Recommendations:</p> <ul style="list-style-type: none"> No upgrades to the system are anticipated in the near future. Risk Rank 1D. Consideration should be made to fire rate the room that the furnaces are installed. Risk Rank 2B. If the outdoor cooling unit is replaced, the indoor cooling coil will need to be replaced to match the outdoor unit. Risk Rank 5D
---	--

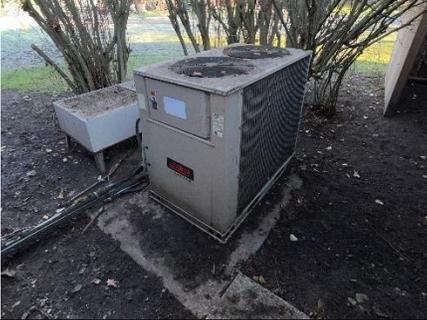
D3030 – Cooling Generation Systems

<p>Observations:</p> <ul style="list-style-type: none"> • Cooling is provided by a single Lennox ten-ton cooling capacity condensing unit. • The unit was manufactured in 1999.
	<p>Recommendations:</p> <ul style="list-style-type: none"> • The unit is nearing the end of its service life and should be replaced in the near future. Due to the change in refrigerants, the cooling coil on the furnaces will need to be replaced as well. Risk Rank 5D

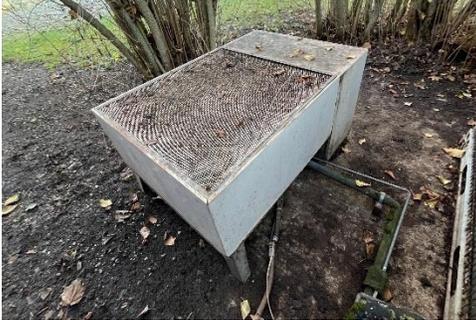
D3030 – Walk in Freezer Cooling System

<p>Observations:</p> <ul style="list-style-type: none"> • The cooling equipment is near the end of its service life, but has effectively been abandoned in place, as the restaurant is no longer in use.
	<p>Recommendations:</p> <ul style="list-style-type: none"> • No recommendation.

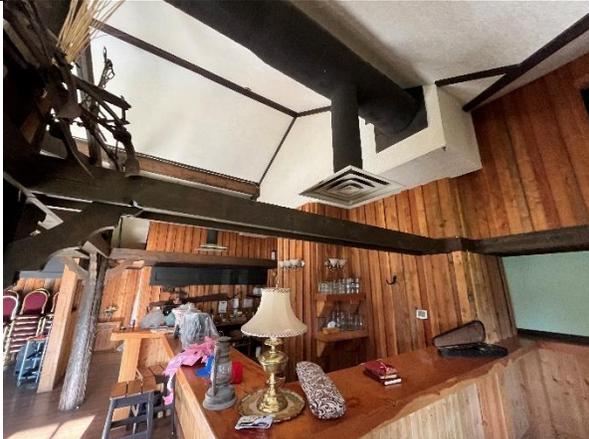
D3040 – Air Distribution Systems

<p>Observations:</p> <ul style="list-style-type: none"> • The supply duct systems are in good shape considering the age of the system.
	<p>Recommendations:</p> <ul style="list-style-type: none"> • At most, an internal inspection of the duct and a duct cleaning every 5 years or so. Risk Rank 3E.

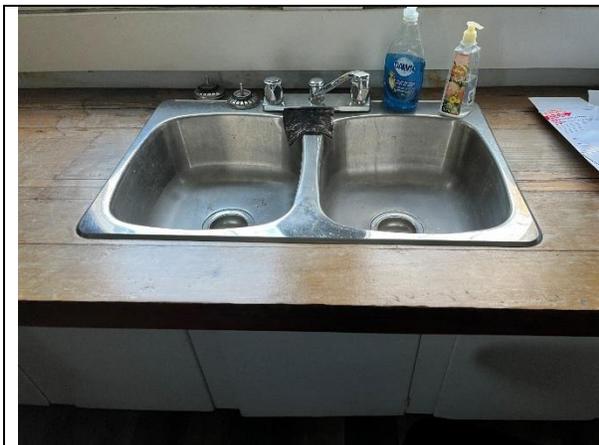
D2010 - Plumbing Fixtures

- Sink is in good condition.

- The existing fixtures should provide good service for the near future. Risk Rank 2E.
- Consideration should be made to provide hot water to both public washrooms for improved hand washing hygiene. Risk Rank 3D.

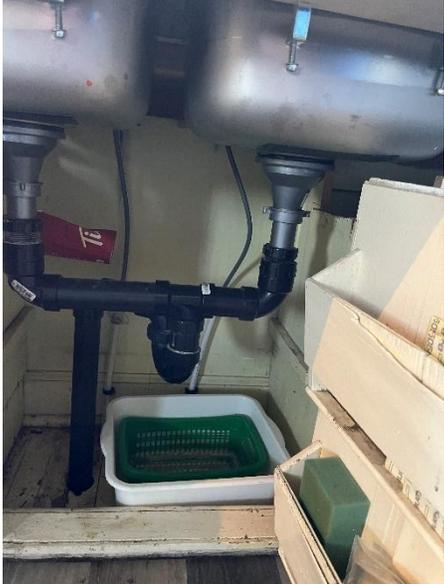
D2020 - Domestic Water Distribution and Sanitary Waste

<p>Observations:</p> <ul style="list-style-type: none">• Original piping systems are copper systems. Recent upgrades have used approved plastic piping systems.• The insulation is in poor condition or missing in certain locations.• Sanitary waste systems utilize ABS piping systems where visible. Buried piping and piping within the walls were not reviewed.
	<p>Recommendations:</p> <ul style="list-style-type: none">• The domestic water piping should provide good service for the near future. Nonetheless, the operators should look for pinhole leaks from time to time. Risk Rank 3C.• Consideration should be made for upgrades to the existing insulation to save energy. Risk Rank 1E.• The sanitary drainage piping should provide good service for the near future. However, the system is at an age where blockages could occur, so should be inspected and cleaned from time to time. Repairs if needed could be completed for the location at hand. There is no need for wholesale piping upgrades in the near future. Risk Rank 3D.

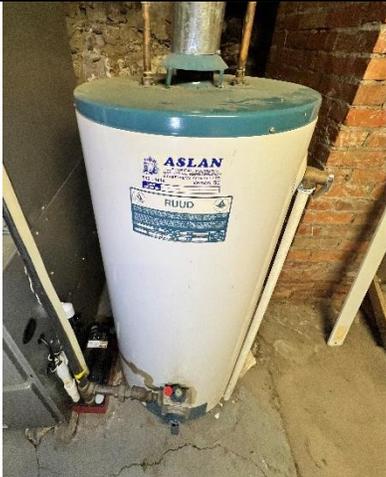
D2090 - Domestic Water Heater

<p>Observations:</p> <ul style="list-style-type: none">• The domestic hot water heater is old (approx. 40 years since manufactured) and is in need of replacement.• The water heater has not been provided with a drain pan.
	<p>Recommendations:</p> <ul style="list-style-type: none">• The domestic water heater should be replaced soon. Risk Rank 4C.• Consideration should be made to provide the water heater with a drain pan to catch and direct the water to a drainage system, in the event of a leak in the tank. Risk Rank 4C.

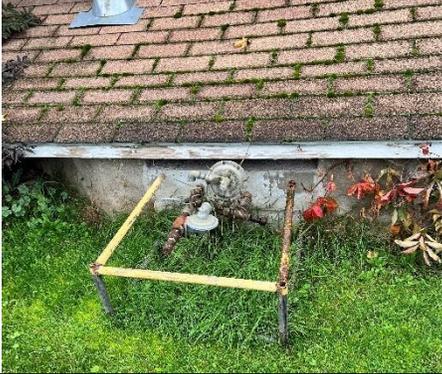
D3010 – Energy Supply

<p>Observations:</p> <ul style="list-style-type: none">• The facility has a natural gas connection and pressure regulation station.• Gas piping does not appear to have the appropriate protective coatings.
	<p>Recommendations:</p> <ul style="list-style-type: none">• The Owner will want to engage a technician to ensure the systems are configured to Code. Risk Rank 2C.

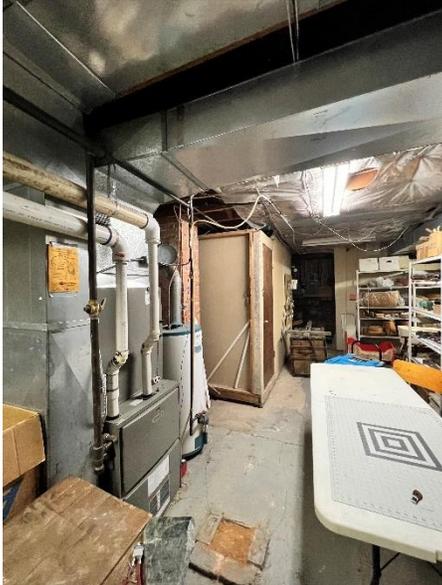
D3020 – Heat Generation Systems

<p>Observations:</p> <ul style="list-style-type: none">• The furnace was upgraded with sealed combustion energy efficient unit about 12 years ago.• The gas fired appliances have not been installed in a room that is fire rated.
	<p>Recommendations:</p> <ul style="list-style-type: none">• No upgrades to the system are anticipated in the near future. Risk Rank 2D.• Consideration should be made to build a fire rated room that would house the furnaces and domestic water heater. Risk Rank 2B.

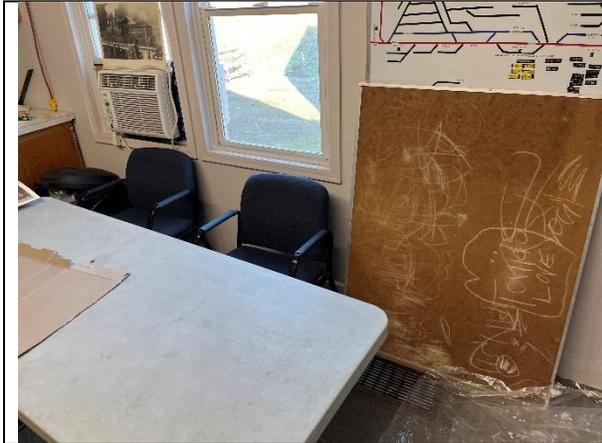
D3030 – Cooling Generation Systems

- Cooling is provided by a single window mounted air conditioning unit.

- If the unit fails, replacement units are readily available and relatively inexpensive. Risk Rank 3E

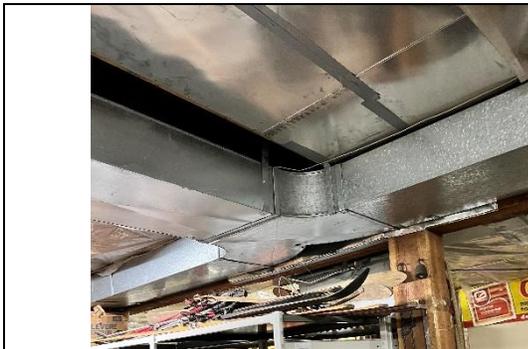
D3040 – Air Distribution Systems

- The supply duct systems are in good shape considering the age of the system.

- At most, an internal inspection of the duct and a duct cleaning every 5 years or so. Risk Rank 3E.

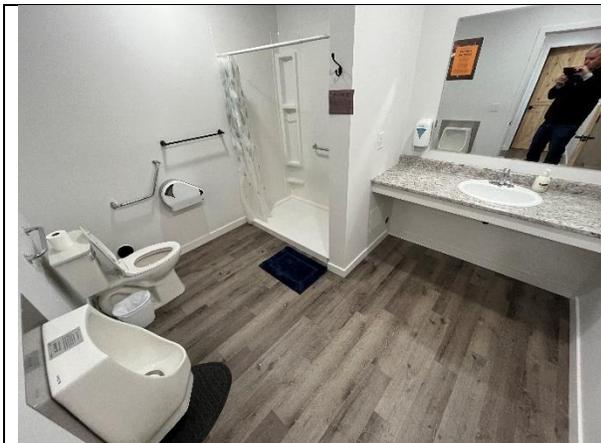
D2010 - Plumbing Fixtures

- Lavatories, urinal, shower and water closets are new and well appointed.

- The existing fixtures should provide good service for the near future. Risk Rank 2E.
- Consideration should be made to provide hot water to both public washrooms for improved hand washing hygiene. Risk Rank 3D.

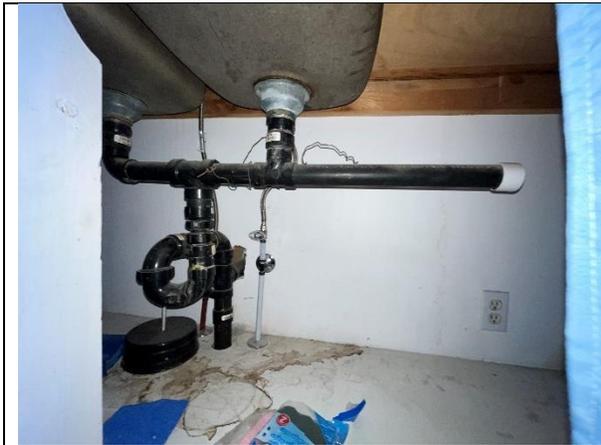
D2020 - Domestic Water Distribution and Sanitary Waste

- Original piping systems are copper systems. Recent upgrades have used approved plastic piping systems.
- The insulation is in poor condition or missing in certain locations.
- Sanitary waste systems utilize ABS piping systems where visible. Buried piping and piping within the walls were not reviewed.

- The domestic water piping should provide good service for the near future. Nonetheless, the operators should look for pinhole leaks from time to time. Risk Rank 3C.
- Consideration should be made for upgrades to the existing insulation to save energy. Risk Rank 1E.
- The sanitary drainage piping should provide good service for the near future. However, the system is at an age where blockages could occur, so should be inspected and cleaned from time to time. Repairs if needed could be completed for the location at hand. There is no need for wholesale piping upgrades in the near future. Risk Rank 3D.

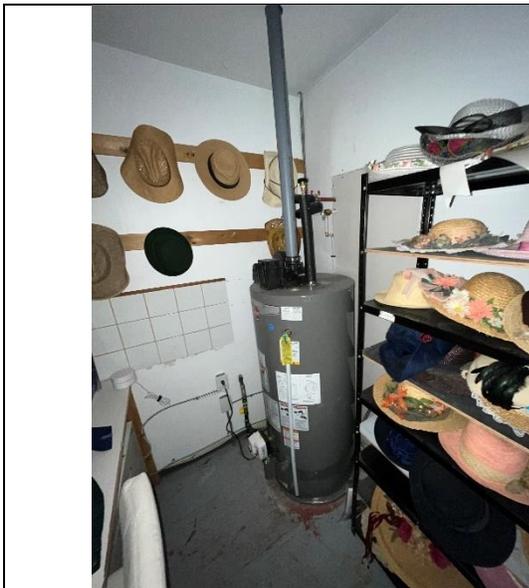
D2090 - Domestic Water Heater

- The domestic hot water heater was manufactured in 2006. The hot water tank is approximately $\frac{3}{4}$ through the service life.
- The gas fired appliances have not been installed in a room that is fire rated.

- The domestic water heater should be replaced relatively soon. Risk Rank 4C.
- Consideration should be made to build a fire rated room that would house the domestic water heater. Risk Rank 2B.

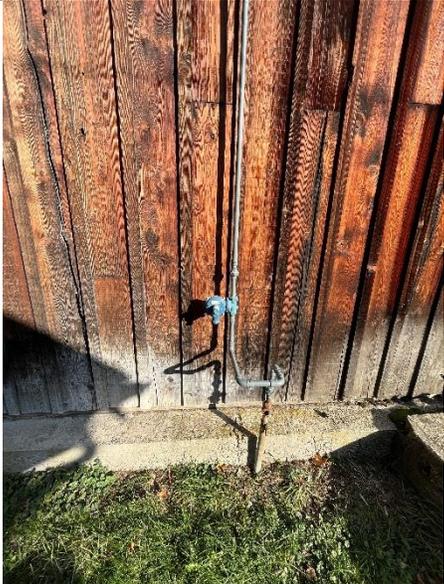
D3010 – Energy Supply

<p>Observations:</p> <ul style="list-style-type: none">The facility has a natural gas connection and pressure regulation station.
	<p>Recommendations:</p> <ul style="list-style-type: none">The system should provide good service for the near future. Risk Rank 1D.
