THE CORPORATION OF THE CITY OF VERNON REPORT TO COUNCIL

SUBJECT: HISTORIC O'KEEFE RANCH FACILITY CONDITION ASSESSMENT

Facility Condition Assessment

At the City of Vernon's request Read Jones Christoffersen Ltd. (RJC) has completed a Facility Condition Assessment (FCA) at the Historic O'Keefe Ranch located at 9380 BC-97 near Vernon, BC per our proposal dated September 14, 2023. The FCA forms part of Phase 1 of the overall services. Phase 1 also includes preparation of Statements of Significance (SoS).

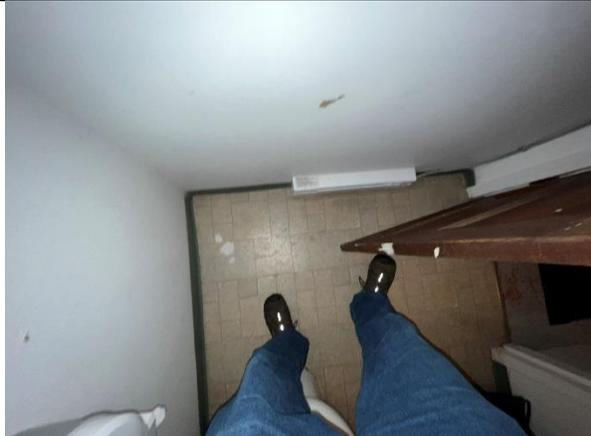
D3020 – Heat Generation Systems

<p>Observations:</p> <ul style="list-style-type: none">Most areas are unheated.Occupied areas use baseboard electric heaters.
	<p>Recommendations:</p> <ul style="list-style-type: none">No recommendations

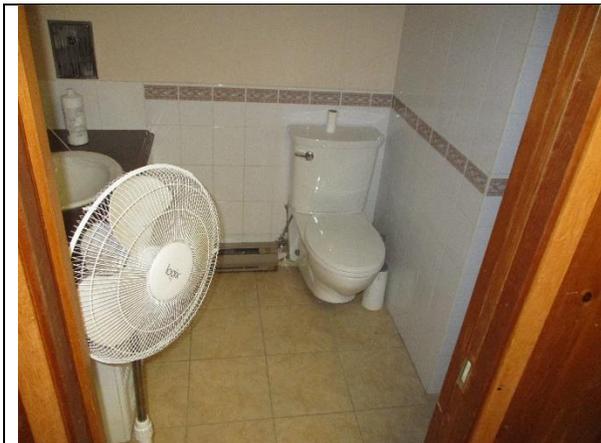
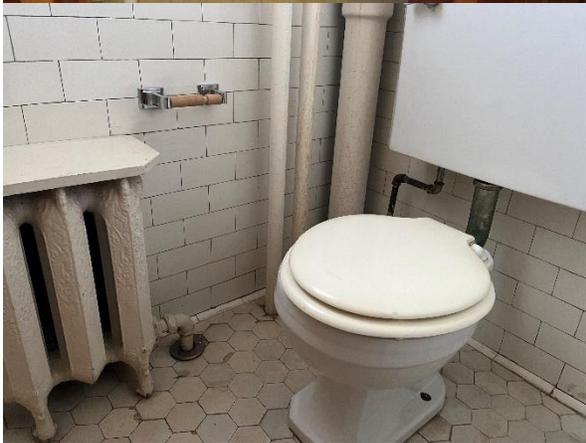
D2010 - Plumbing Fixtures

- Lavatories, urinal, shower and water closets for the residence appear to be recently installed.
- The plumbing fixtures for the historic part of the mansion are of course old.

- The existing fixtures should provide good service for the near future. Risk Rank 2E.

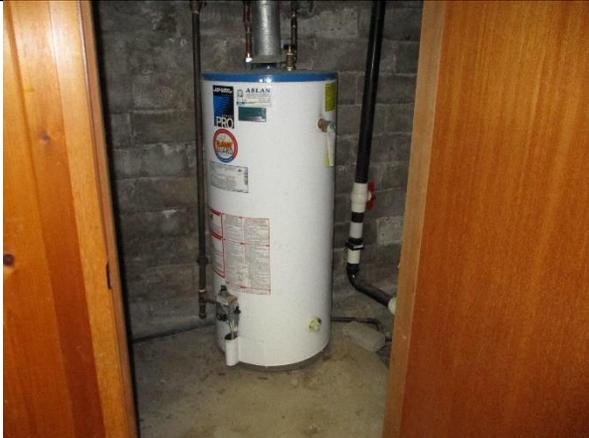
D2090 - Domestic Water Heater

<p>Observations:</p> <ul style="list-style-type: none">• The domestic hot water heater was installed in 2008. The hot water tank is approximately $\frac{3}{4}$ through the service life.• This gas fired appliances has not been installed in a room that is fire rated.• The water heater has not been provided with a drain pan.
	<p>Recommendations:</p> <ul style="list-style-type: none">• The domestic water heater should be replaced relatively soon. Risk Rank 4C.• Consideration should be made to build a fire rated room that would house the domestic water heater. Risk Rank 2B.• Consideration should be made to provide the water heater with a drain pan to catch and direct the water to a drainage system, in the event of a leak in the tank. Risk Rank 4C.

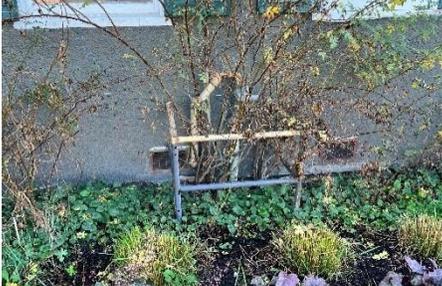
D3010 – Energy Supply

Observations: <ul style="list-style-type: none">The facility has a natural gas connection and pressure regulation station.
	Recommendations: <ul style="list-style-type: none">The system should provide good service for the near future. Risk Rank 1D.

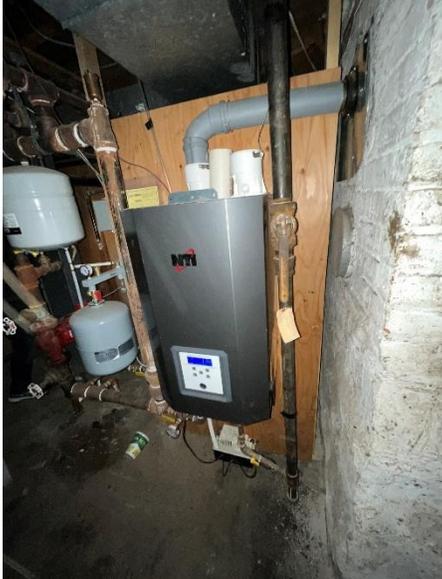
D3020 – Heat Generation Systems

Observations: <ul style="list-style-type: none">The hot water heating systems for the historical portion of the building is served by a modern sealed combustion condensing boiler manufactured in 2013. The boiler is approximately ½ through its service life.This gas fired appliances have not been installed in a room that is fire rated.
	Recommendations: <ul style="list-style-type: none">No upgrades to the system are anticipated in the near future. Risk Rank 2D.Consideration should be made to build a fire rated room that would house the boiler. Risk Rank 2B.

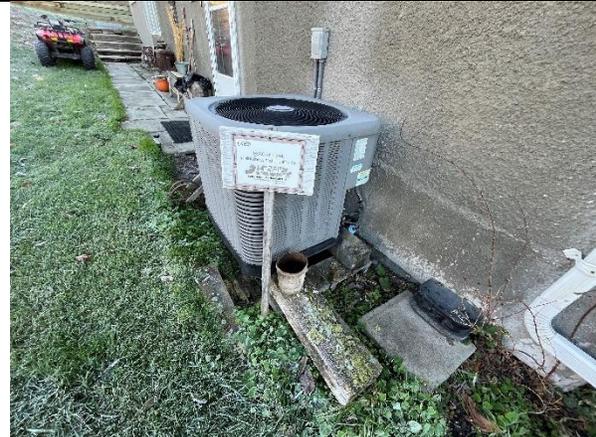
D3030 – Cooling Generation Systems

Observations: <ul style="list-style-type: none">Cooling is provided by a single Rheem five-ton cooling capacity condensing unit.The unit was manufactured in 2016.
	Recommendations: <ul style="list-style-type: none">The unit is 1/3 through its service life and should provide good service for the near future. Risk Rank 2D

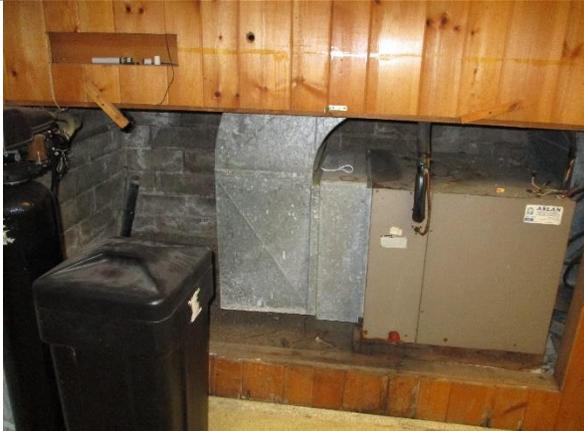
D3040 – Cooling Distribution Systems

<p>Observations:</p> <ul style="list-style-type: none"> • The fan and cooling coil are in fair shape considering the age of the system. • The condensate is intentionally plugged and is showing signs of degradation and rust. <p>Recommendations:</p> <ul style="list-style-type: none"> • Consideration should be made to provide a condensate pump. Risk Rank 3D • If the outdoor cooling unit is replaced, the indoor cooling coil will need to be replaced to match the outdoor unit. Risk Rank 2D
---	--

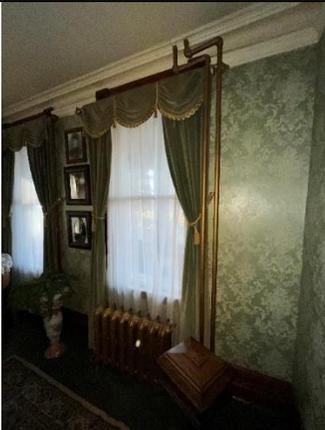
D3040 – Heat Distribution Systems

<p>Observations:</p> <ul style="list-style-type: none"> • Steel uninsulated piping is used for the hydronic heating systems. If the hot water heating system gets above 140°F, the bare pipe can scald bare skin in seconds. It appears that these systems are well barricaded from the public, to avoid an inadvertent incident. <p>Recommendations:</p> <ul style="list-style-type: none"> • The system should provide good service for the near future. Risk Rank 1D. • Care should continue to be made to keep the public from touching the heating piping and terminal units while the systems are hot.
--	---

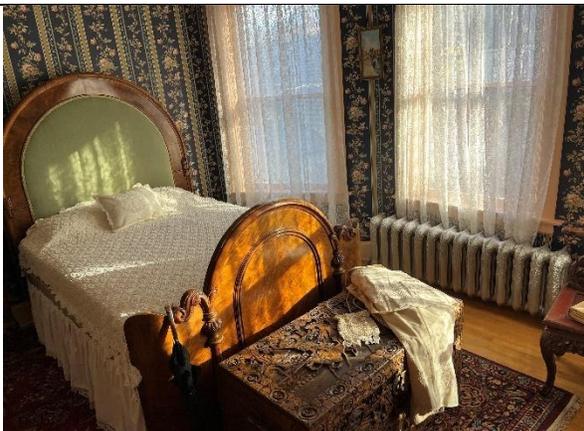
D3050 – Terminal Heating

<p>Observations:</p> <ul style="list-style-type: none"> • The heating systems are original and are still in use. It is hard to determine the life expectancy of these older systems, but they seem to be built to last as there are many facilities that utilize them. <p>Recommendations:</p> <ul style="list-style-type: none"> • Deal with failing systems as they occur. Risk Rank 1C.
---	--

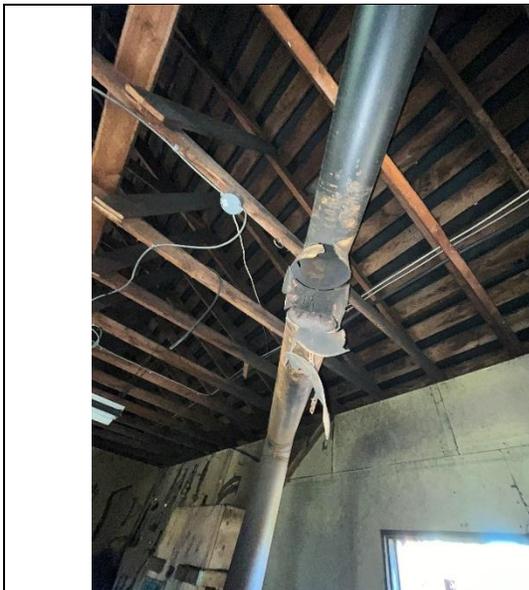
D3040 – Forge Venting Systems

- Except for one system, the forge venting system will need to be replaced.

- The systems should be replaced, and appropriate thimbles are needed for the penetrations through the roof. Risk Rank 5C.

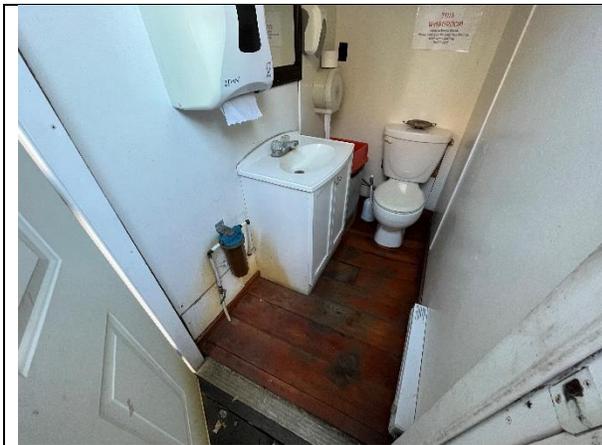
D2010 - Plumbing Fixtures

- Lavatories and water closets appear to be relatively new.

- The existing fixtures should provide good service for the near future. Risk Rank 2E.
- Consideration should be made to provide hot water to both public washrooms for improved hand washing hygiene. Risk Rank 3D.

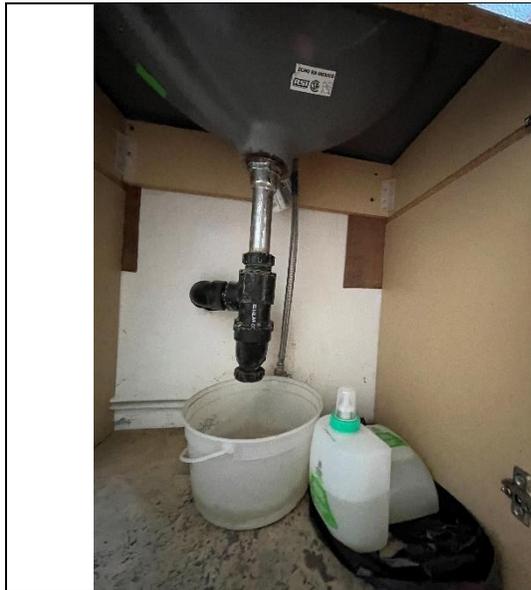
D2020 - Domestic Water Distribution and Sanitary Waste

- Original piping systems are not visible. The systems are not likely to be very old as the washrooms seem to be a recent renovation to the building.
- Sanitary waste systems utilize ABS piping systems where visible. Buried piping and piping within the walls were not reviewed.

- The domestic water piping should provide good service for the near future. Risk Rank 2E.
- The sanitary drainage piping should provide good service for the near future. Risk Rank 2E.

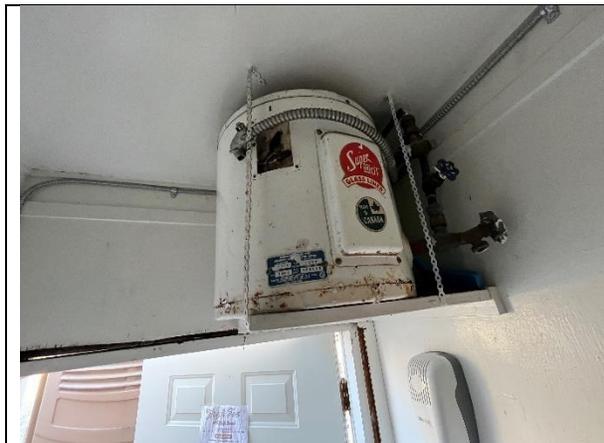
D2090 - Domestic Water Heater

- The electric domestic hot water heater is nearing the end of its service life.

- The domestic water heater should be replaced relatively soon. Risk Rank 3D.

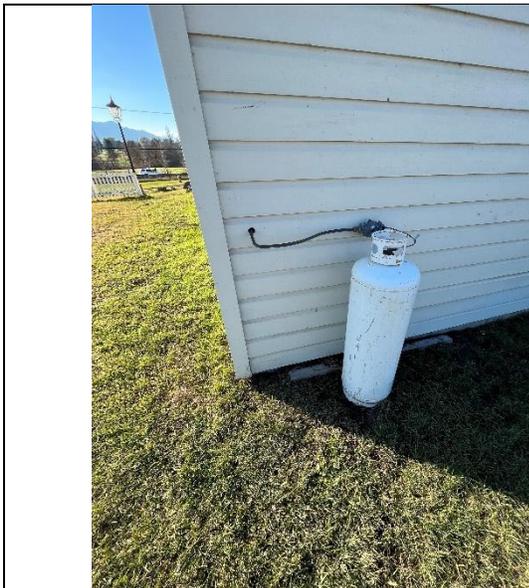
D3010 – Energy Supply

- The bulk of the facilities that are heated are served through the natural gas meter and pressure regulation systems. These systems are owned and operated by the utility supplier. The only building that is heated but not connected to natural gas is the St. Annes Church, that has a dedicated propane tank.
- Gas piping where visible appears to be in good condition.

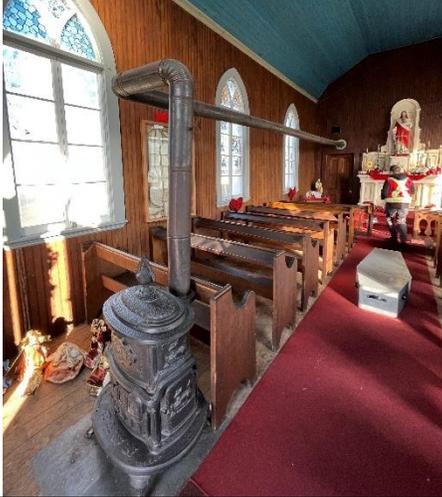
<p>Observations:</p> <ul style="list-style-type: none"> The wood fired pot belly stove is not in use. The chimney for this unit has been reconfigured to serve the furnace mentioned above.
	<p>Recommendations:</p> <ul style="list-style-type: none"> Refer to discussion in Executive Summary.

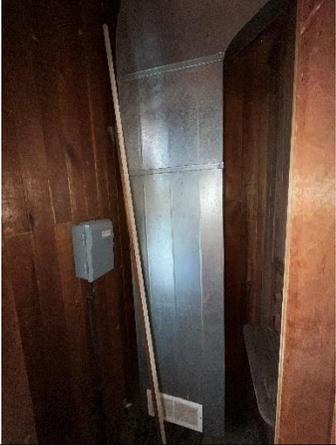
D3040 – Air Distribution Systems

<p>Observations:</p> <ul style="list-style-type: none"> The supply duct systems are in good shape considering the age of the system.
	<p>Recommendations:</p> <ul style="list-style-type: none"> At most, an internal inspection of the duct and a duct cleaning every 5 years or so. Risk Rank 3E.

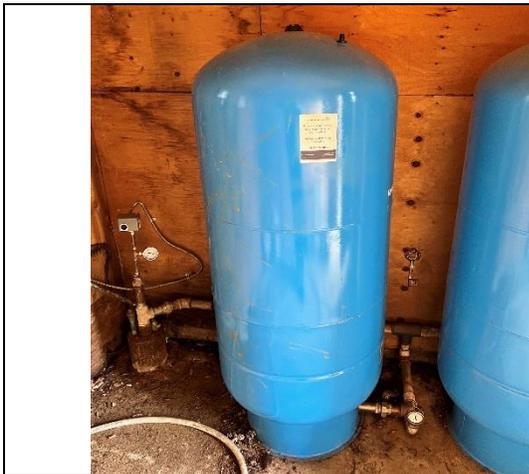
D2020 - Domestic Water Distribution

- The piping systems use galvanized, copper, and plastic piping. Galvanized piping is no longer approved on domestic water systems.
- The tanks and recent piping system appear to be functional.

- The next time the system needs work, we recommended replacing the galvanized piping with approved domestic water system piping. Risk Rank 3D.

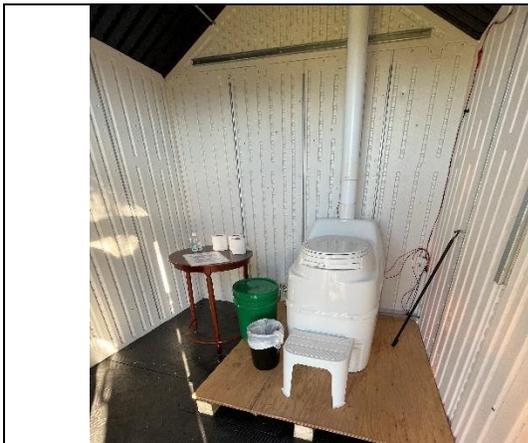
D2010 - Plumbing Fixtures

- The water closets are a purpose-built composting type unit.
- The system appears to be functional. Composting toilets are generally not considered a “high volume” system.

- As the glamping site becomes more popular, the operator may need to add more toilet systems to keep up with demand.

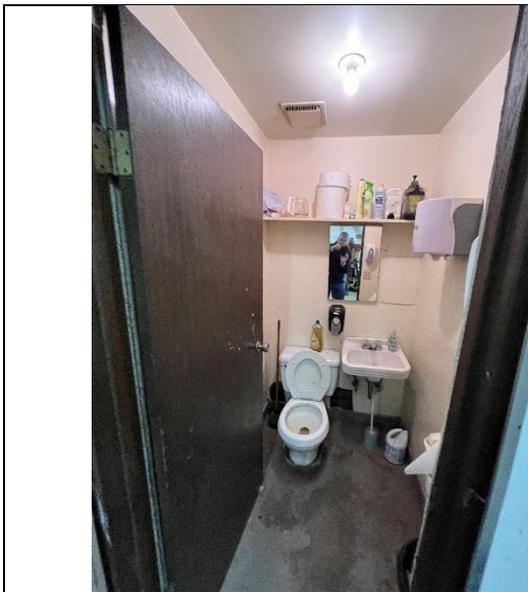
D2010 - Plumbing Fixtures

- Lavatories and water closets are in fair condition but are still serviceable.

- The existing fixtures should provide good service for the near future. Risk Rank 2E.

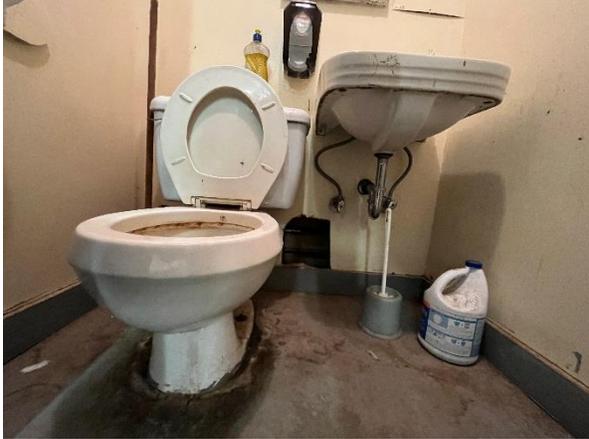
D2020 - Domestic Water Distribution and Sanitary Waste

<p>Observations:</p> <ul style="list-style-type: none">• Original piping systems are copper.• The insulation is in poor condition or missing in certain locations.• Sanitary waste systems are not visible. <p>Recommendations:</p> <ul style="list-style-type: none">• The domestic water piping should provide good service for the near future. Non the less, the operators should look for pinhole leaks from time to time. Risk Rank 3C.• Consideration should be made for upgrades to the existing insulation to save energy. Risk Rank 1E.• Based on the age of the building, sanitary drainage piping should provide good service for the near future. However, the system is at an age where blockages could occur, so should be inspected and cleaned from time to time. Repairs if needed could be completed for the location at hand. There is no need for wholesale piping upgrades in the near future. Risk Rank 3D.

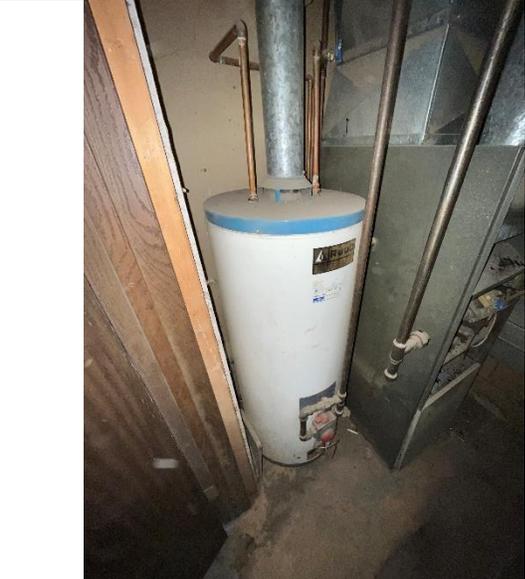
D2090 - Domestic Water Heater

<p>Observations:</p> <ul style="list-style-type: none">• The domestic hot water heater is nearing the end of its service life and is need of replacement.• This gas fired appliances has not been installed in a room that is fire rated.• The water heater has not been provided with a drain pan. <p>Recommendations:</p> <ul style="list-style-type: none">• The domestic water heater should be replaced soon. Risk Rank 4C.• Consideration should be made to provide the water heater with a drain pan to catch and direct the water to a drainage system, in the event of a leak in the tank. Risk Rank 4C.• Consideration should be made to build a fire rated room that would house the domestic water heater. Risk Rank 2B.
---	--

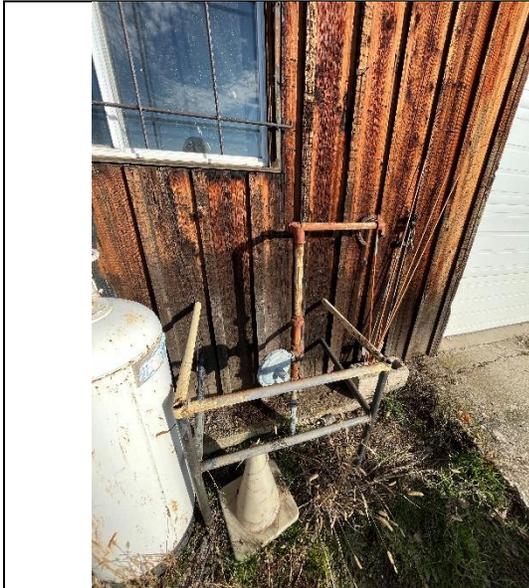
D3010 – Energy Supply

- The facility has a natural gas connection and pressure regulation station.
- Gas piping does not appear to have the appropriate protective coatings.

- The Owner will want to engage a technician to ensure the systems are configured to Code. Risk Rank 2C.

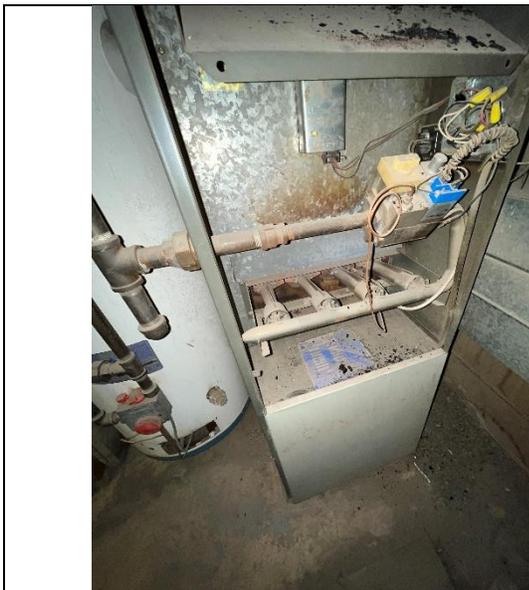
D3020 – Heat Generation Systems

- The furnace is at the end of its service life.
- The gas fired appliances have not been installed in a room that is fire rated.

- The system should be upgraded soon. Risk Rank 5D.
- Consideration should be made to build a fire rated room that would house the furnaces and domestic water heater. Risk Rank 2B.

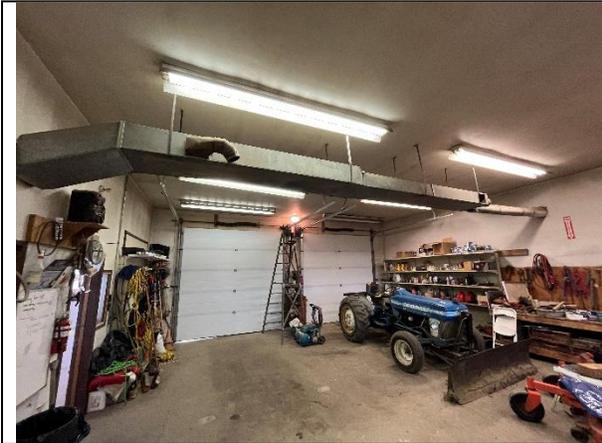
D3040 – Air Distribution Systems

- The supply duct systems are in good shape considering the age of the system.

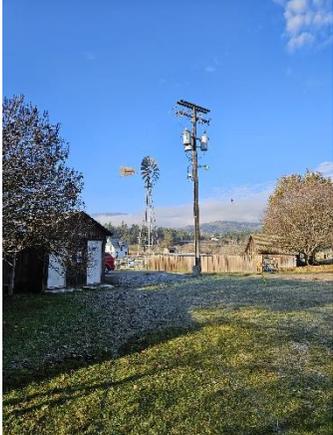
Observations: <ul style="list-style-type: none">• BC Hydro overhead power line and 3 phase transformer bank with secondary DIP feeding the visitor's centre.
	Recommendations: <ul style="list-style-type: none">• N/A. Equipment owned and maintained by BC Hydro.

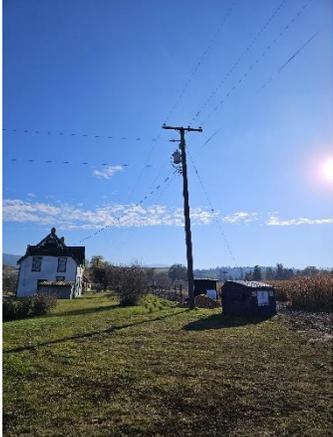
Observations: <ul style="list-style-type: none">• BC Hydro overhead power line near where it enters the site by the Schubert Barn. Three phase line continues on to the Visitor's Centre and single phase tap continues on to the rest of the site. Single phase overhead secondary service to Schubert House.
	Recommendations: <ul style="list-style-type: none">• N/A. Equipment owned and maintained by BC Hydro.

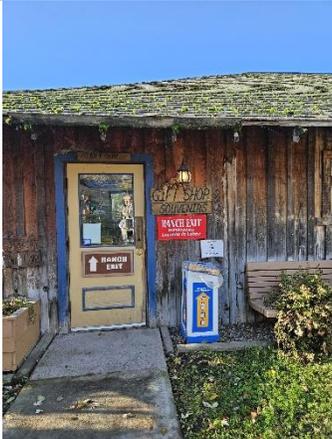
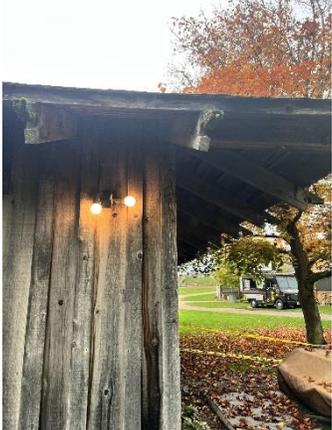
Exterior lighting consists of some incandescent wall sconces on buildings, some older high intensity discharge (HID) davit lights mounted on wood poles, incandescent post top coach lights, and some in ground up lights at the church. This lighting is generally of poor quality, provides poor illumination levels, and is inefficient. It is recommended that all lighting be upgraded to LED fixtures as budgets permit.

<p>Observations:</p> <ul style="list-style-type: none">• Examples of exterior lighting.

<p>Recommendations:</p> <ul style="list-style-type: none">• Upgrade lighting to LED fixtures as budgets permit.

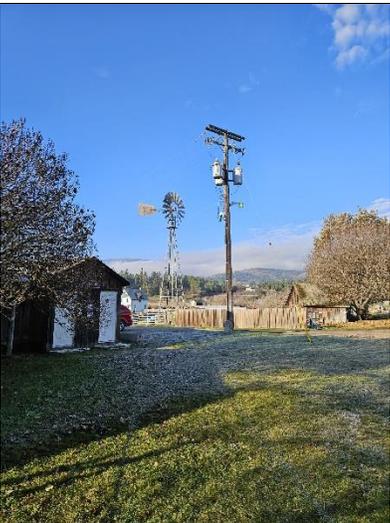
<p>Observations:</p> <ul style="list-style-type: none">• 400A-120/208V three phase secondary underground DIP BC Hydro service
	<p>Recommendations:</p> <ul style="list-style-type: none">• n/a

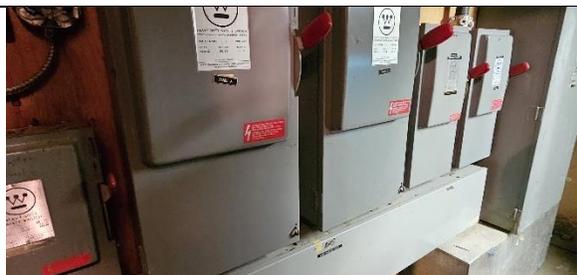
<p>Observations:</p> <ul style="list-style-type: none">• Main switch and sub-switches feeding several panel in the building.
	<p>Recommendations:</p> <ul style="list-style-type: none">• Maintain switches

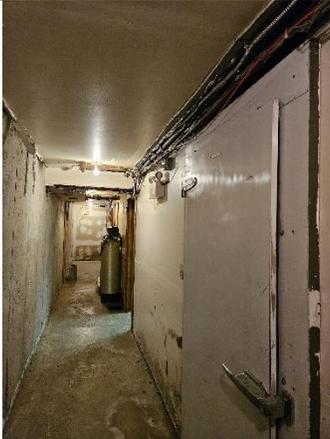
<p>Observations:</p> <ul style="list-style-type: none">• Emergency lighting is minimal but has been maintained. Lighting is generally fluorescent in fair condition.
	<p>Recommendations:</p> <ul style="list-style-type: none">• Continue annual checks of EM lighting. Upgrade general lighting to LED as fixtures fail or when funding is available.

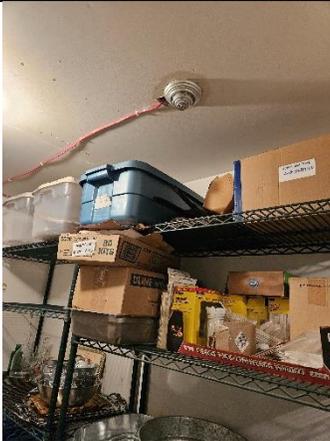
<p>Observations:</p> <ul style="list-style-type: none">• Building has a fire alarm system with minimal fire detectors.
	<p>Recommendations:</p> <ul style="list-style-type: none">• Continue annual verification and testing of fire alarm system.• Adding fire alarm devices could improve early detection of fires but not required by code.

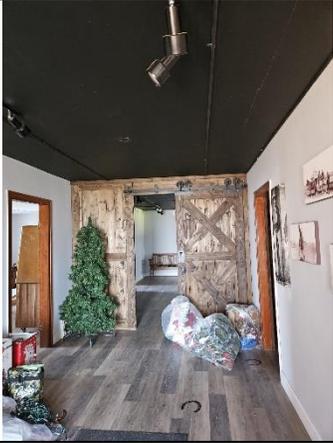
<p>Observations:</p> <ul style="list-style-type: none">• Mixture of fluorescent and screw base track lighting•
	<p>Recommendations:</p> <ul style="list-style-type: none">• Upgrade general lighting to LED as fixtures fail or funding becomes available

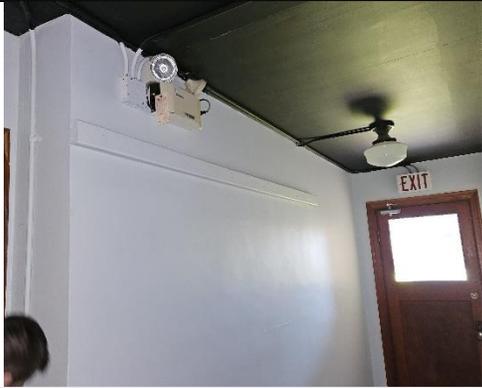
<p>Observations:</p> <ul style="list-style-type: none">• Minimal but acceptable level of emergency lighting and exit signage. No fire alarm system.
	<p>Recommendations:</p> <ul style="list-style-type: none">• Continue annual checks of EM lighting.

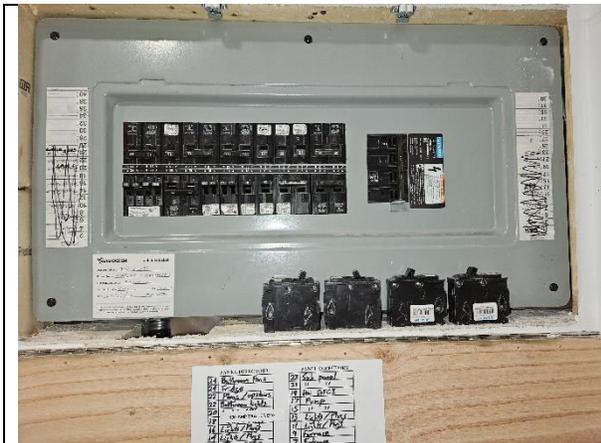
- Newer 200A-120/240V single phase BC Hydro service and panel

- Continue to maintain.

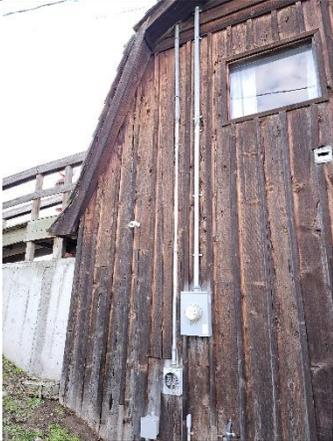
<p>Observations:</p> <ul style="list-style-type: none"> • Old decommissioned meter base on west side of building. •
	<p>Recommendations:</p> <ul style="list-style-type: none"> • Remove.

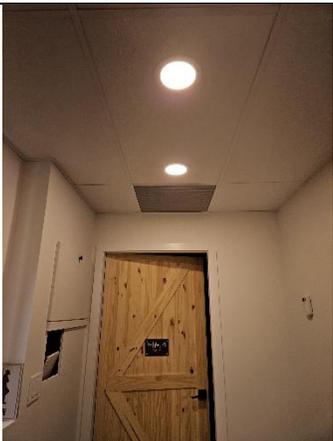
<p>Observations:</p> <ul style="list-style-type: none"> • Newer LED lighting in washrooms, fluorescent and screw base track in other areas.
	<p>Recommendations:</p> <ul style="list-style-type: none"> • Upgrade general lighting to LED as fixtures fail or funding becomes available.

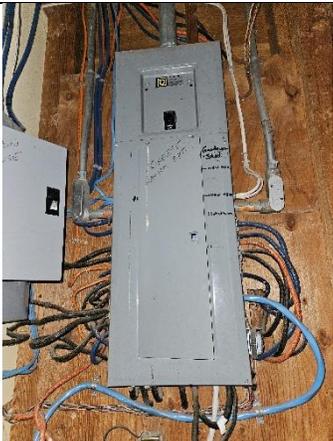
<p>Observations:</p> <ul style="list-style-type: none">• 200A single phase BC Hydro service is adequate. 60A sub panel adjacent.• <p>Recommendations:</p> <ul style="list-style-type: none">• N/A
---	--

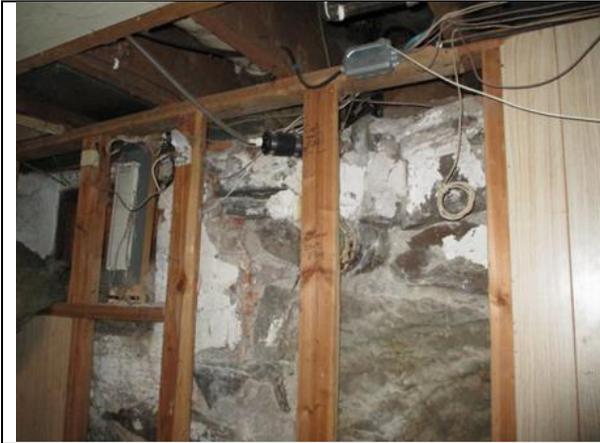
- Communications wiring and branch circuit wiring in basement is very messy.

- Clean up and support wiring in basement.

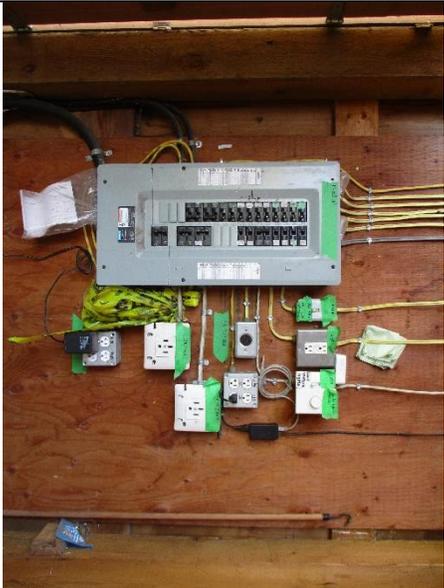
<p>Observations:</p> <ul style="list-style-type: none">• 100A-120/240V single phase service is sub-fed from the adjacent building. Special event receptacles installed adjacent.
	<p>Recommendations:</p> <ul style="list-style-type: none">• Maintain devices as required.

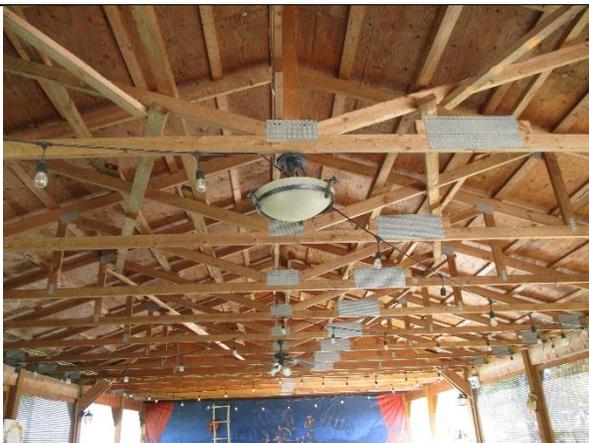
<p>Observations:</p> <ul style="list-style-type: none">• Screw base residential fixtures and string light suitable for location as long as no water spraying is done
	<p>Recommendations:</p> <ul style="list-style-type: none">• Ensure LED lamps are utilized. Weatherproof outdoor rated lights could be considered as an upgrade.• Continue to maintain emergency lighting battery packs.

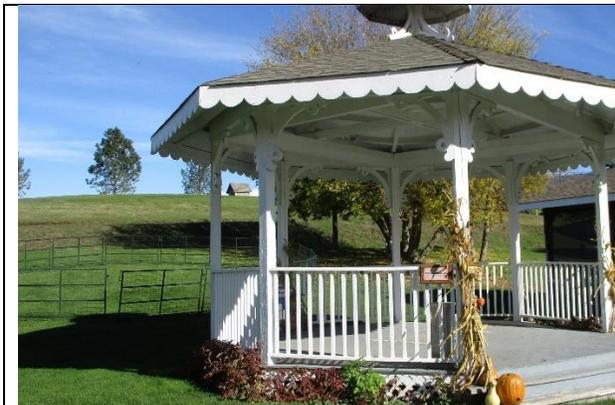
- Single lighting circuit fed from Pavilion

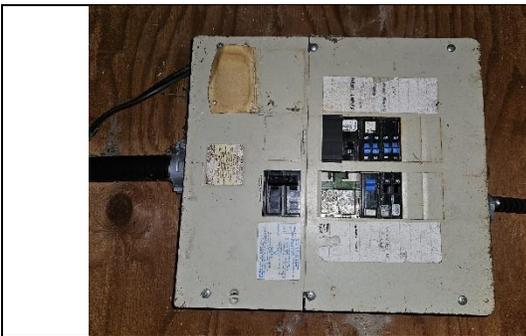
- 60A-120/240V single phase panel sub-fed from another building is adequate

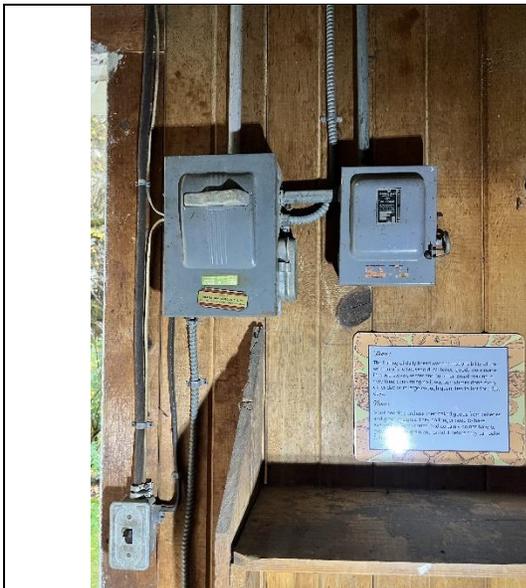
- Circuit fed overhead from mansion. Disconnect is very old and may fail when operated.

- Replace disconnect switch.

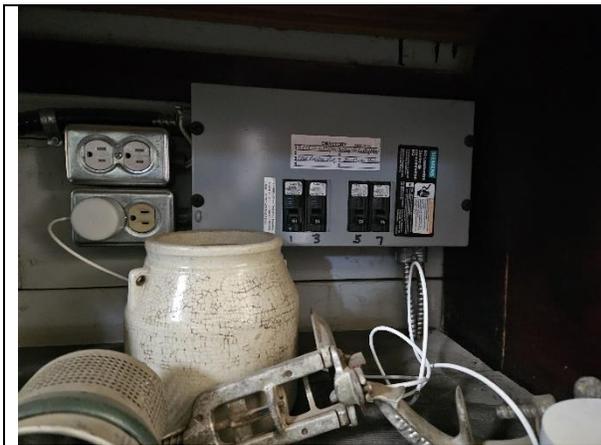
- 30A-120/240V single phase load centre located under the counter is sub-fed from the Log House service and is adequate for the usage.

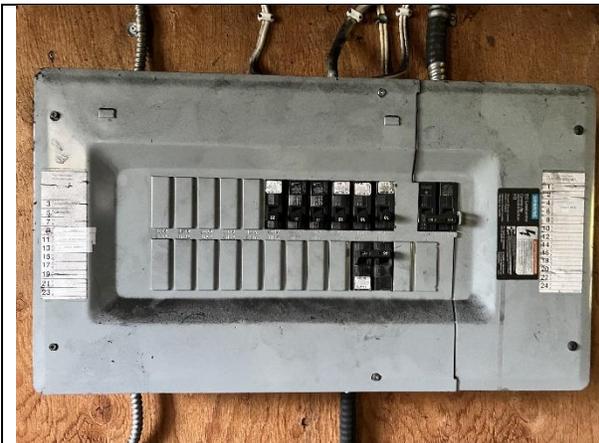
- Panel is sub-fed from the Log House at 60A-120/240V single phase and appears adequate for the useage.

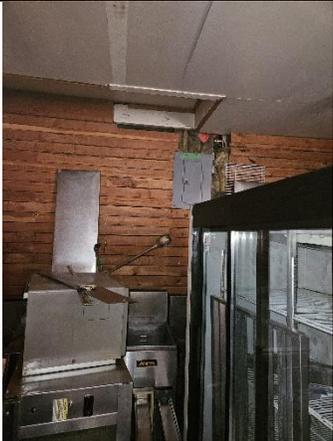
Observations: <ul style="list-style-type: none">• 120/240V load centre panel is fed from the Carriage Shed service.
	Recommendations: <ul style="list-style-type: none">• N/A

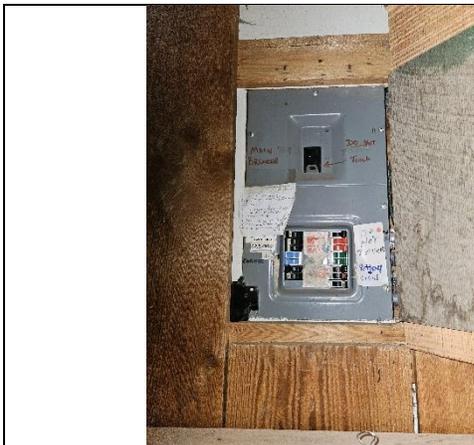
- 120/240V load centre panel is fed from a BC Hydro pole on the highway.
-

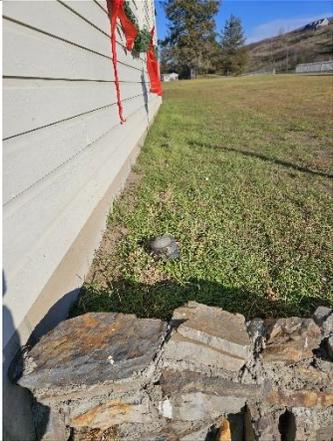
<p>Observations:</p> <ul style="list-style-type: none">• Exterior in ground lights are proud of the ground. <p>Recommendations:</p> <ul style="list-style-type: none">• Check that these lights are properly installed and protected from equipment damage.
---	---

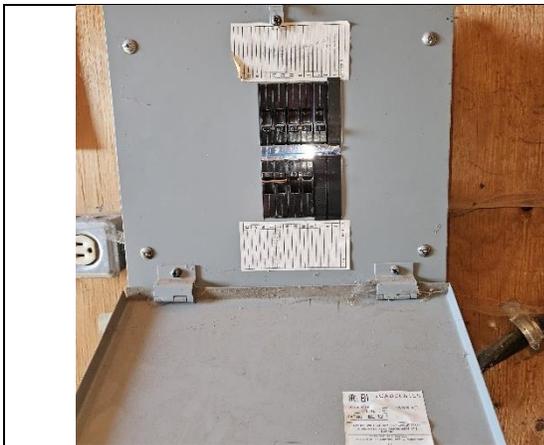
- Electrical panel is sub-fed from Implement Shed.

- Older style ITE panel breakers will be difficult to obtain. Panel should be scheduled for replacement.

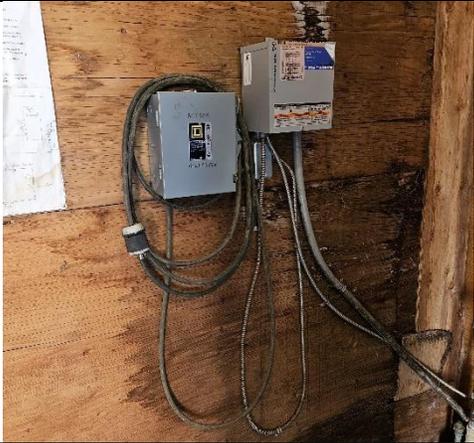
<p>Observations:</p> <ul style="list-style-type: none">• Pumphouse has a manual transfer switch for connection of a portable generator. <p>Recommendations:</p> <ul style="list-style-type: none">• N/A
---	---

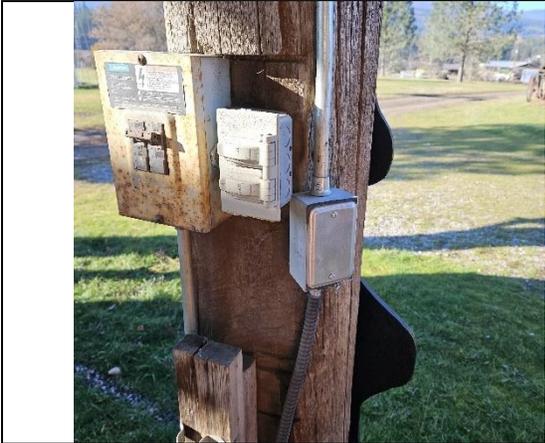
- Circuits fed from panel in SPPC#2. Non-weatherproof disconnect switch is exposed to weather and is rusting.

- Replace disconnect switch with weatherproof.

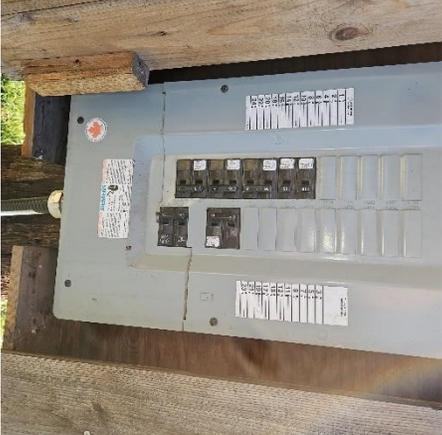
<p>Observations:</p> <ul style="list-style-type: none">• Newer 100A-120/240V single phase panel is located in weather protective wooden cabinet. <p>Recommendations:</p> <ul style="list-style-type: none">• N/A
---	--

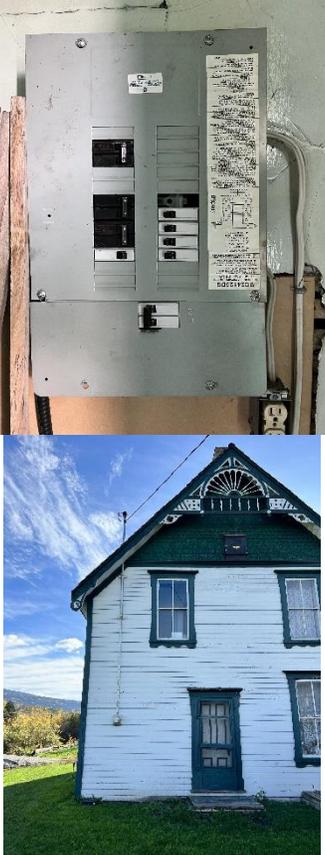
<p>Observations:</p> <ul style="list-style-type: none">• 600A-120/240V single phase service BC Hydro overhead service is sufficient for the use <p>Recommendations:</p> <ul style="list-style-type: none">• Provide missing breaker fillers.
--	--

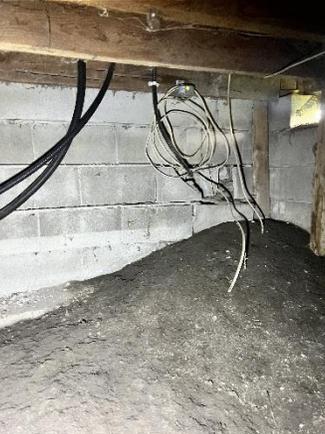
<p>Observations:</p> <ul style="list-style-type: none">• Wiring appears to be standard NMD-90 cable throughout. <p>Recommendations:</p> <ul style="list-style-type: none">• Wiring in crawlspace should be cleaned up.
---	--

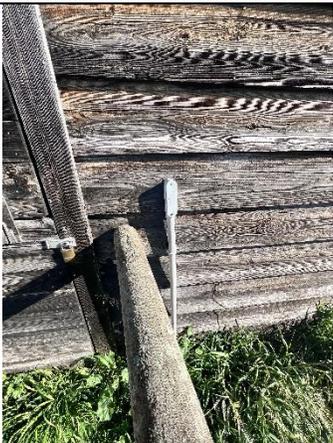
<p>Observations:</p> <ul style="list-style-type: none">• Single lighting circuit is fed from the house. <p>Recommendations:</p> <ul style="list-style-type: none">• N/A
---	---

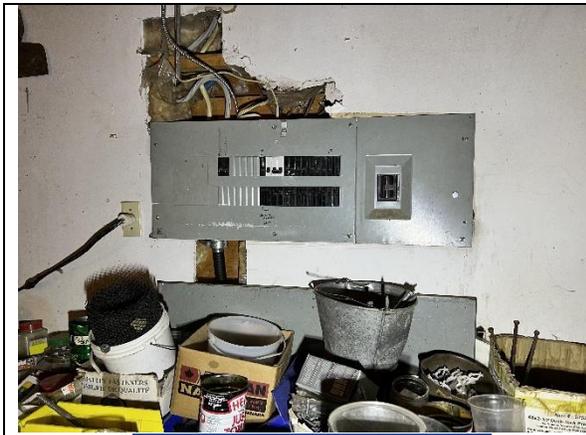
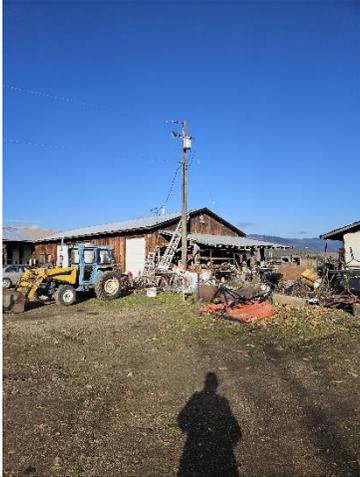
- 200A 120/240V single phase panel is fed overhead from BC Hydro system.

- Maintain circuit breakers.

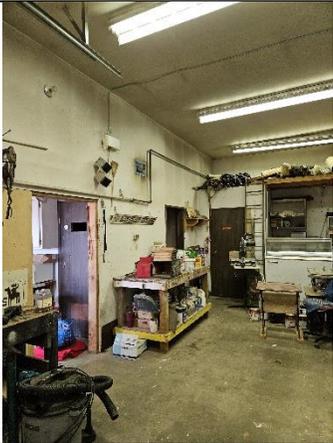
<p>Observations:</p> <ul style="list-style-type: none">• Minimal emergency lighting is installed
	<p>Recommendations:</p> <ul style="list-style-type: none">• Continue to test emergency lighting regularly.
